# FORMER BRADLEY MILL BUILDINGS, BRADLEY LANE, NEWTON ABBOT, DEVON

Heritage Assessment

> > Document No: ACD2470/1/2

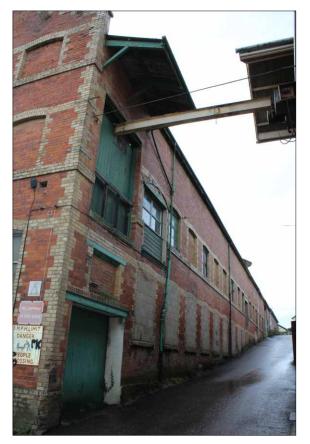
Plate 1: North elevation of structure 1, looking south

- **6.3** The north elevation has 10 ground-floor window openings and an inserted doorway to the east with a blocked opening above (Plate 1). The door is wooden and all the window openings are infilled with concrete blocks. On the first floor are eight window openings and three doors; four of the windows have been infilled with brick. The eastern doorway is secondary, and has a loading arm and is fitted with wooden doors. The doorway adjacent to this has been partially infilled and contains a late 20th-century window. Two of the other windows have UPVC fittings, whilst the other two have early 20th-century wooden frames with multiple panes. The western door is a wooden sliding design and has been inserted into a former window opening. All the openings apart from the inserted doorway have arched brick heads.

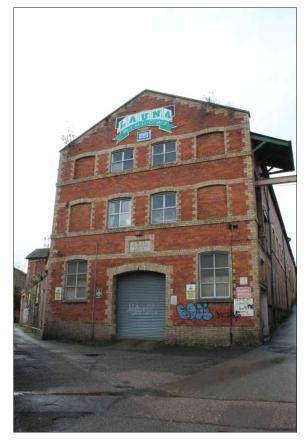
Plate 2: East elevation of structure 1, looking southwest

- **6.4** The east elevation has two windows and a large central doorway, fitted with a modern roller shutter, on the ground floor (Plate 2). The windows have mid-20th century metal frames. Above the door is a plaque engraved 'J.V. & S. Rebuilt 1883'. This probably refers to J. Vicary and Sons, run by John Vicary junior following the death of his father, also John in 1880; the company was previously called J. Vicary and Brothers (Bodman 2008, 95). On both the first and second floors there are four window openings with the outer openings on each floor being infilled with brick. The others have mid 20th-century metal-framed windows. All the openings have arched brick heads. At the top of the gable is a circular opening obscured by modern signage.

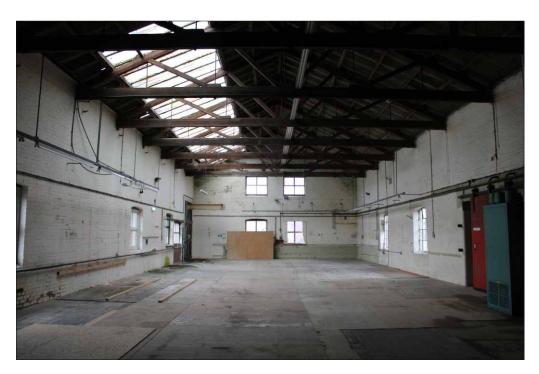
Plate 3: Internal view of structure 1, looking northeast

**6.6** Only the first floor of the structure was accessible at the time of the site visit. This floor comprises a single open room with wooden floorboards (Plate 3). Towards the west end of the south elevation, there is a sliding mid-20th century metal door with a further two blocked doorways beyond this, infilled with brick. The first has a concrete lintel and the second has an arched head and is probably an original opening. In the

west wall is a large opening into structure 2. The roof is supported on nine wooden king-post trusses each with five vertical iron braces and diagonal wooden struts.

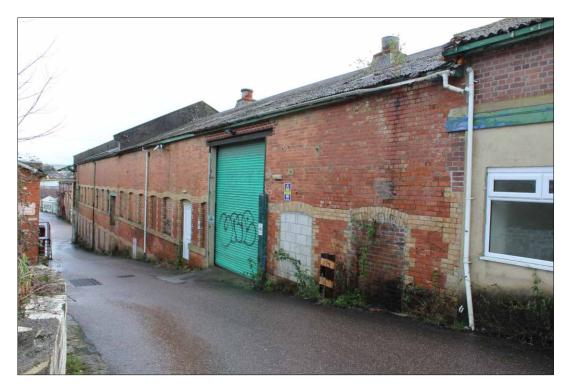
Plate 4: North elevation of structure 2, looking east

**6.7** This structure is contemporary with and integral to structure 1, and is constructed in the same style. The north elevation has five ground-floor window openings that have been infilled with concrete blocks and are partially obscured by the road (Plate 4). Although the building is terraced into the hillside, the design of the windows indicates that the adjacent length of Bradley Lane has been raised in height in the recent past in front of the openings at the west end of the building. The first floor has eight window openings infilled with brick, a doorway in a former window opening (now infilled with concrete blocks but retaining a UPVC door internally) and an inserted large roller door that has truncated one infilled window and based on the spacing of the historic openings has completely removed another window opening.

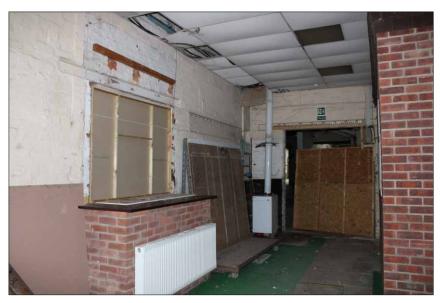
Plate 11: Internal view of structure 4, showing blocked openings in the north wall, looking north

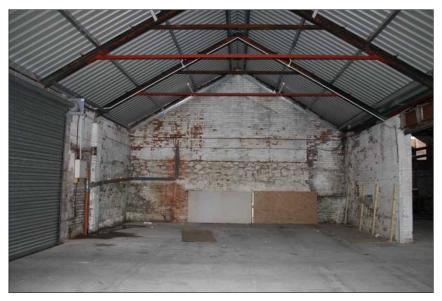
**6.14** This building is terraced into the hillside to the north, but is only single storeyed. The north wall has a sloping buttress along the base and the line of a former lower roof is visible (Plate 12). Parts of the buttress are constructed of rubble stone along with brick. The replacement roof is supported on four steel trusses. The floor is concrete. There is a large opening in the east wall giving access to structure 6, with an adjacent UPVC door to the south.

Plate 12: Internal view of structure 5, showing earlier roof line, looking north
