Teignbridge District Council

Teignmouth Beach Management Plan

Teignmouth and Shaldon Beach Management Plan

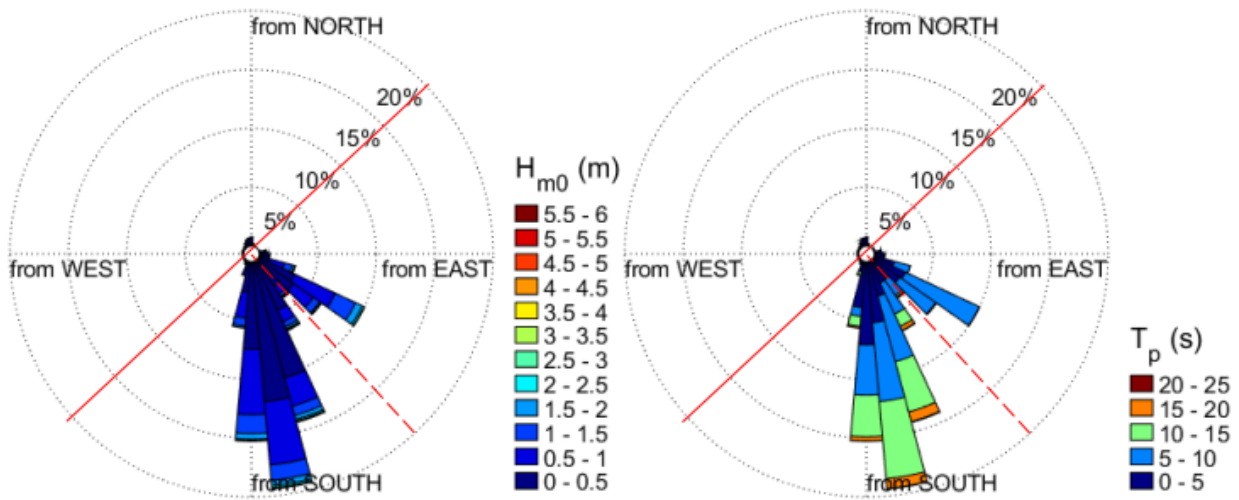
Figure 2-3 Directional wave roses of significant wave height (left panel) and peak wave period (right panel), measured by the Dawlish waverider buoy at the -14mODN depth contour, between December 2010 and Feb 2024. The red solid and dashed lines indicate the angle of the shoreline and shore normal wave approach (145°), respectively.

- A bimodal wave climate, with a dominant wave component from the south-south-east (southerly component), and a secondary component from the east-south-east (easterly component), see Figure 2-3 for wave rose plots.
- A clear seasonality in the wave height, where December, January, and February experience the largest average and maximum wave heights, which usually decline to their minimum values in July.
- A decline in easterly wave conditions, starting in the 1950s, and declining further from the 1990s.
- Relatively constant southerly storm activity over the same period (i.e. since the 1950's).
- For wave data between 2010 and 2024, 2/3rds (67%) of the total wave power came from the south, and only 1/3rd (33%) came from the east.

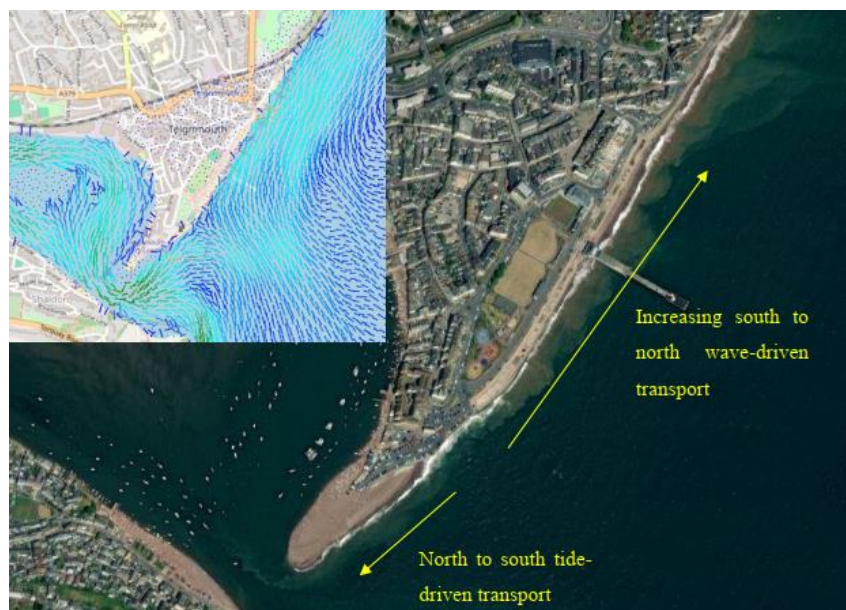
Figure 2-4 Demonstration sediment being transported in opposing directions during a flooding-high tide with southerly wave approach.

Rather, the latest modelling demonstrated that flow divergences (and therefore a net sediment flux divergence) are likely to occur under certain conditions between Teignmouth Lighthouse and Teignmouth Pier during flooding and high tide stages, and particularly when spring tides are combined with southerly storm waves. Such a divergence is not predicted to occur at ebbing or low tide stages, or under waves arriving from the east, such that sediment transport to the north is dominated by southerly wave-driven transport. An example of diverging sediment transport occurring at this location can even be seen from aerial imagery, visible as suspended sediment plumes moving in opposite directions. This is demonstrated in Figure 2-4.

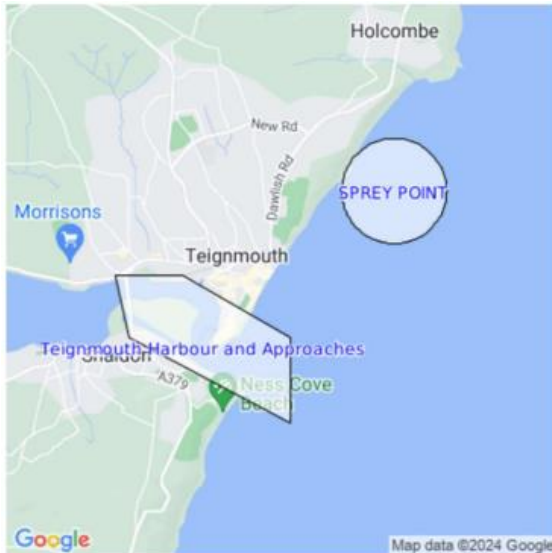
Figure 2-5 Map showing areas of the estuary channel dredged by THC and the dredge disposal location at Sprey Point (reference number PO070) (source: ADBP LLP, 2024).

- **Grab hopper dredging** – where material is removed from the channel and redeposited at a designated spoil site. The depositing of the spoil requires a licence and following successful application from the Marine Management Organisation (MMO), THC have been granted permission to deposit 99,999 tonnes/annum of dredged material at Sprey Point. (as shown in Figure 2-5). However, this is seen as an

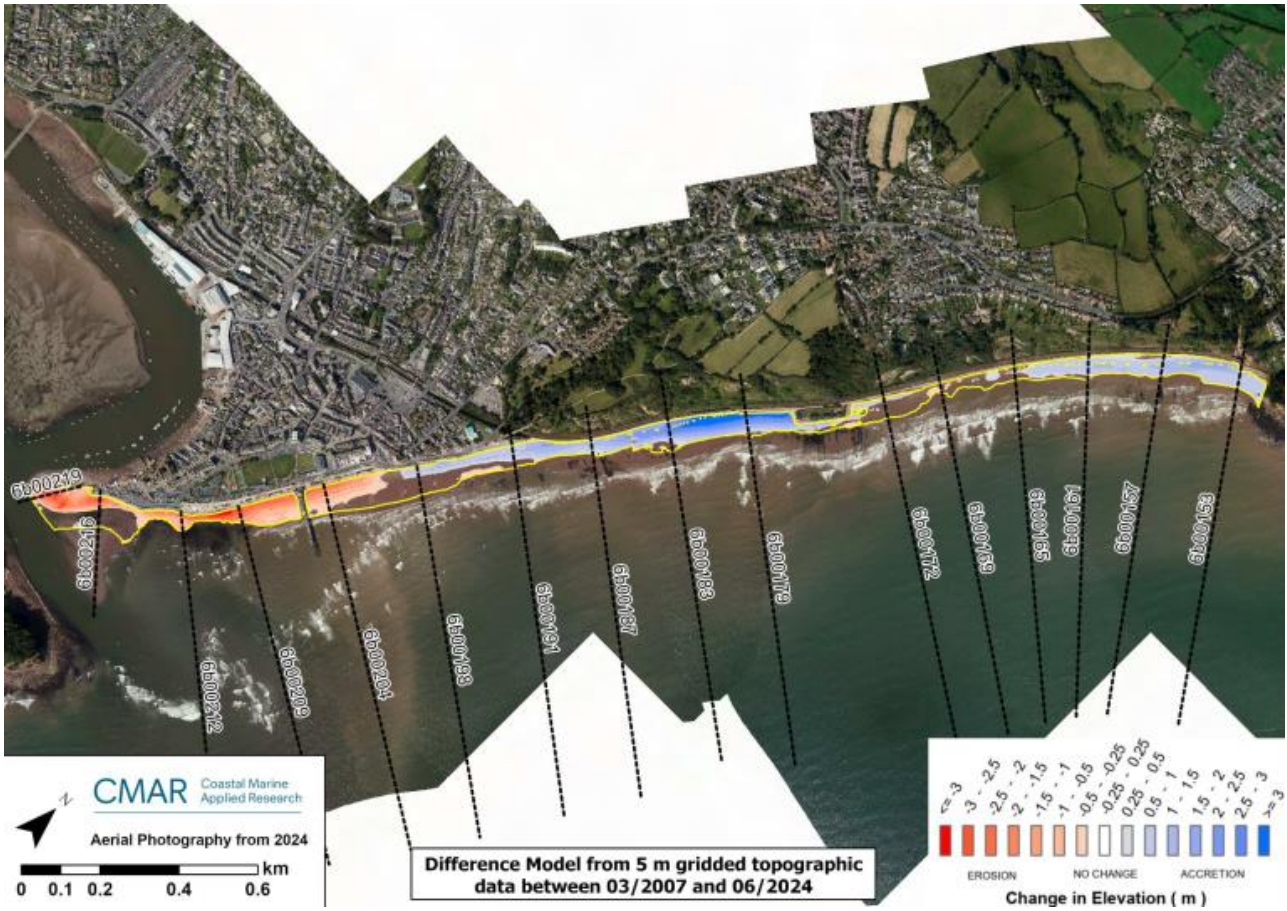
Figure 2-6 LiDAR difference plot showing beach elevation change for the period 2007–2022 along the Teignmouth open coast. Red colour indicates net loss of material and blue colour indicates net gain of material.

Beach levels along sections of the Shaldon and Teignmouth frontage are observed to be lowering, and are particularly volatile along the Teignmouth open coast. This is noted in the project scope and has been investigated further with new analysis (completed for this BMP) of topographic (LiDAR) data sets (May 2007 & April 2022) and intertidal beach profiles (2007 to 2023 (2011 to 2023 for Shaldon Beach), to assess changes to beach elevation and volume. The findings are summarised below and presented in Figure 2-6 and Figure 2-7.

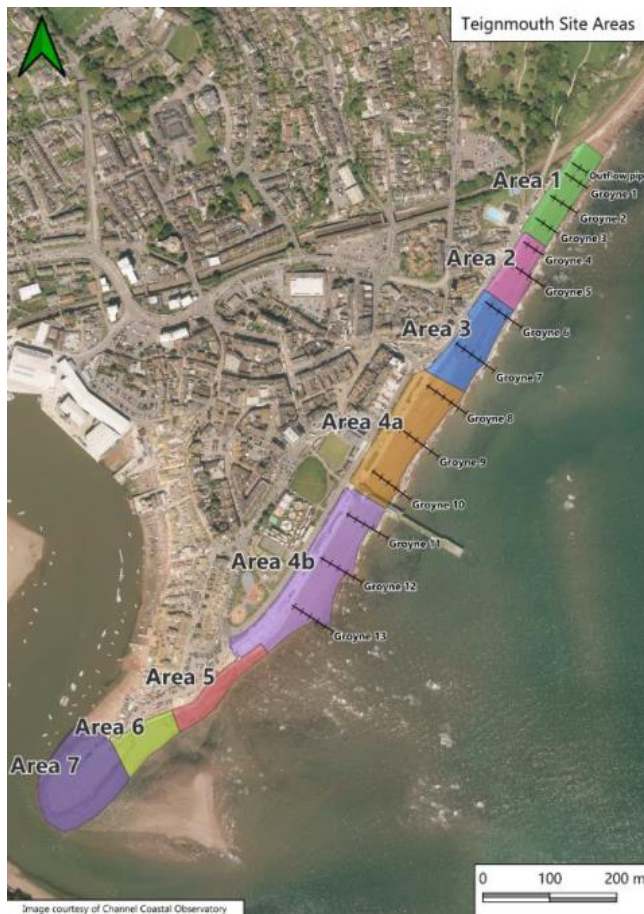
Figure 3-1 Seawall stability assessment area division (Binnies, 2024).

Area	Profile	FoS = 1 (mOD)*	1in100 scour depth (m)**	Largest inter survey drop in past 5 years (m)	Alarm (mOD)	Crisis (mOD)
2	6b00194 to 6b00196	-3.5	1.72	-0.95	-0.83	-1.78
3	6b00197 to 6b00200	-0.3	1.72	-0.95	2.37	1.42
4a	6b00201 to 6b00205	-1.25	1.97	-1.48	2.2	0.72
4b	6b00206 to 6b00211	-1.25	1.86	-1.12	1.73	0.61
5	6b00212 to 6b00214	-4	1.79	-1.73	-0.48	-2.21
6	6b00215 to 6b00216	-3.7	1.75	-0.9	-1.05	-1.95

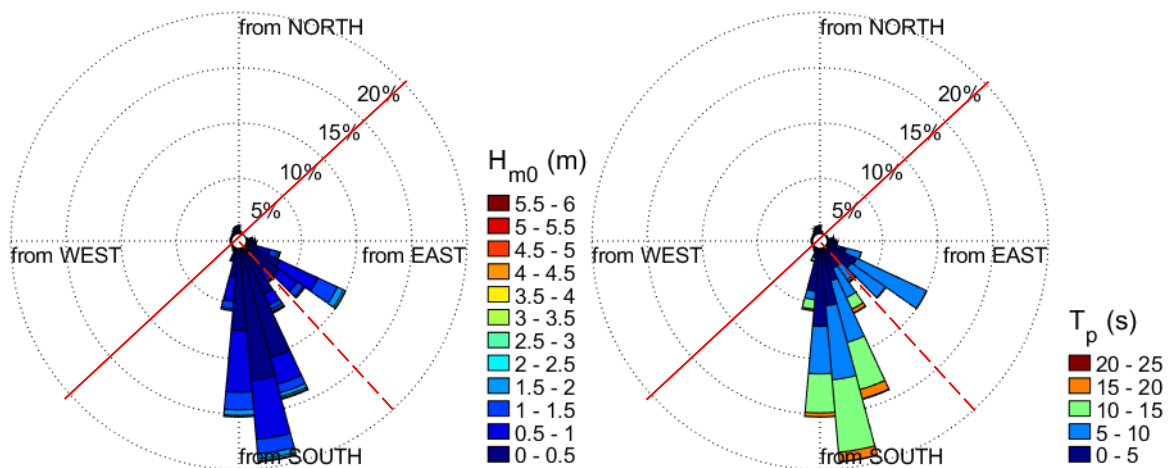
Figure 2-1 Directional wave roses of significant wave height (left panel) and peak wave period (right panel), measured by the Dawlish waverider buoy at the -14 mODN depth contour, between December 2010 and Feb 2024. The red solid and dashed lines indicate the angle of the shoreline and shore normal wave approach (145°), respectively.

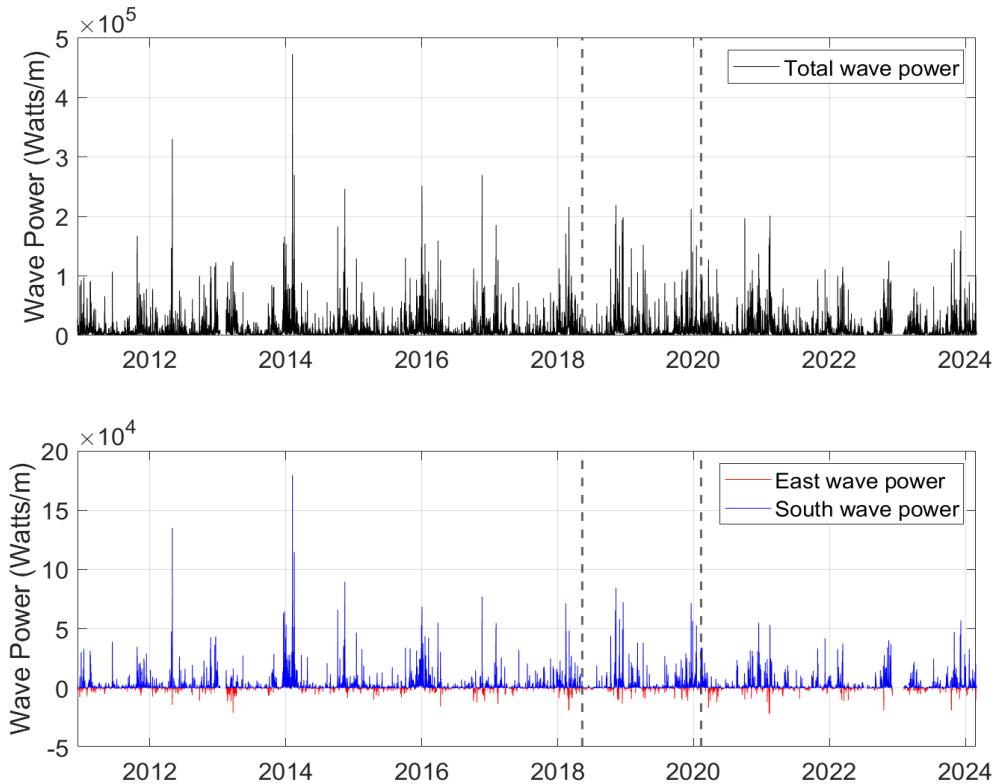
Figure 2-7.Total wave power (upper panel) and alongshore orientated wave power (lower panel) from the south (blue) and east (red) computed from Dawlish wave buoy data, measured at approximately -14 mODN depth contour. A direction of 145° from north was used to differentiate waves arriving from the two dominant approaches. The dashed lines indicate the multi-annual period simulated in Section 5.3.

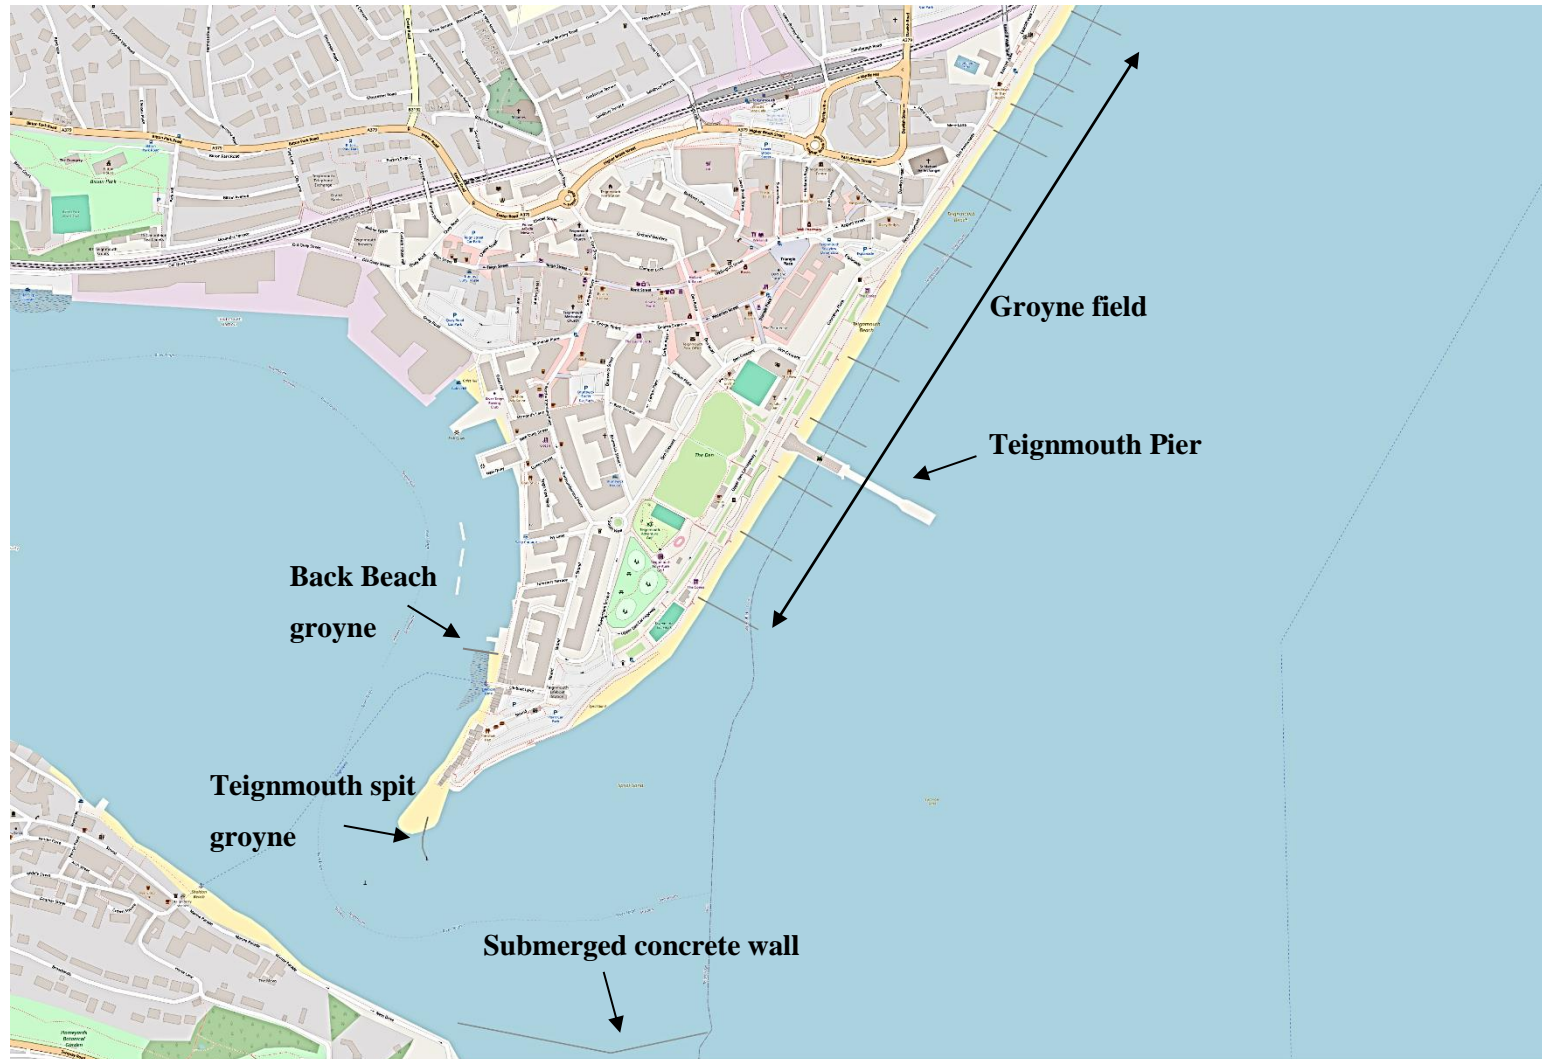
Figure 3-2. Teignmouth coastline featuring various engineered structures. Seawalls extending along the entire frontage of Teignmouth seafront beach, Teignmouth Back Beach and Shaldon Beach.

Teignmouth's coastline also features a number of engineered structures, which influence sedimentation and geomorphology in various ways (Figure 3-1 and Figure 3-2). The conceptual effects of such structures on beach geomorphology are reviewed in Appendix A. The structures include:

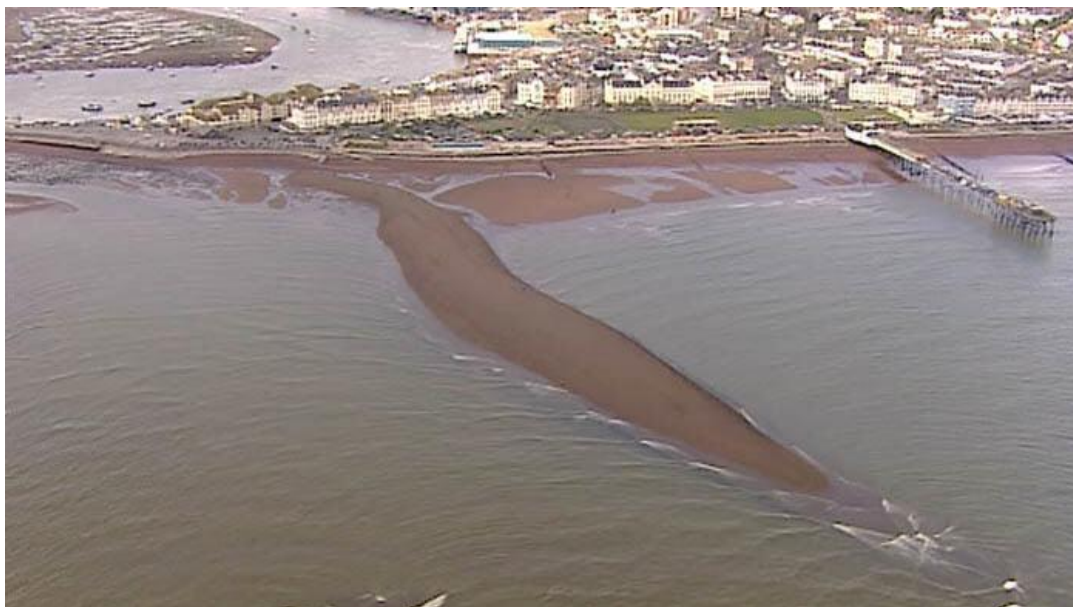
Figure 3-6. The Inner Pole of Teignmouth ebb-tidal delta during a shore-attached phase in 2001. As the Inner Pole migrates to the shore it delivers a significant supply of sand to the beach adjacent to Teignmouth Lighthouse (New Forest District Council, 2017).

For example, the Outer Pole can hold 7,000-9,000 m³ of sediment (Siegle et al., 2007) which, during stage 3, returns to the shore adjacent to Teignmouth Lighthouse (Figure 3-6), before the sand is moved southwards by tide and wave-driven littoral currents back towards the ebb-tidal delta. This is likely to be a key natural process for re-nourishing the shoreline between Teignmouth Lighthouse and Denn Spit (New Forest District Council, 2017), returning sediment to the shoreline that was previously stored within the ebb-tidal delta.

The Outer Pole (Figure 3-4 and Figure 3-5) is known to sporadically inject large volumes of sediment back onto the intertidal beach approximately at the location of the observed beach lowering (for example in 2001, Figure 3-6). The sandbank circulation takes on average 40 months (Robinson, 1975), so it would be expected that at least 4 cycles have occurred since the start of the 15-year SWCMP monitoring record. Close inspection of intertidal beach volumes at the worst affected area of beach lowering (SWCMP profiles 6b00204-6b00212) indicate that peaks in sediment volume have indeed occurred at approximately 2-4 year intervals (Figure 4-8). This is assumed to be caused by welding of the Inner Pole/Horseshoe Bank to the shore at this location and represents a significant increase in sediment volume when it occurs (50-100 m³/m). However, these peaks in volume are short-lived, typically reducing again in the following years. The statistically significant negative trend over the 15-year monitoring record suggests that the sandbar circulation alone is not sufficient to maintain beach levels over the long term.

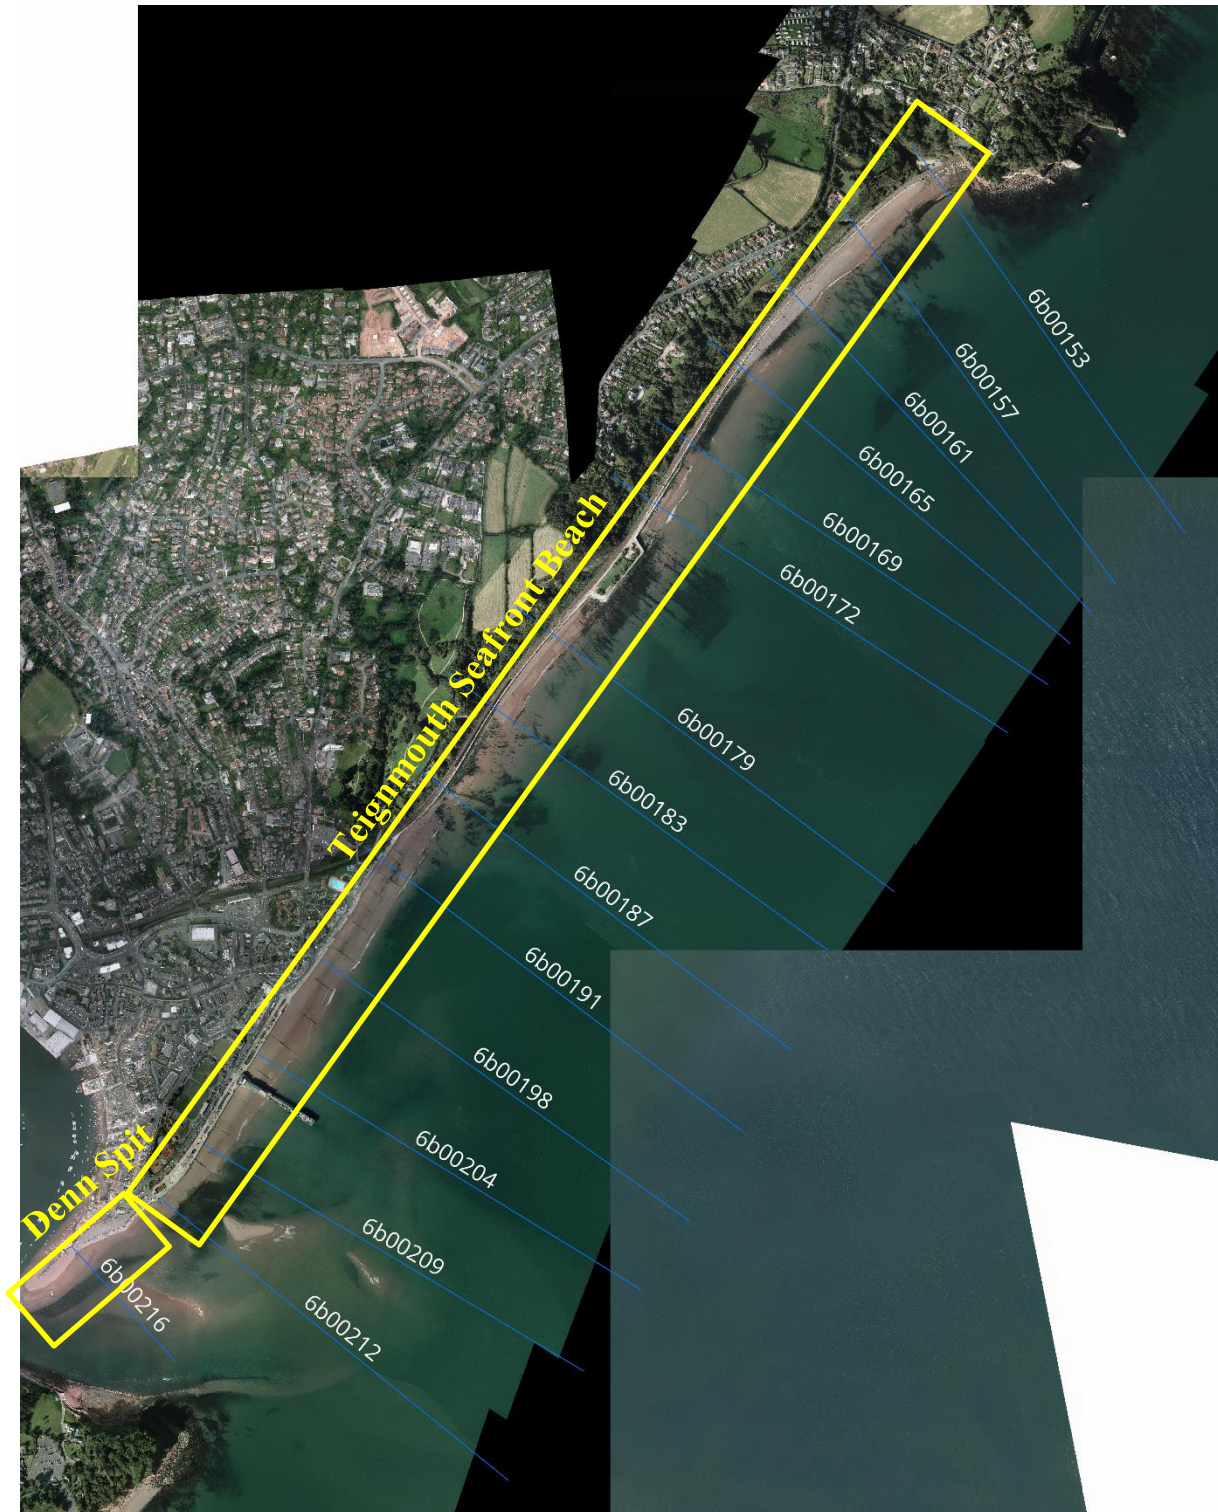
Figure 4-1. Sitemap showing SWCMP interim profile locations for the Teignmouth Seafront Beach. All of the profiles shown were analysed as part of this coastal processes assessment.

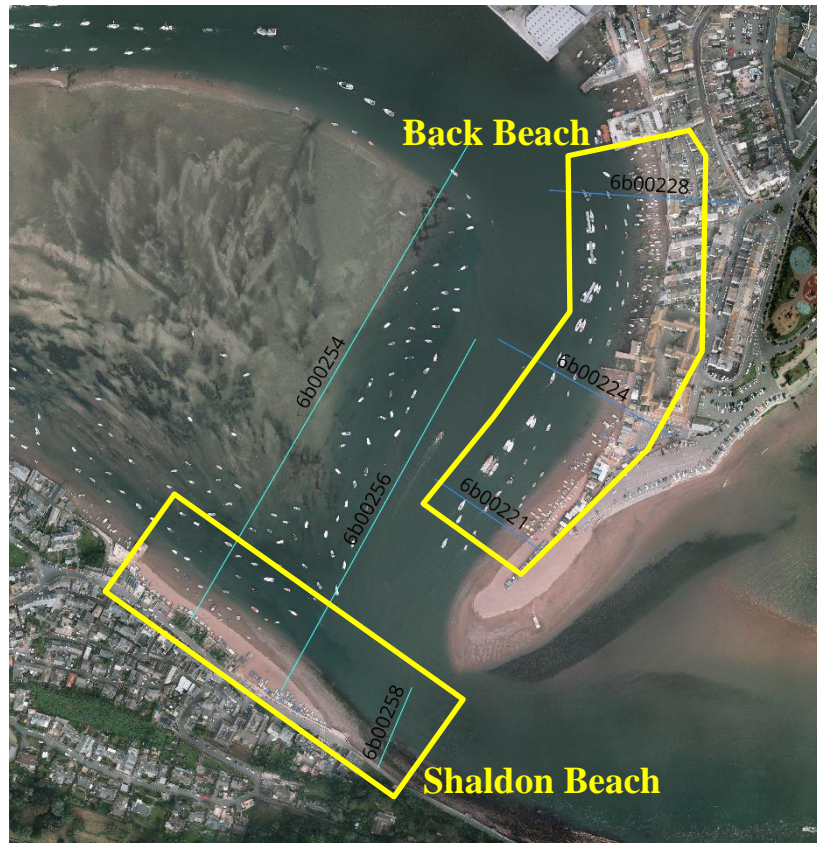
Figure 4-2. Sitemap showing SWCMP interim profile locations for Teignmouth Back Beach and Shaldon Beach.

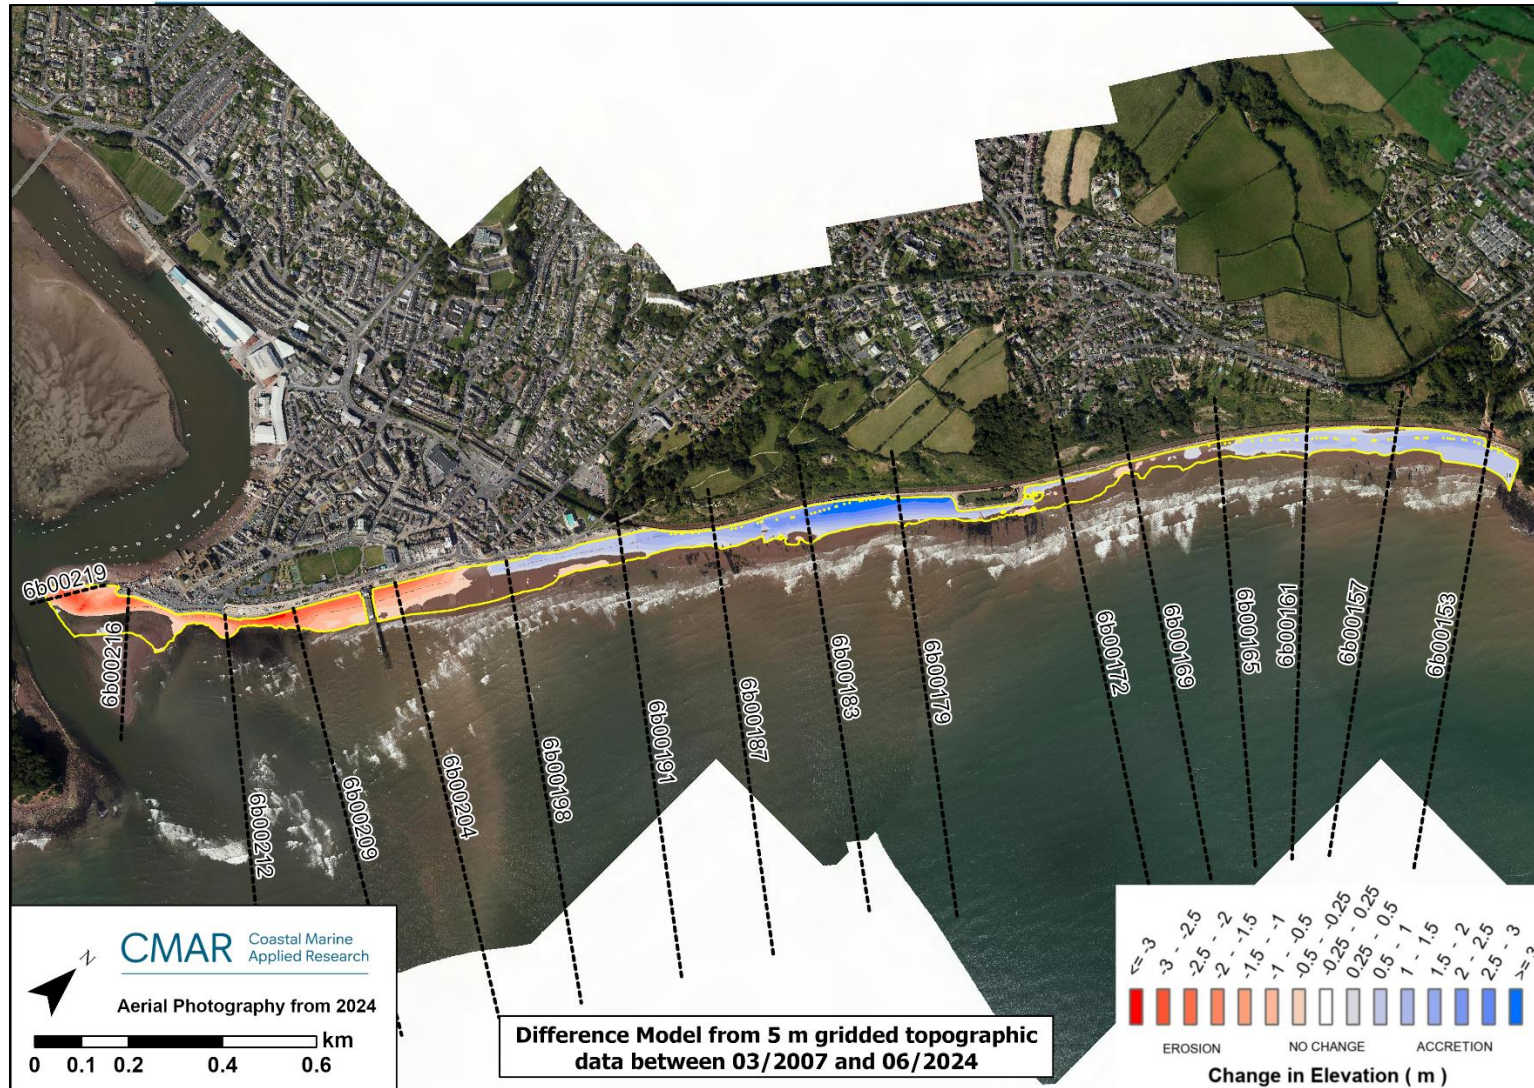
Figure 4-7. Net morphological response for the period 2007–2024 across all of Teignmouth Seafront Beach (Full Extent) from gridded topographic data. Red colour indicates net loss of material and blue colour indicates net gain of material.

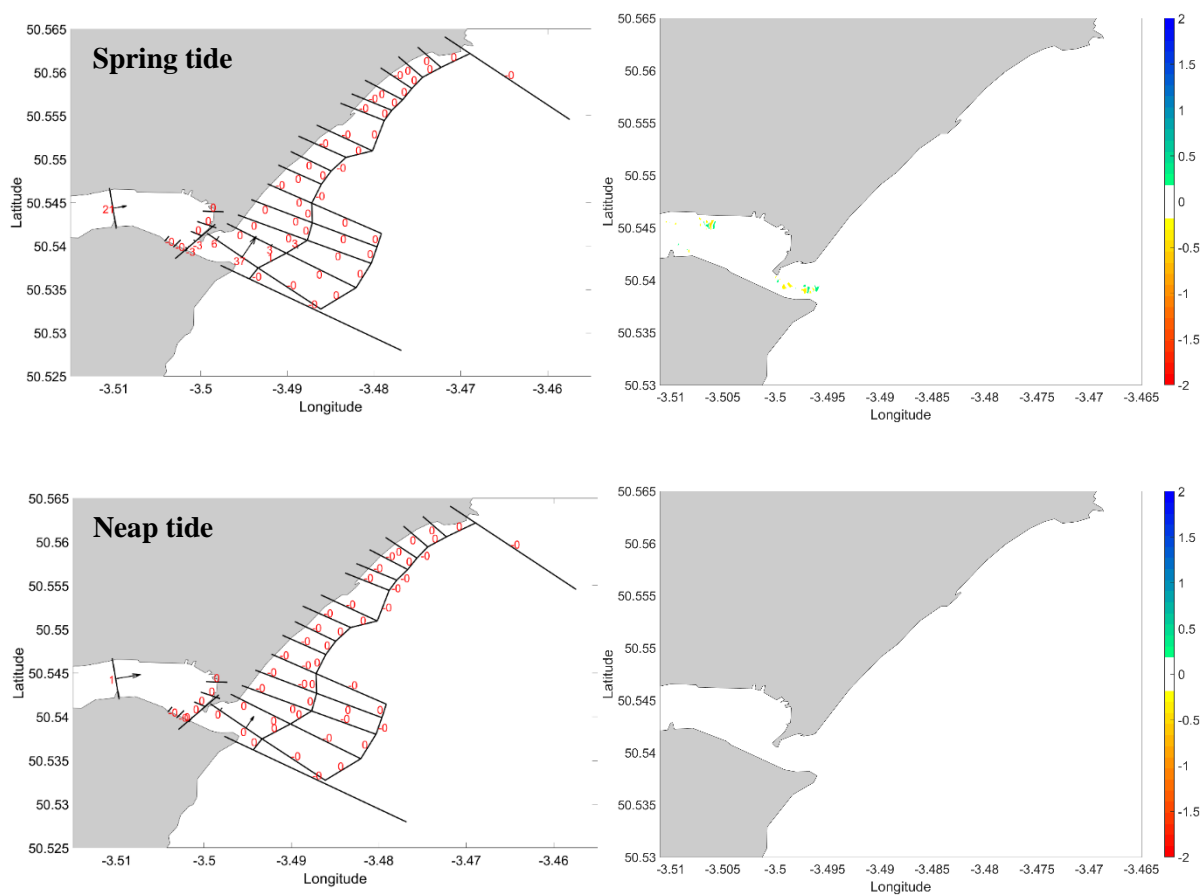
Figure 5-1. Net sediment transport fluxes (left panels; m³/day) and bed level change (right panels; m) predicted by the Delft3D-FM model for a 3.5-day tide-only simulation (Section C.3) under mean spring tides (upper panels) and mean neap tides (lower panels). Alongshore net fluxes are predicted at the locations of SWCMP interim profiles (See Figure 4-1. and Figure 4-2.) and bounding headlands, while cross-shore fluxes are predicted at the DoC contour (-5.4

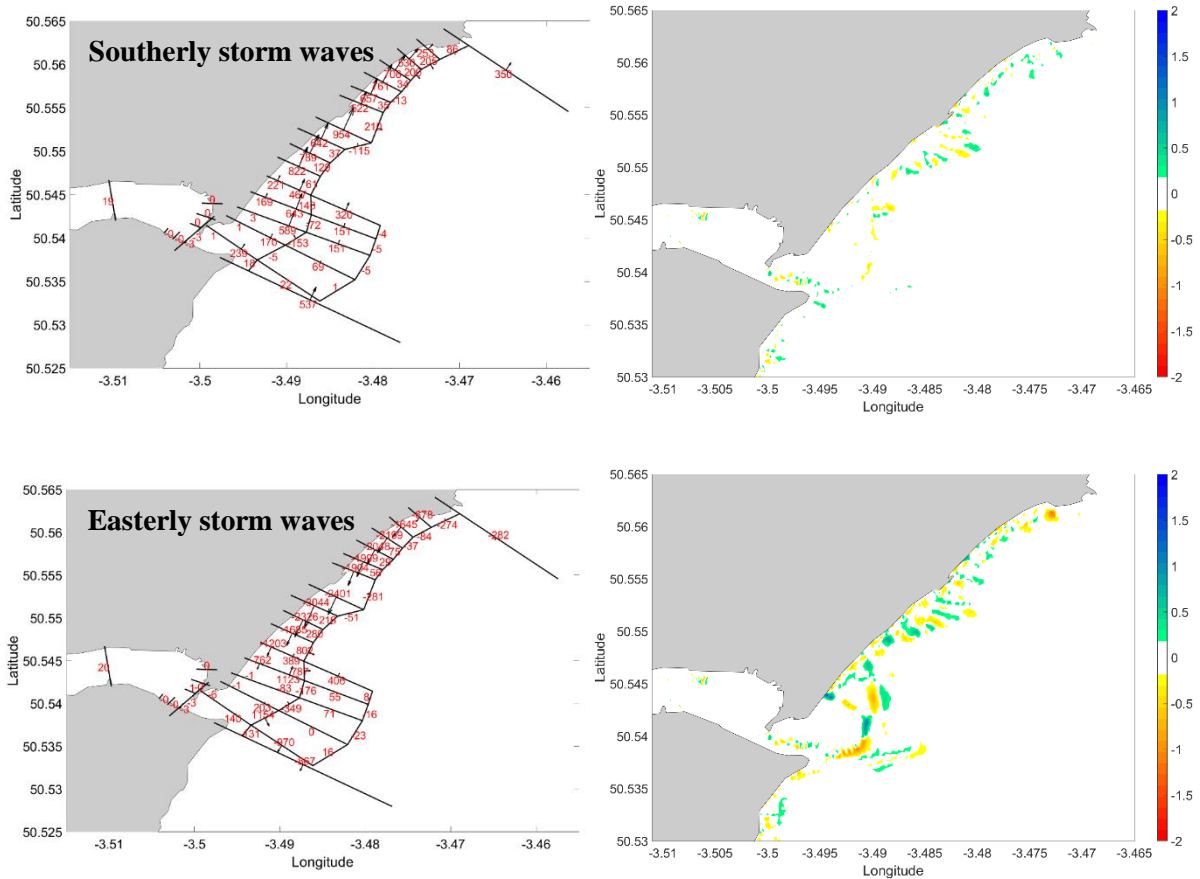
Figure 5-2. Net sediment transport fluxes (left panels; m³/day) and bed level change (right panels; m) predicted by the Delft3D-FM model for a 3-day simulation under storm threshold waves from the south (upper panels) and east (lower panels), combined with mean spring tides (Section C.3). Alongshore net fluxes are predicted at the locations of SWCMP interim profiles (See Figure 4-1. and Figure 4-2.) and bounding headlands, while cross-shore fluxes are predicted at the DoC contour (-5.4 mODN) for the coastal frontage, plus the 10 m depth contour for the ebb-tidal delta. Positive fluxes are northward and/or eastward.

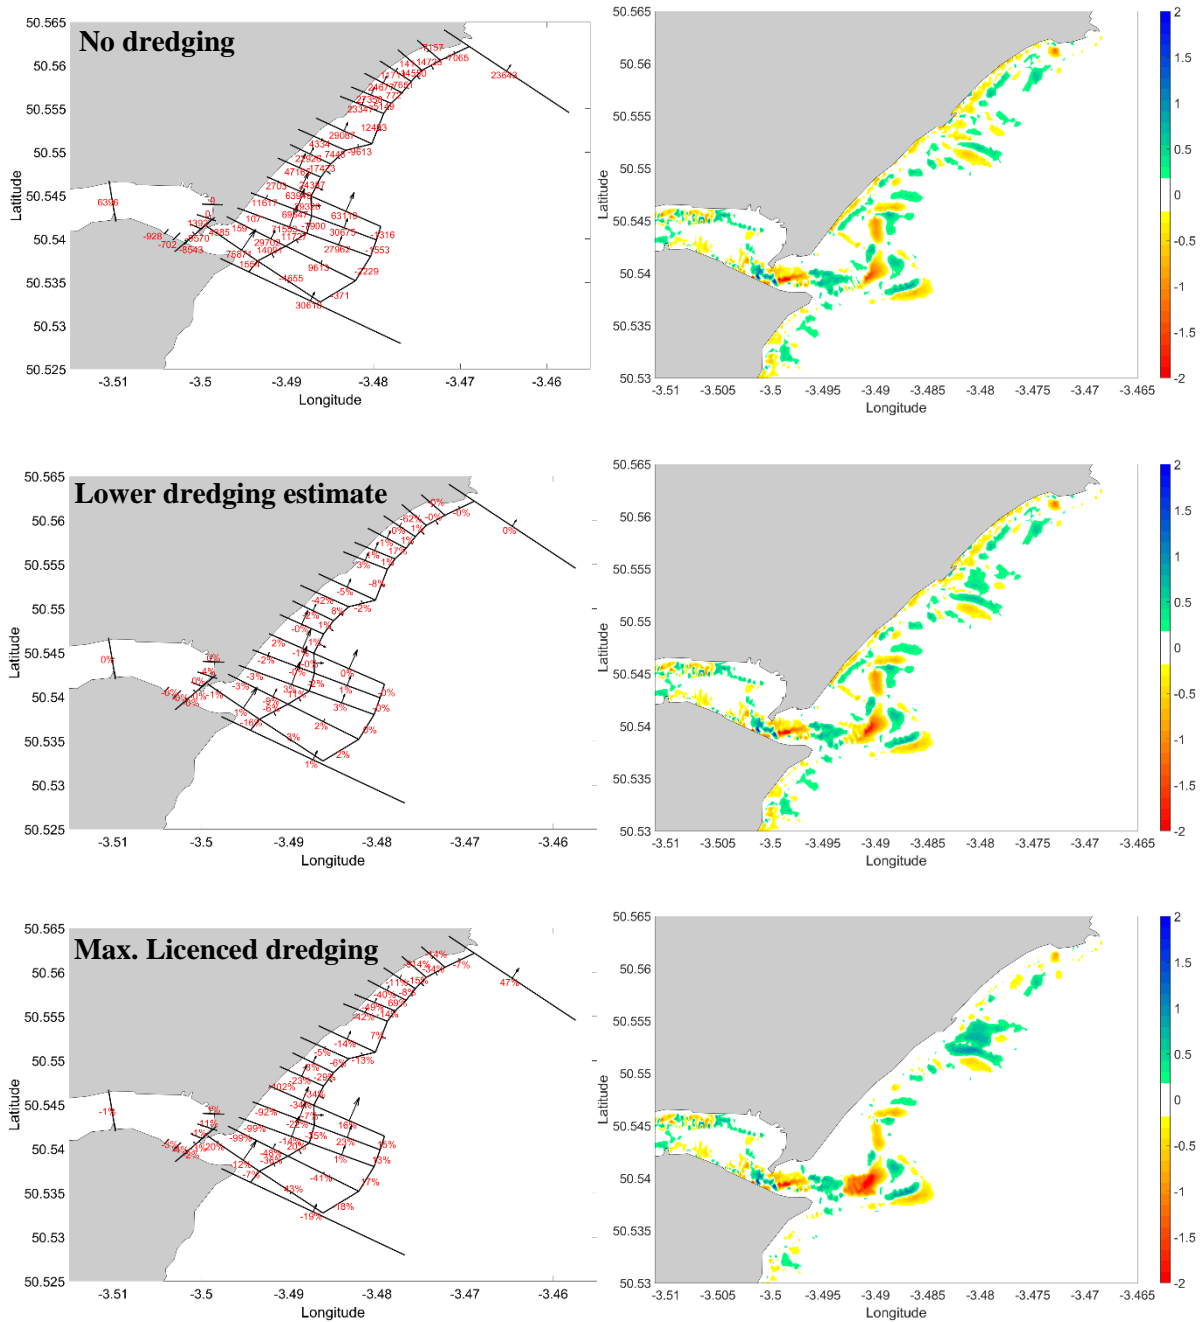
Figure 6-2. Change in net sediment transport flux due to dredging (left panels; %) and bed level change (right panels; m) predicted by the Delft3D-FM model for a 21-month simulation with varied waves and tides (Section C.3). Results are from simulations with no dredging (upper panels), the lower estimated dredge quantity (middle panels), and the maximum licenced dredge quantity (lower panels). Alongshore net fluxes are predicted at the locations of SWCMP interim profiles (See Figure 4-1. and Figure 4-2.) and bounding headlands, while cross-shore fluxes are predicted at the DoC contour (-5.4 mODN) for the coastal frontage, plus the 10 m depth contour for the ebb-tidal delta. Positive fluxes are northward and/or eastward.

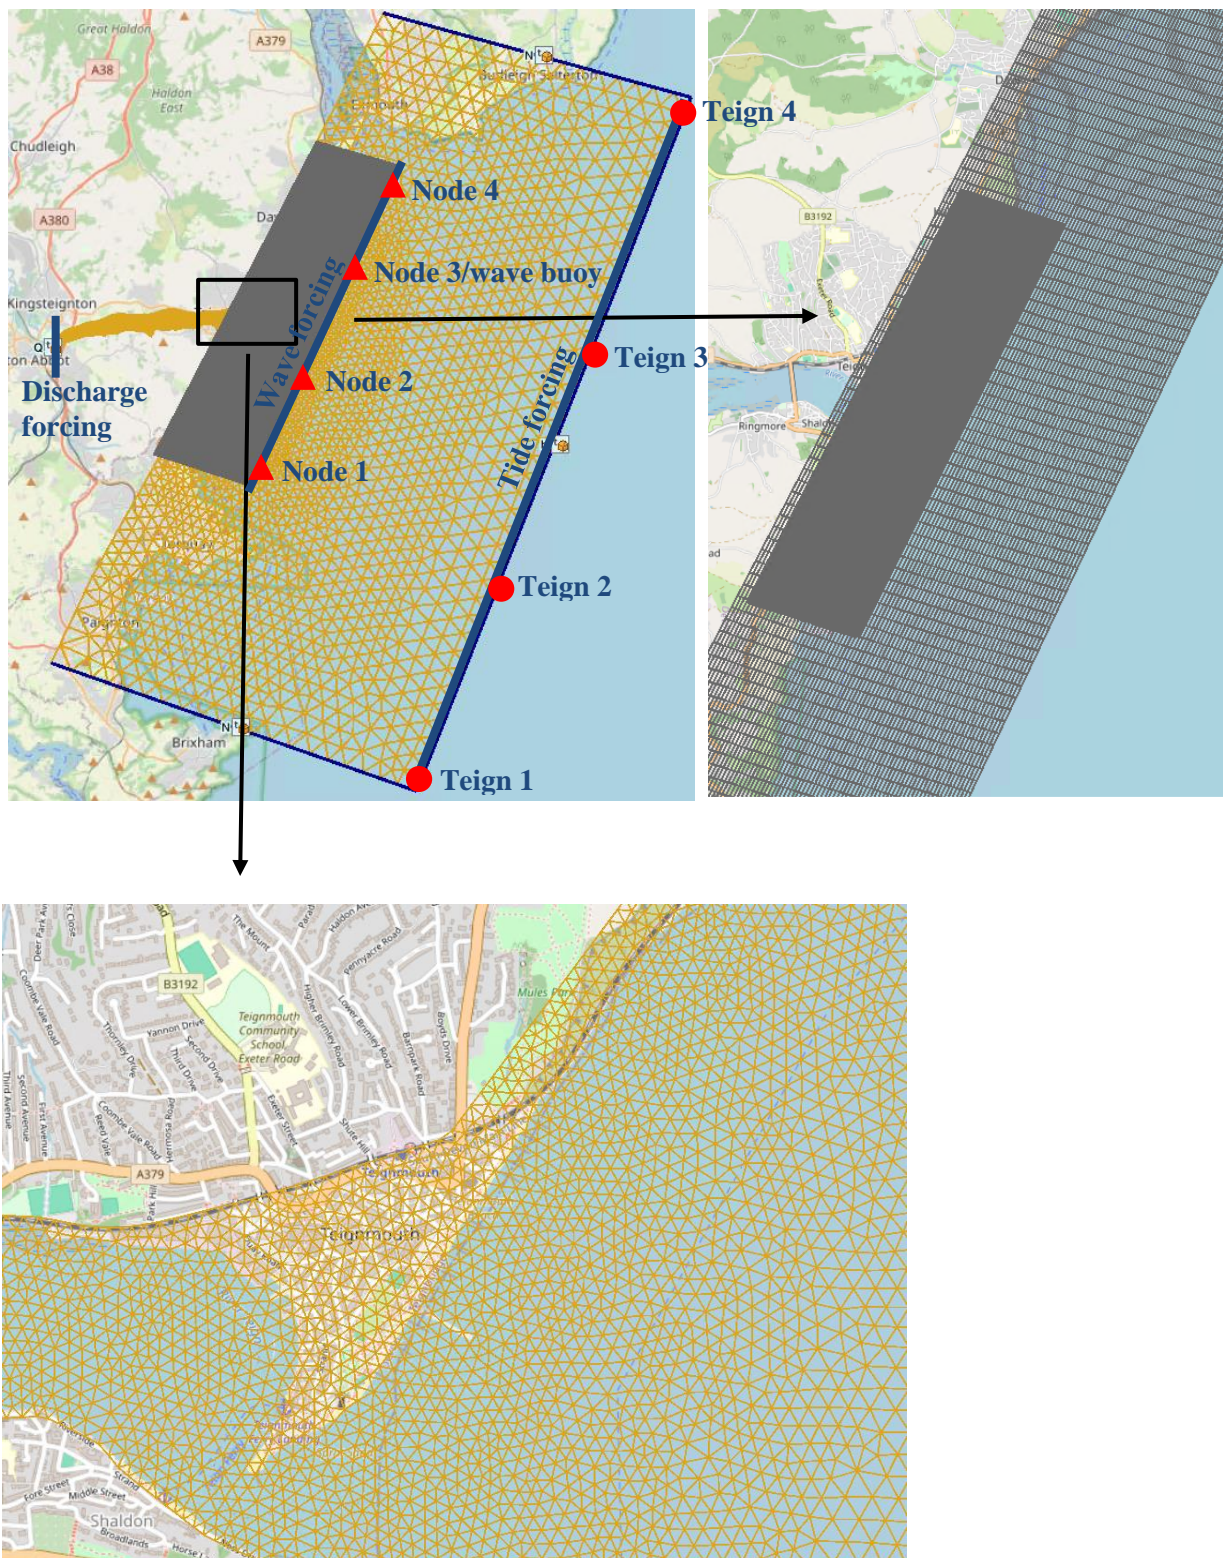
Figure C-2. Model grid showing combined D-FLOW flexible mesh (orange) and two meshes from the D-WAVE module (grey). Upper left panel: overview of all the model grids, forcing boundaries (blue lines), and wave (red triangles) and tide (red circles) forcing nodes. Upper right panel: two grids used in the wave model. Lower panel:

detailed view of the D-FLOW flexible mesh grid in Teignmouth delta and beach with resolution of 30 m in the shallowest areas.

The model domain consists of three grids as illustrated in Figure C-2. In the D-FLOW module, a flexible mesh was generated with resolutions ranging from 30 m in shallow areas to 700 m at the offshore boundary. The grid covers an area of 30 km along the coast and 12 km in the cross-shore direction. It was essential for the flow model to cover a sufficiently large area to ensure that there was no influence of the estuary on the model boundary, and to correctly generate and propagate tidal flows.

The wave module D-WAVE uses two rectangular grids, consisting of a coarse outer grid and a fine inner grid. The nested inner grid has a spatial resolution of 20 x 75 m and is centred around the area of interest to resolve detailed wave shoaling and refraction processes near the shore, while the coarse outer grid has a resolution of 45 x 170 m and is used to propagate waves from nearshore wave forcing nodes (Figure C-2) at approximately -14 mODN depth in to the inner grid.

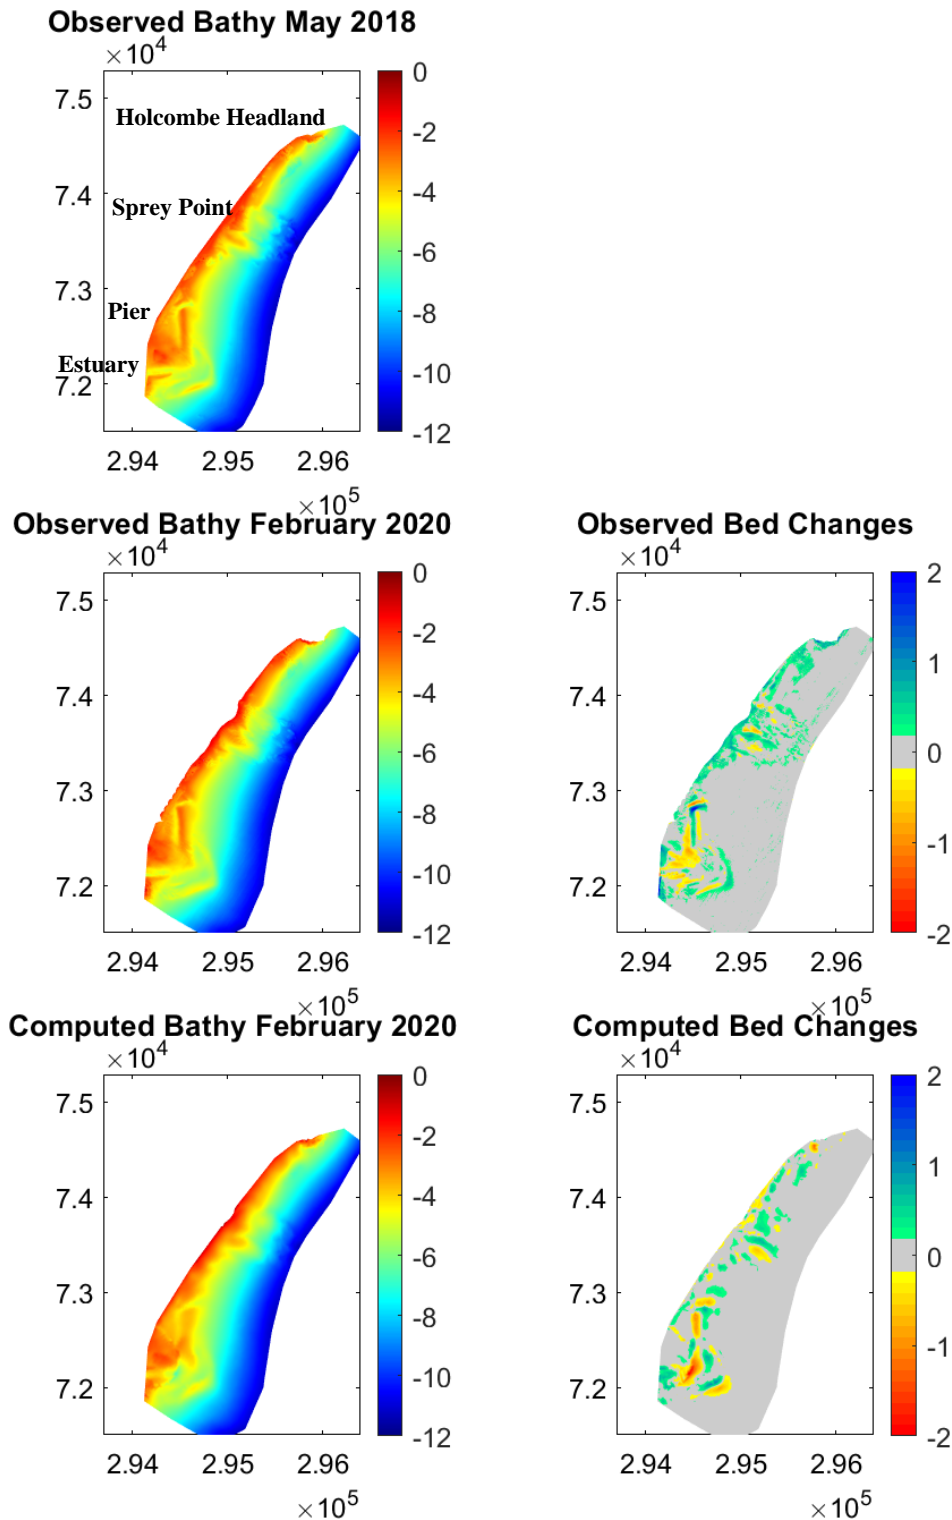
Figure C-10. Overview of observed and computed bed changes for the 3 mm/1 mm run (Section C.4) from May 2018 to February 2020. Upper panel shows measured bathymetry in May 2018. Middle panels illustrate measured bathymetry from 2020 (left) and measured bed changes (right). Lower panels show computed bed levels (left) and bed changes (right). The simulation includes the lower estimated dredge quantity of 15,000 tonnes per year in the ebb-tidal delta and disposal of the same material quantity in front of Sprey Point.

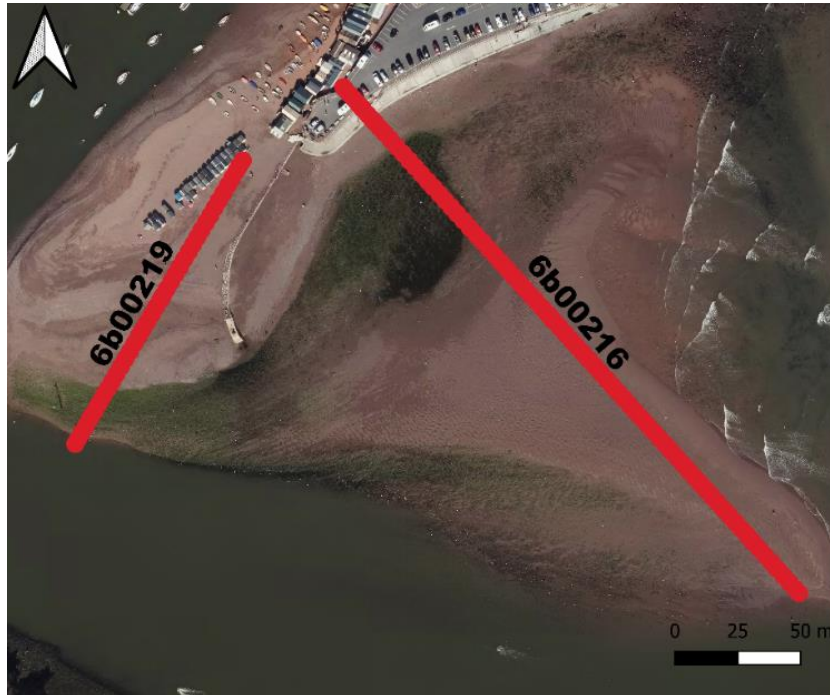
Figure E-4. Aerial view of Denn Spit showing the locations of beach profile measurements. The red line on the left corresponds to Profile Reg ID: 6b00219 (shown in the top panel of Figure E-5), while the red line on the right corresponds to Profile Reg ID: 6b00216 (shown in the middle and bottom panels of Figure E-5).
