Teignbridge District Council

Teignmouth Beach Management Plan

Teignmouth and Shaldon Beach Management Plan

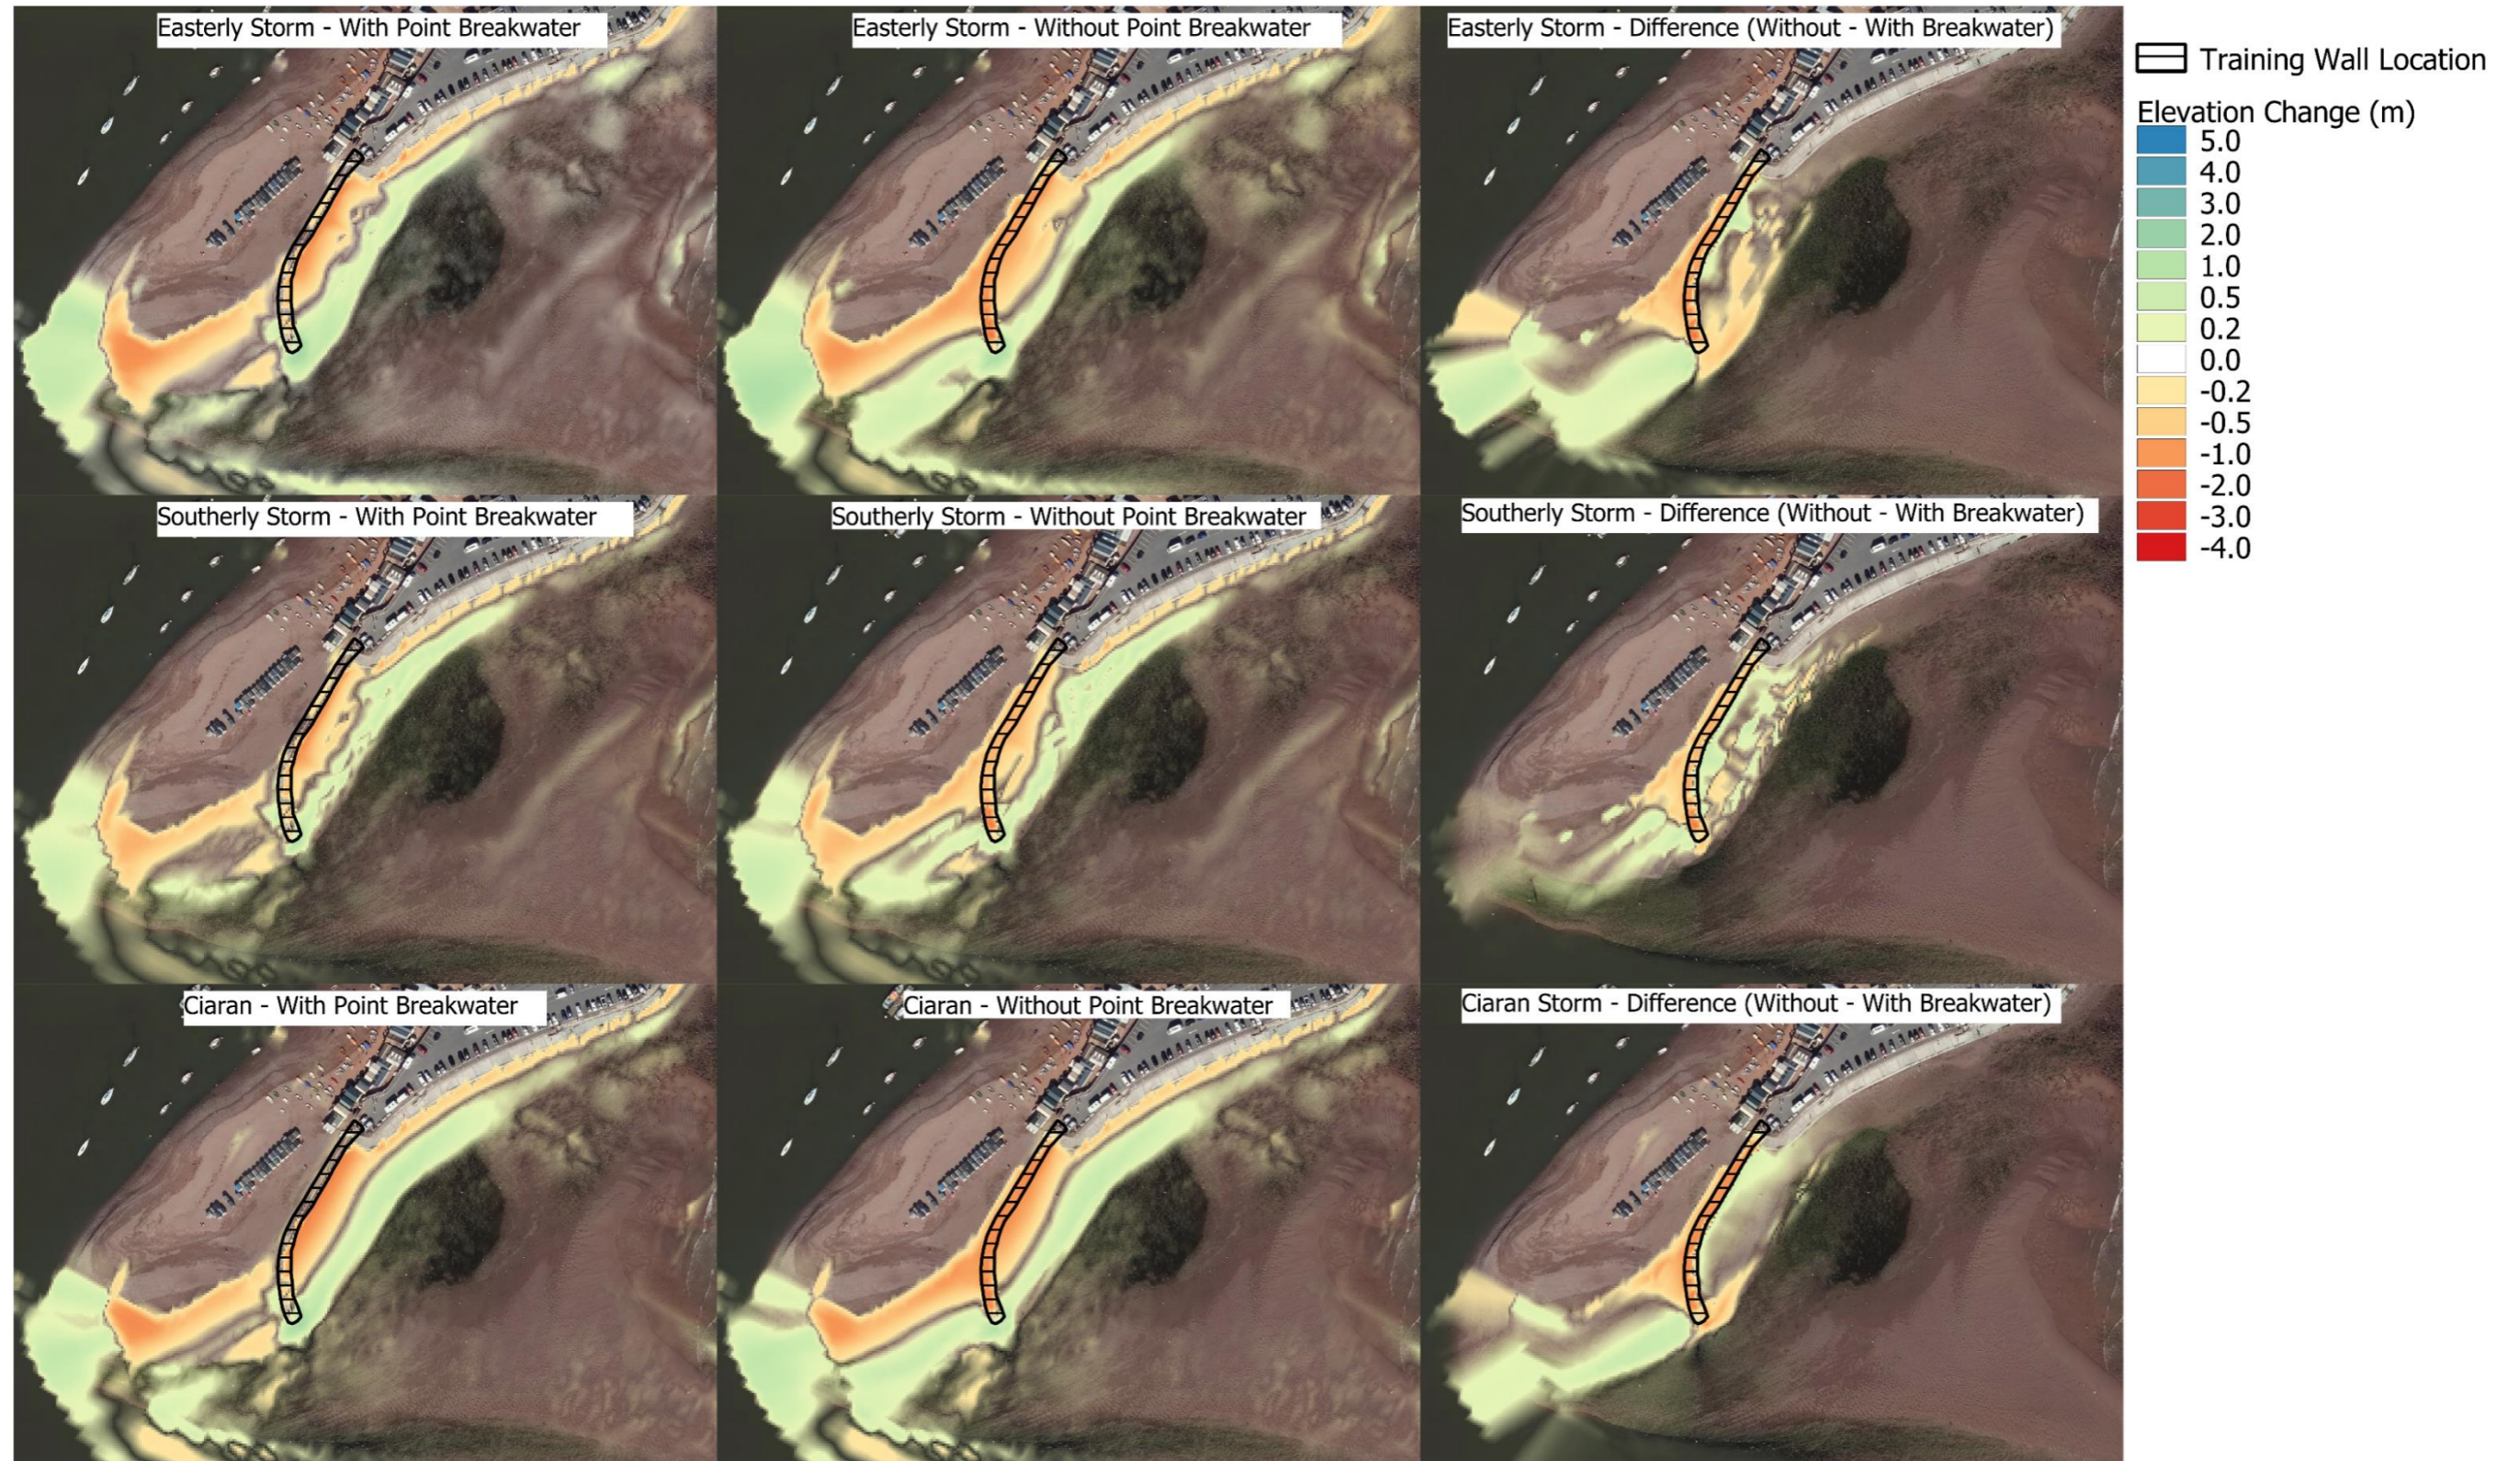
Figure E-8. Modelled elevation changes at Teignmouth Point under different storm scenarios and point breakwater configurations. Left column: elevation change with point breakwater in place; middle column: elevation change without point breakwater; right column: difference in elevation change between scenarios (Without Wall - With Wall). Top row: Easterly Storm; middle row: Southerly Storm; bottom row: Storm Ciarán. Negative values (red) in the difference plots indicate areas where erosion was greater (or accretion was less) without the point breakwater. Positive values (blue/green) indicate areas where accretion was greater (or erosion was less) without the point breakwater. The extended point breakwater location is marked in black.

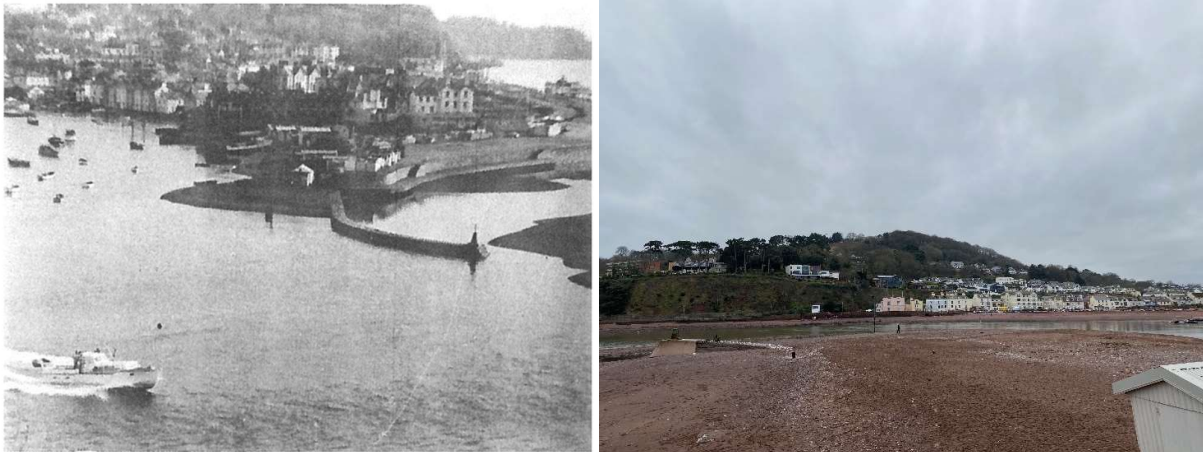
Figure 2.1 Photos showing differences in sand accumulation around The Point breakwater, left: photo from c 1963-4 (Binnes, 2024), and right: Teignmouth BMP site visit photo from 2024.

In 1906, a river training wall was constructed of masonry, extending from under the present Point Car Park in a radiused arc to seaward. It is understood that the purpose of the structure was to hold the sands back from impinging on the inner channel (Harbour Master / Martin Davies, *Pers. Comms.*, 2024). The structure was originally constructed of granite and masonry, and later capped by concrete (Graeme Smith, *Pers. Comms.*, 2011). Although now mostly buried, the cap is visible on the beach today. Today, the structure acts to retain sediment at The Point, resulting in an increased width of the beach there, as demonstrated by the photos in Figure 2.1, which show The Point in 1936 and in 2024. It is possible that the structure acts to reduce wave exposure in the estuary during storms, when it is over washed/breached during storms (for example Storm Ciaran in 2013), but this is not known for certain. Additional modelling has been undertaken for this BMP to look into the effects that the The Point could have on water levels and wave heights in the Teign Estuary.

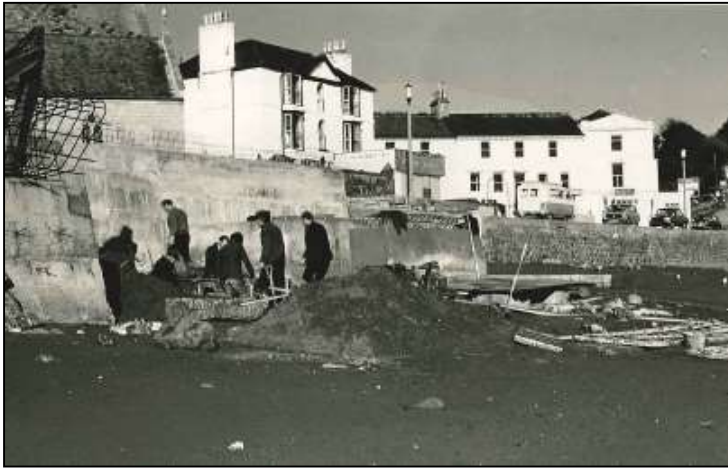
Figure 2.3 Flood defences under construction at Denn Promenade, November 1972 (Gundry, 1982).

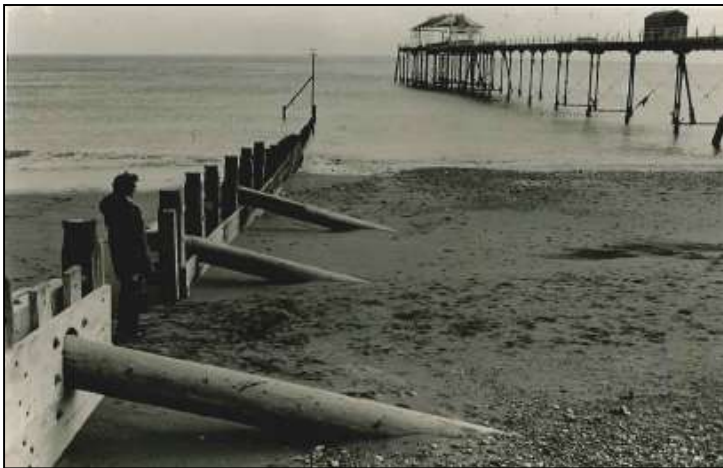
Figure 2.4 Groyne 11, with elevated beach level, in November 1974 (Gundry, 1982).

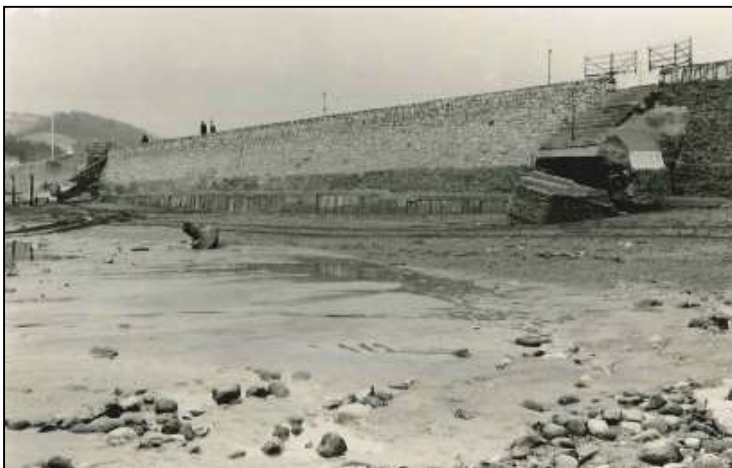
Figure 2.5 Low beach levels between groyne 12 and 13 in December 1975 allowed exposure of concrete piles at the base of the seawall (Gundry, 1982).

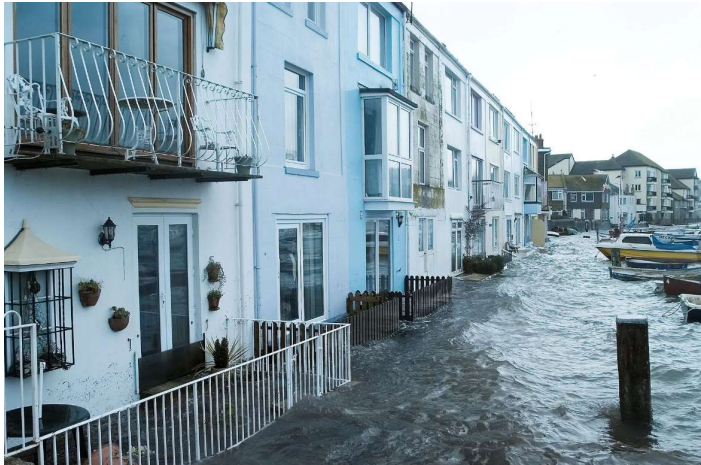
Figure 2.6 Flooding at Teignmouth Back Beach in 2008 (photo from Devon live, 2017).

- In March 2008, a 0.7m storm surge resulted in a 3.0mOD observed tide. This equates to a 1 in 5 flood level (Atkins, 2013), however, extreme water level analysis carried out as part of State of the Nation would put such a level at around 1 in 10 (10% AEP). This resulted in some flooding to 10 properties along Back Beach due to wave action. Wrack marks caused by lines of debris indicating the high water level were evident on the roads leading from Back Beach.

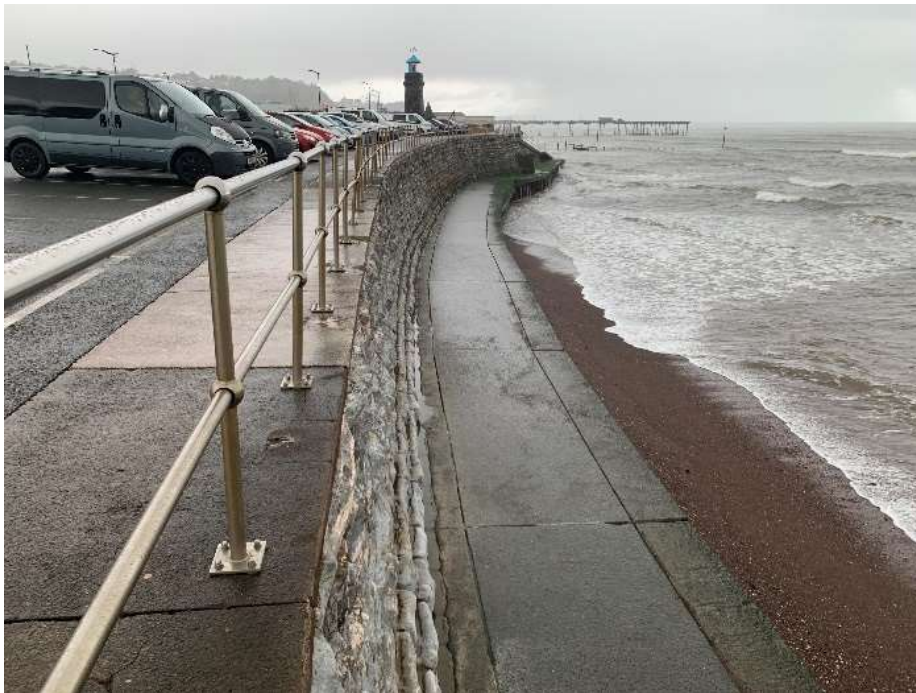
Figure 2.10 Image of the Seawall near The Point Car Park.

The seawall along the coastline consists of 4 different sections. Near The Point Car Park the seawall is a granite facing vertical wall with a walkway located halfway up its height. This can be seen in Figure 2.10 and Figure 2.11.

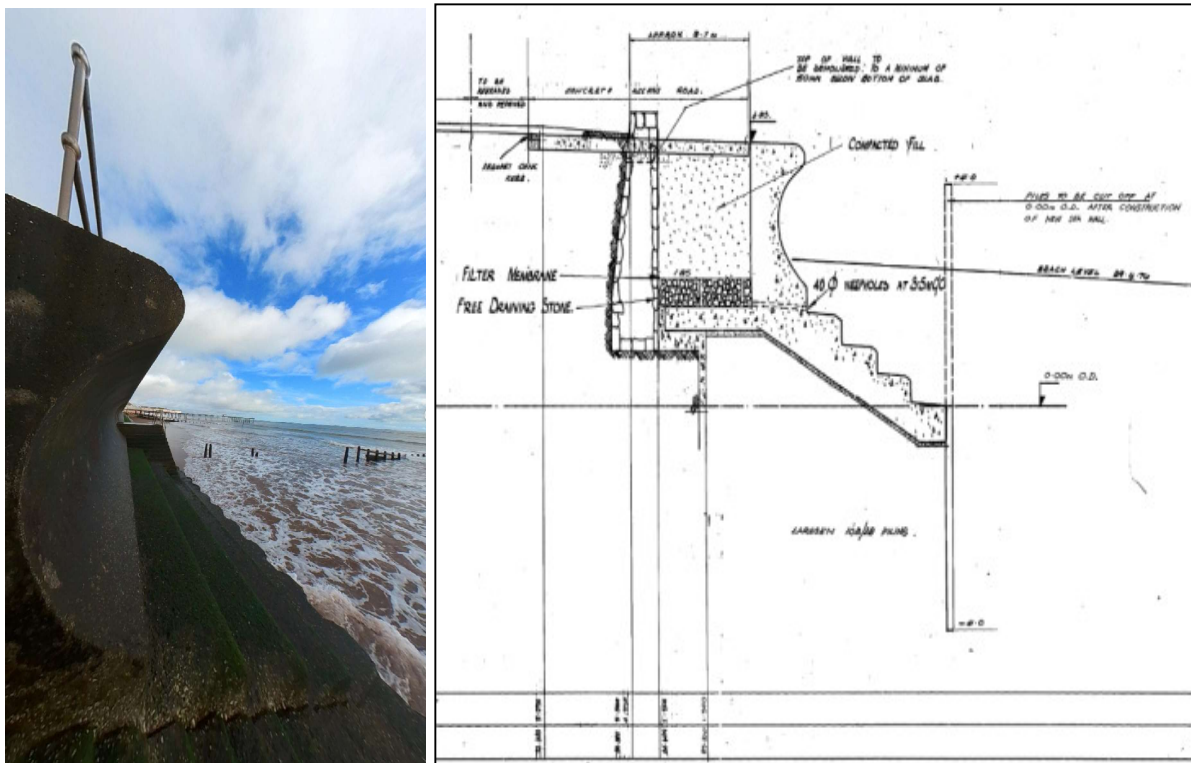
Figure 2.2.12 Seawall located behind groyne 12 with a cross section of the groyne (Binnies, 2023)

The seawall near groyne 12 consists of a bullnose, concrete steps and a sheet pile toe. The sheet pile toe in this section has become more exposed due a decrease in beach crest level. This can be seen in Figure 2.2.12.

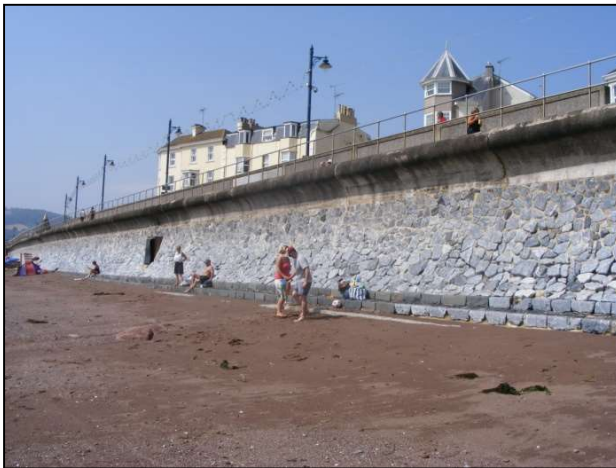
Figure 2.13 Rock-faced, concrete seawall constructed in the mid 1970's.

A section of rock-faced concrete seawall provides flood defence between Saint Michael's Church and Groyne 9, as shown in Figure 2.13. This defence largely continues the structural profile of the previous concrete section with a wave return wall, and a set-back smaller flood protection wall. The cross section of which is shown in Figure 2.13.

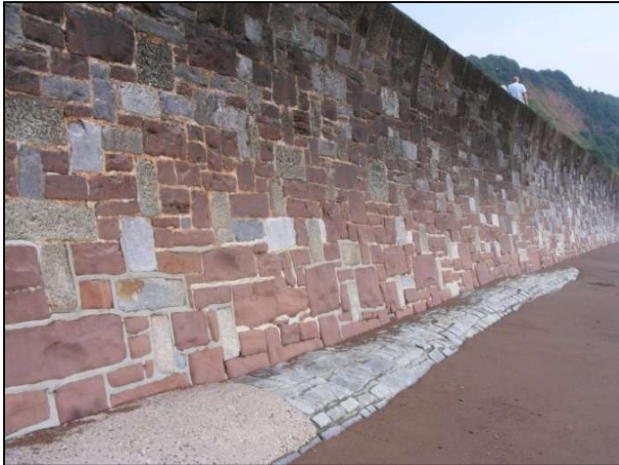
Figure 2.15 Defence protecting the railway line between Sprey Point and East Cliff.

Further north towards Teignmouth Lido, the older seawall adjoins the previous section. The seawall has some replacement masonry blocks and patch repairs to the masonry elements, and replacement of the mortar joints to prevent further damage to the seawall. Toe protection emerges at some specific locations where the beach level drops, and this also shows some signs of patched repair and maintenance works. This section of wall is owned by Network Rail.

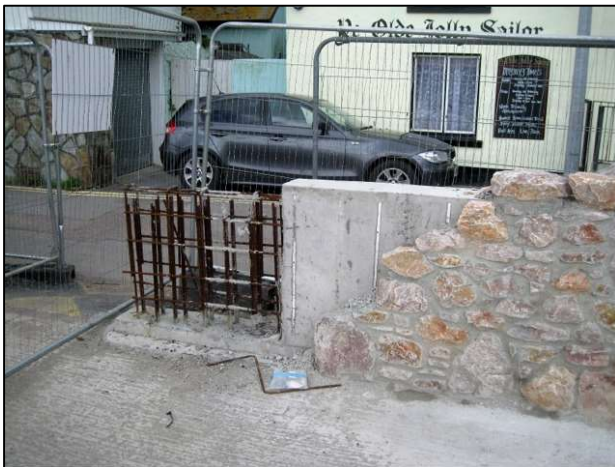
Figure 2.16 Construction of reinforced concrete floodwalls with masonry facing as part of the Teignmouth flood defence scheme (R. Scott 2012).

The current 2012 flood defence scheme at the Back Beach includes flood gates, masonry clad reinforced concrete flood walls and demountable flood boards. The adjoining historic properties along Back Beach were also provided more comprehensive protection against flooding including air bricks, flood defence doors, flood defence windows and glazing panels. Further resurfacing of the road/public seating area was also part of the scheme to ensure no worsening of the surface water flood risk. Some photos of the construction stage of this scheme are provided in Figure 2.16 and Figure 2.17.

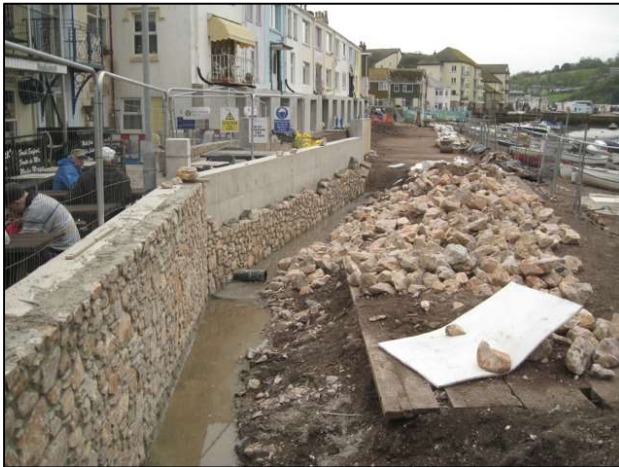
Figure 2.17 Construction of reinforced concrete flood walls with masonry facing as part of the Teignmouth flood defence scheme (R. Scott 2012).

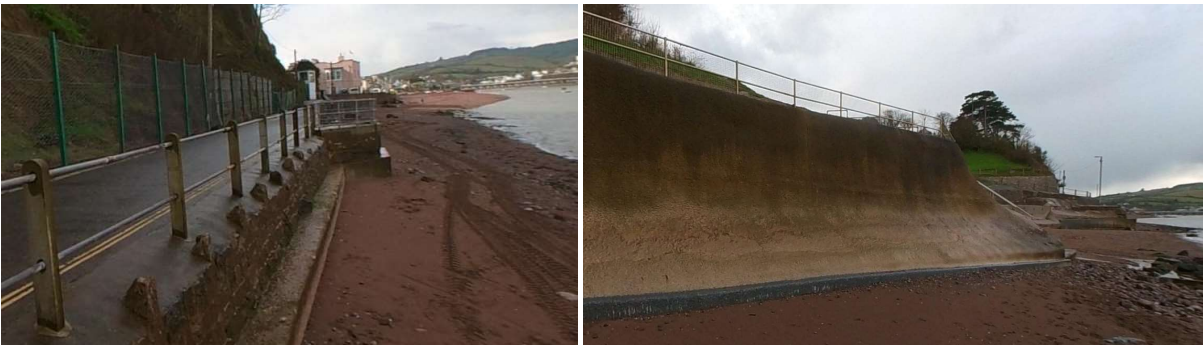
Figure 2.18 Two different seawall types found at Shaldon.

The existing defences at Shaldon comprise sections of seawall. There are no groynes present for beach stabilisation. Working in a northwestern direction from beneath The Ness public house towards Shaldon village, the flood defences are formed by an assortment of different seawalls constructed at different times and exhibiting different levels of maintenance and repair. These seawalls are either concrete, masonry, or a combination of the two, and primarily provide flood and erosion protection to the adjacent road, Marine Parade. Examples of seawalls at Shaldon are shown in Figure 2.18.

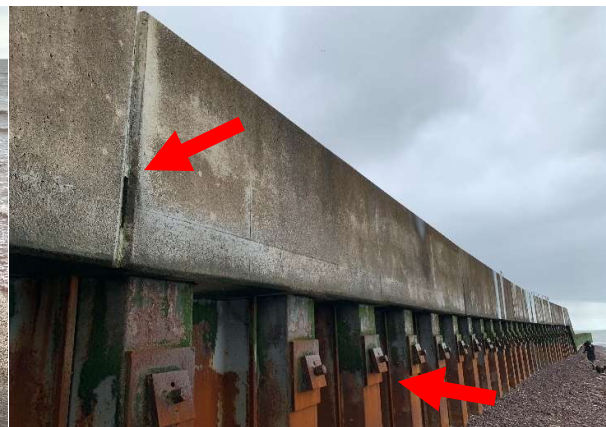
57776 Loss of paint system and surface corrosion of toe piles. Loss of majority expansion joint sealant.

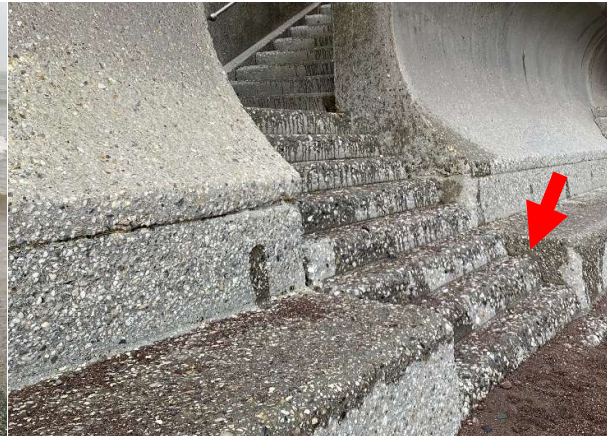
177697 Heavy abrasion of concrete toe and steps.

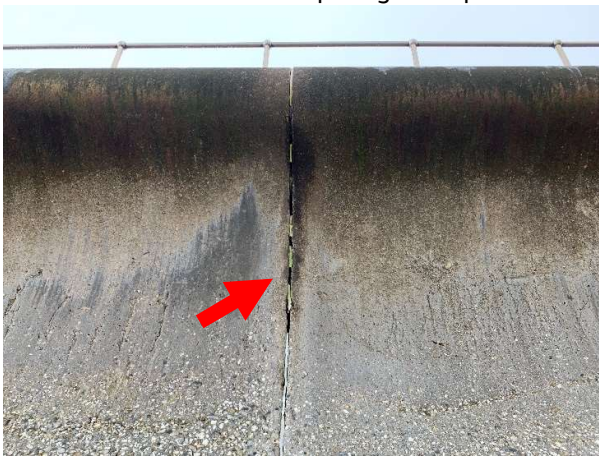
177697 Loss of expansion joint sealant at most joints.

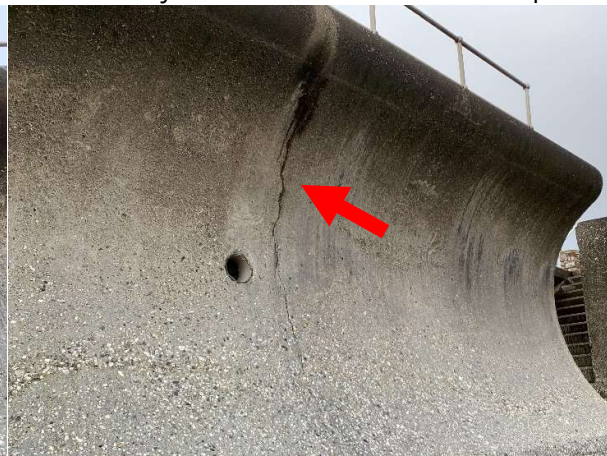
177697 Vertical cracks in upper recurved section of wall at mid-point of many wall sections.

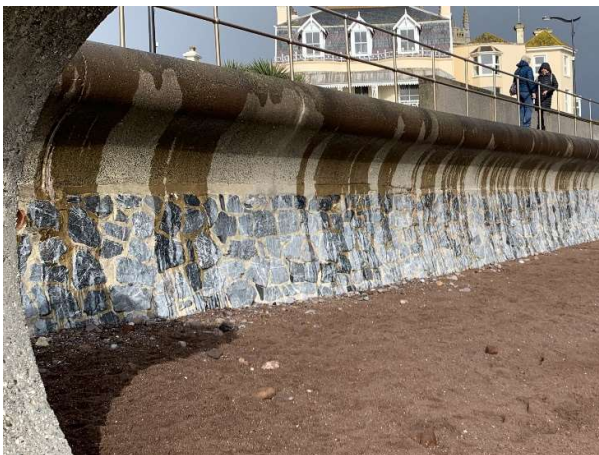
177501 Upper concrete bullnose and masonry facing in good condition, high beach levels.

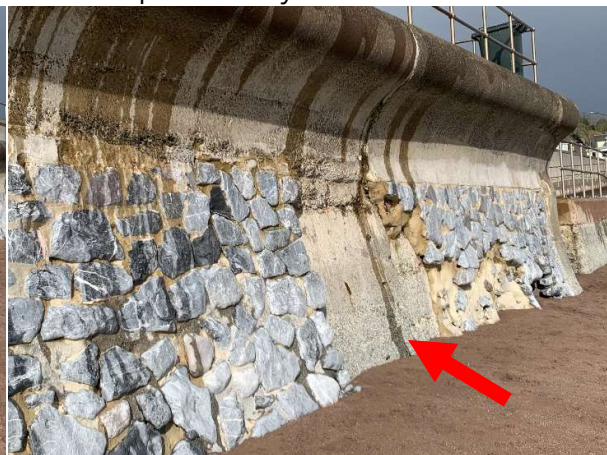
177501 Localised loss of section of masonry facing at northern end of wall exposing concrete backing.

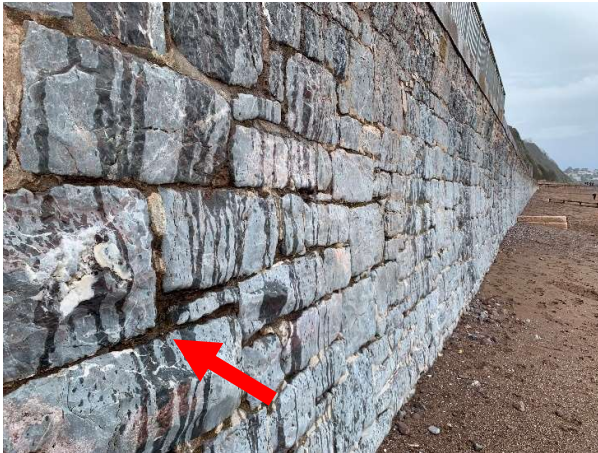
No AIMS Asset ID. Masonry blocks sound, minor abrasion to mortar joints.

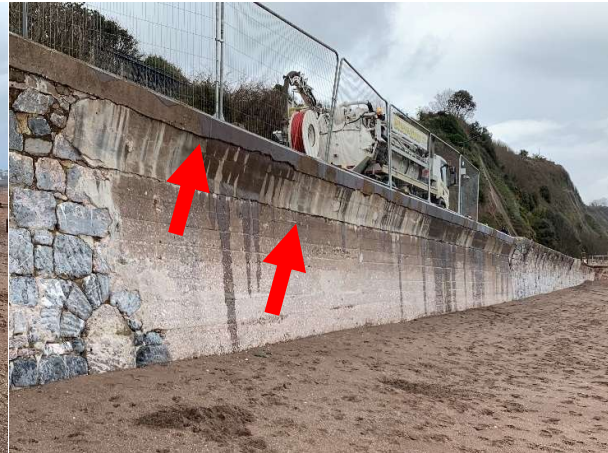
No AIMS Asset ID. Small horizontal cracks between construction joints at repaired section of wall.

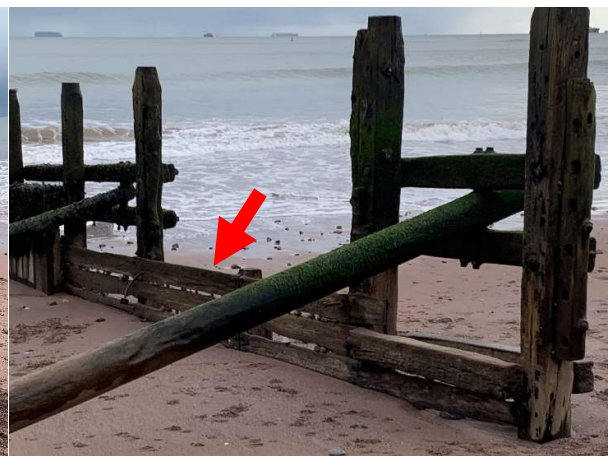
327117 Heavy abrasion of posts and planks with gaps showing between boards.

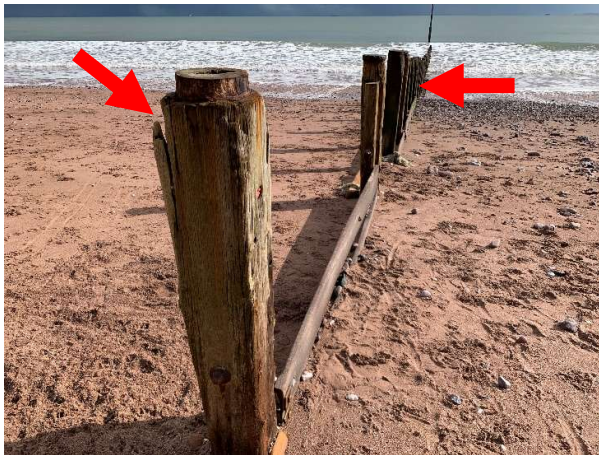
327084 Most posts vertical with only minor rotation evident. Many posts split and cracked.

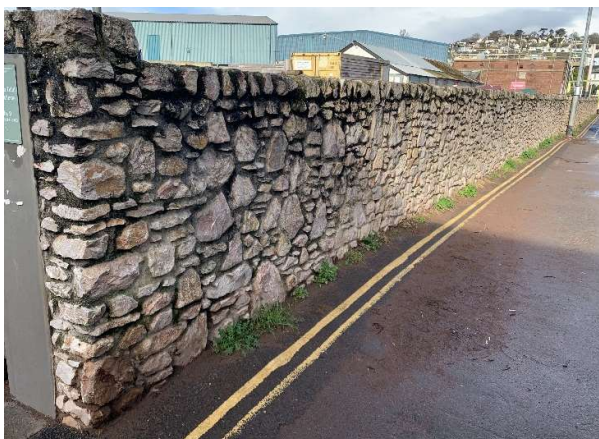
180688 No gaps or cracks in masonry or mortar joints in new walls constructed.

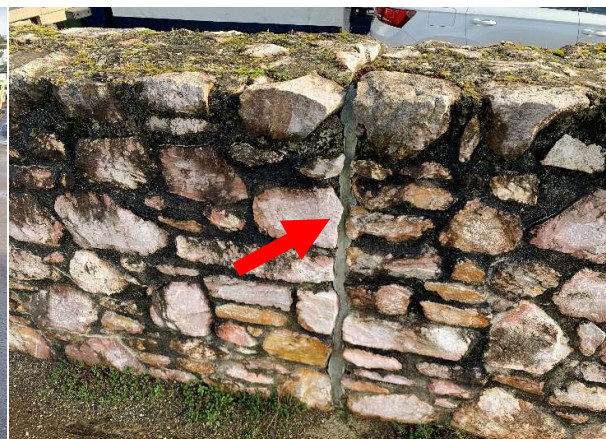
180688 Joint sealant in new masonry walls remains in good condition with no signs of debonding or cracking.

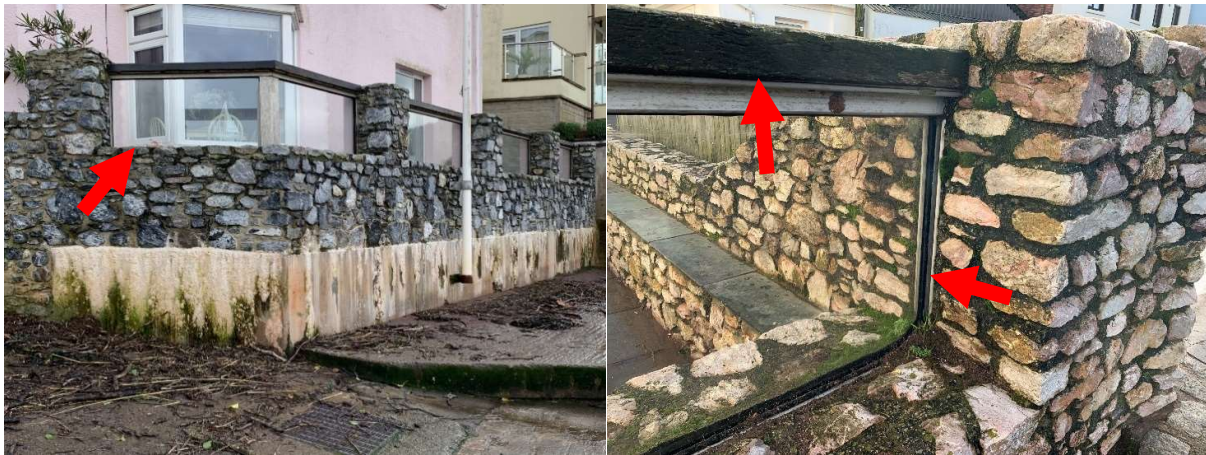
392781 Waterproof glazing panels in good condition. 392781 Seals to floodproof glazing panels intact. Some rot evident in lintles.

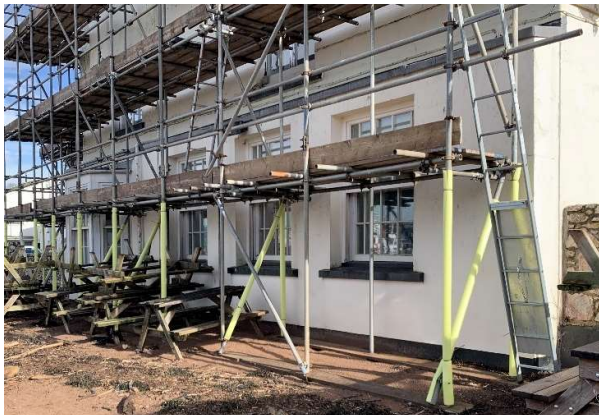
392734 Property wall of the New Quay Public House in good condition, windows do not appear to be floodproof.

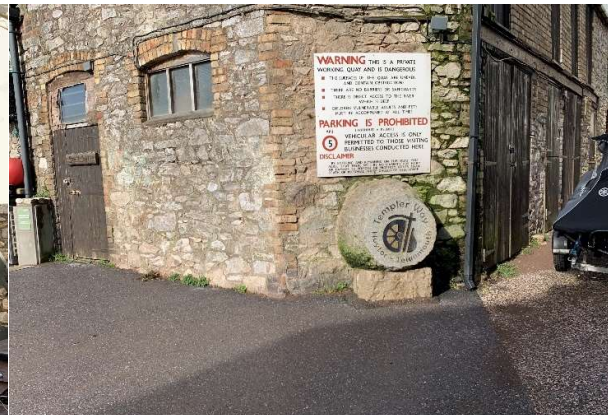
4142 Flood defence alignment appears to run through the Garstone Garden Ornaments property. Not inspected.

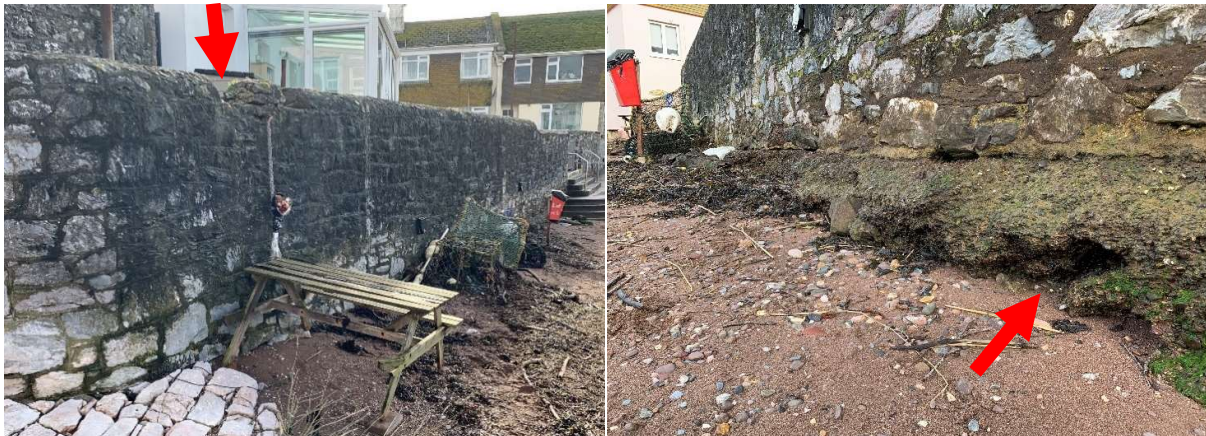
392776 Masonry blocks and mortar joints good, two short sections of missing coping stones.

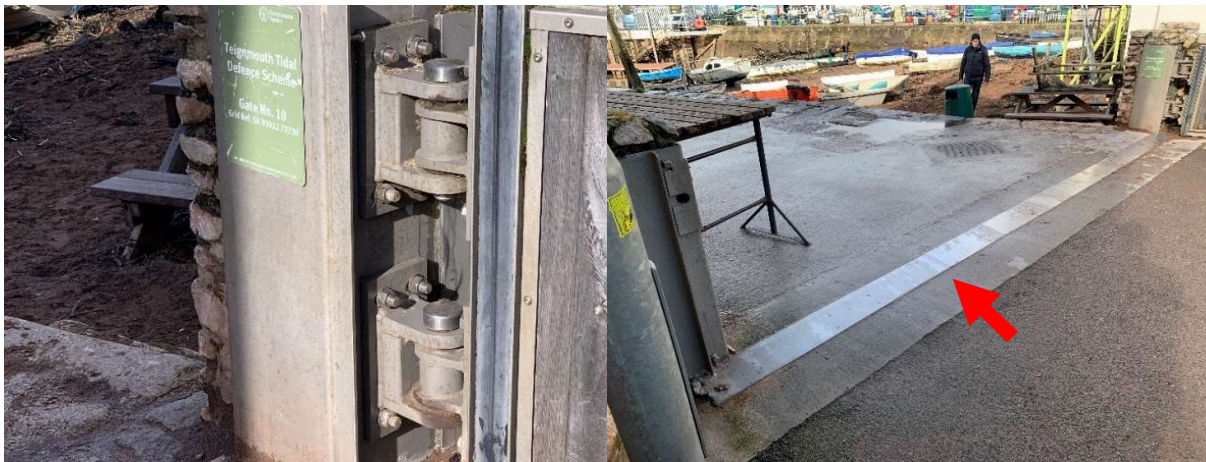
392735 No corrosion to hinges which appear to be in good working order.

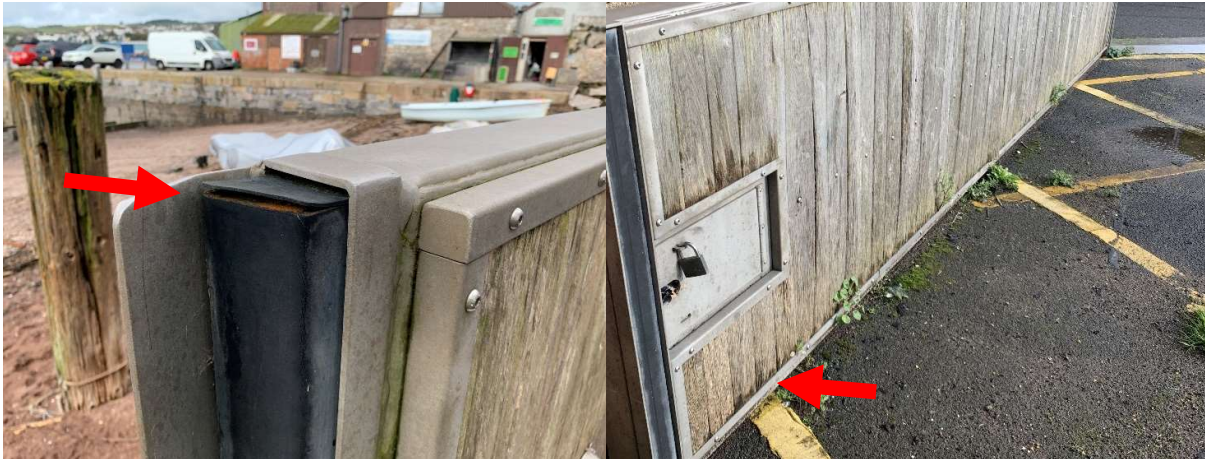
392754 Minor cracking evident to most rubber seals, with some delamination of one seal (flood gate No.12).

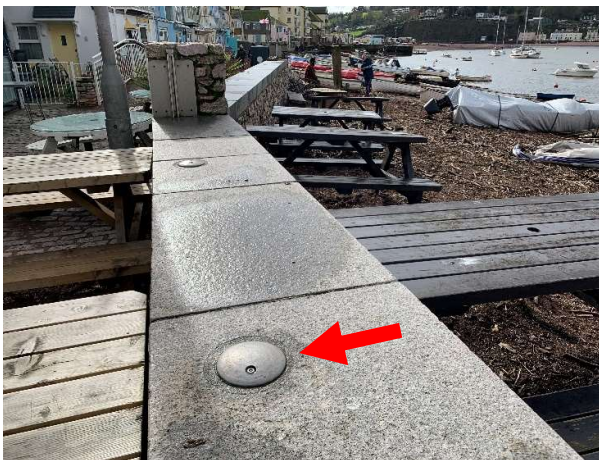
524451 All post caps and hold down bolts present and in very good condition.

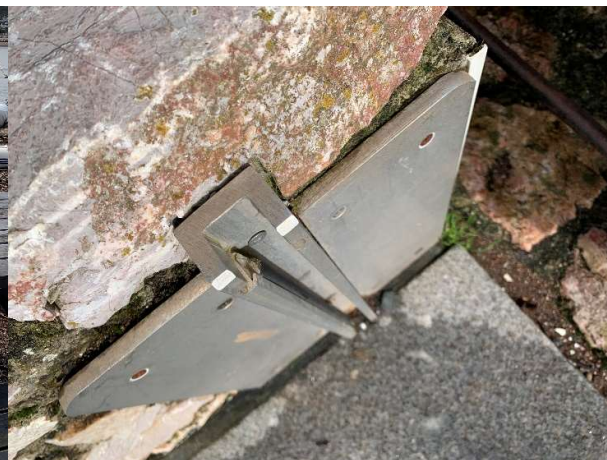
524451 End channels secure and in very good condition.

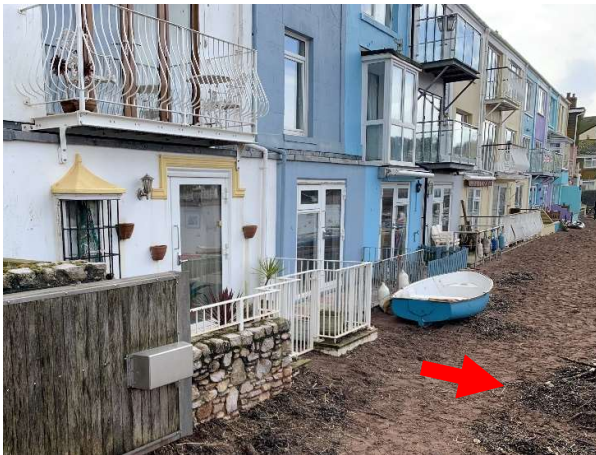
42304 Narrow beach between Queens Street and Ivy Lane with high tide mark near flood defence line of properties.

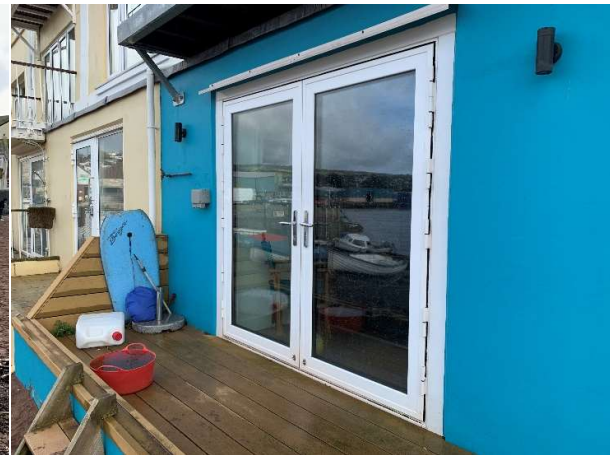
42304 All flood proof doors to property defence line along back of beach in good condition.

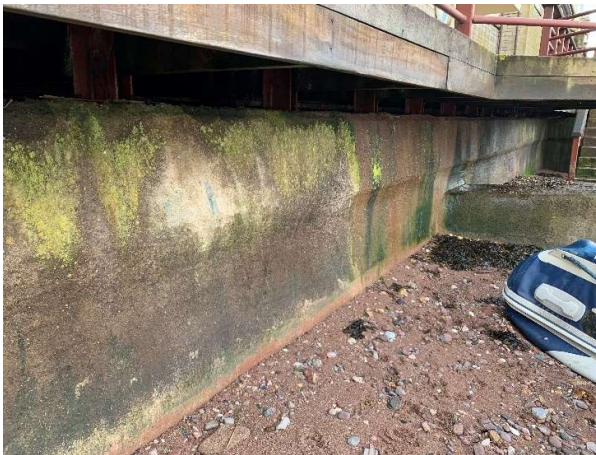
3934 Minor cracks evident in concrete wall but render largely intact along northern end.

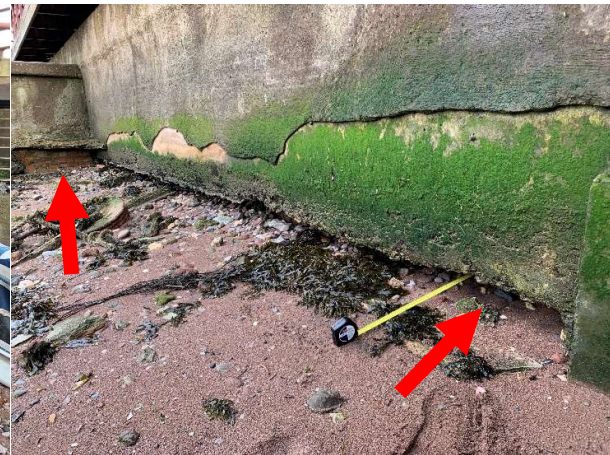
3934 Some cracking and spalling evident in concrete render, beach lowering and localised undermining of toe.

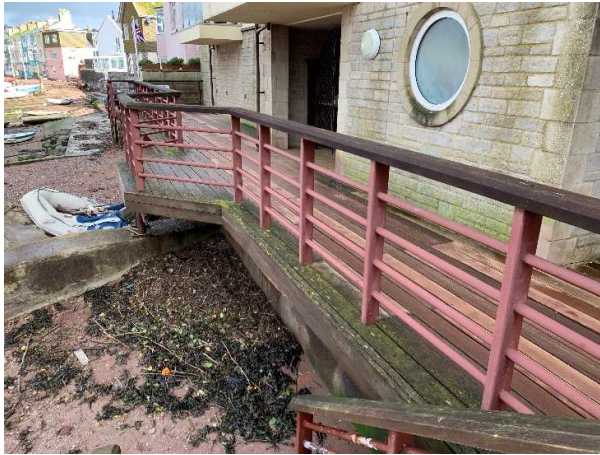
3934 No gaps or damage to timber boards or hand railings along crest of concrete wall.

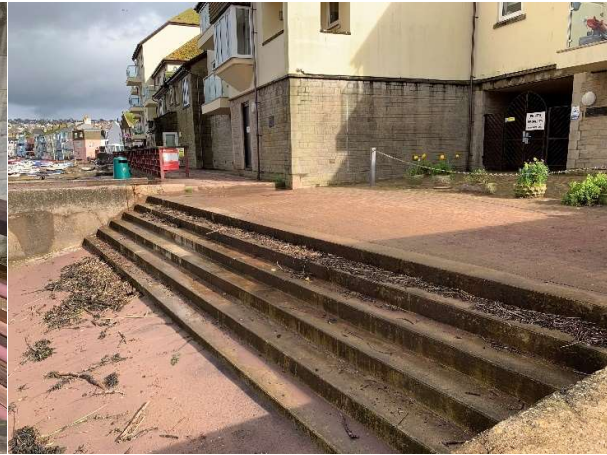
3934 Concrete quay and steps fronting Morgans Quay properties with low levels doors and openings through properties.

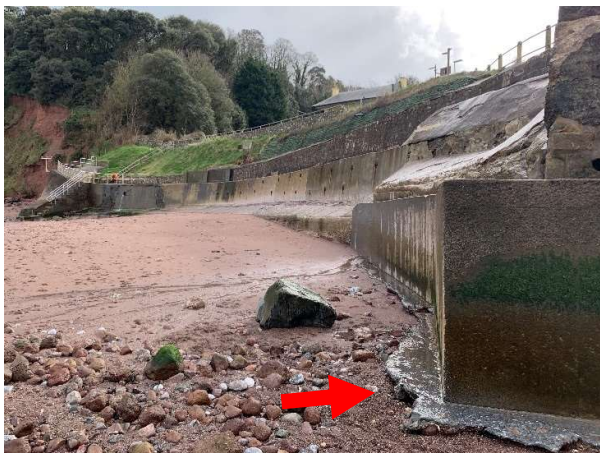
No AIMS Asset ID Low beach levels and undermining of toe.

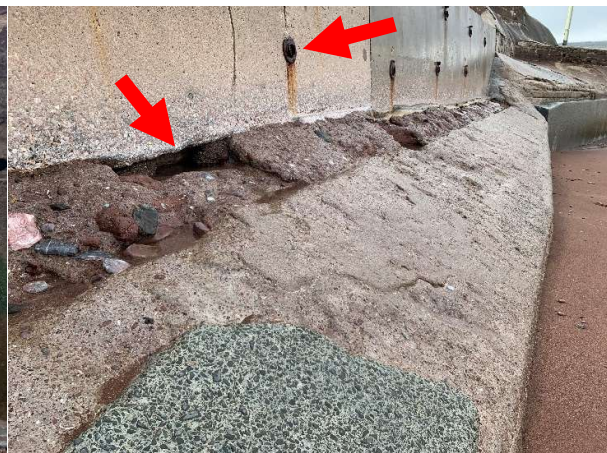
No AIMS Asset ID Heavy abrasion and voids opening in toe. Most flap valves missing.

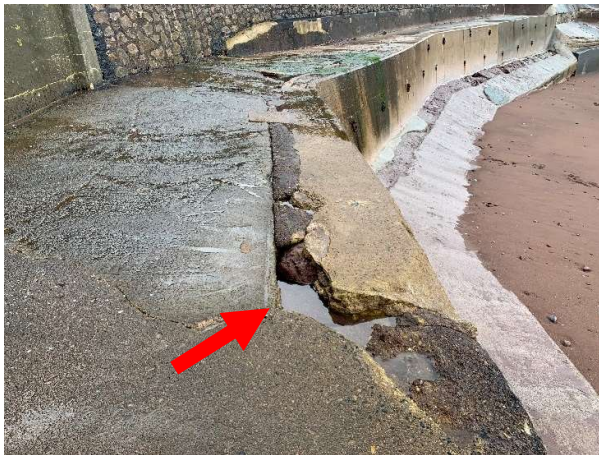
No AIMS Asset ID Cracks in concrete and rendering, some sections of concrete broken and missing.

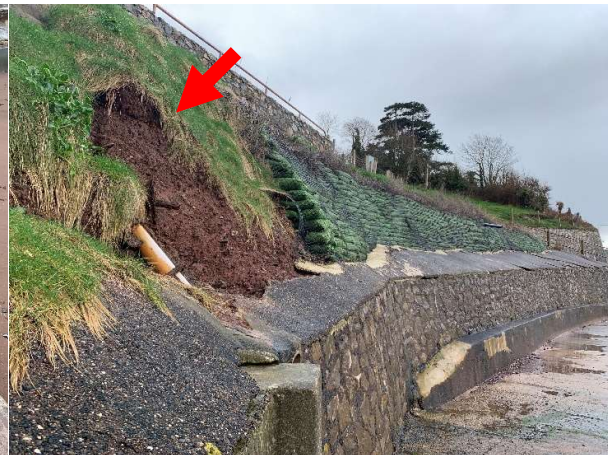
No AIMS Asset ID Erosion of grass bank as southern end of wall.

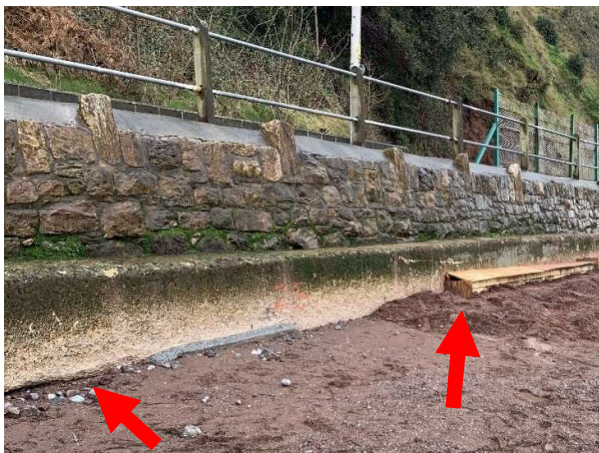
84539 Evidence of undermining of concrete toe, concrete fill repairs underway at time of inspection.

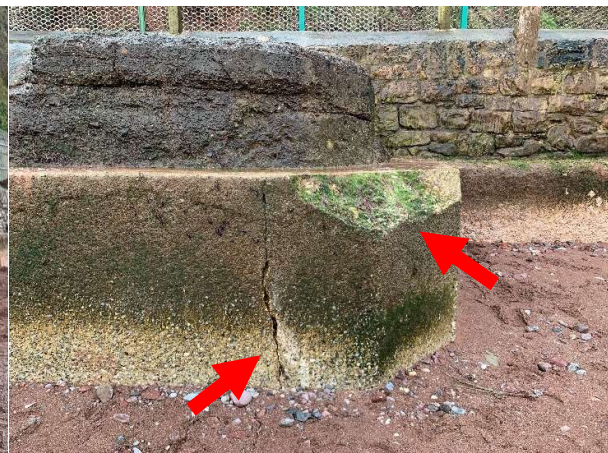
84539 Abrasion along concrete toe and localised cracks and missing sections of some concrete.

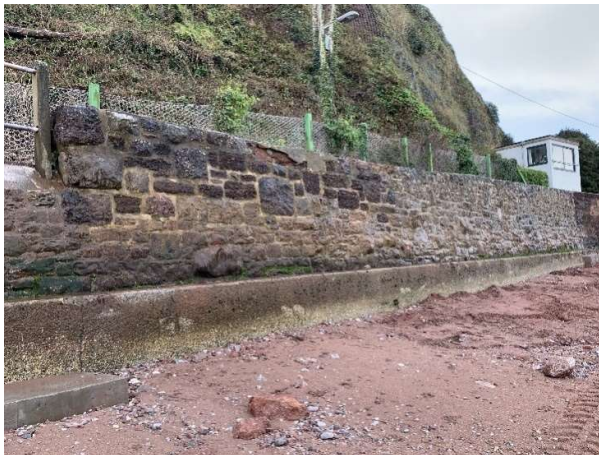
84538 Masonry blocks generally in good condition with no cracks or gaps in mortar.

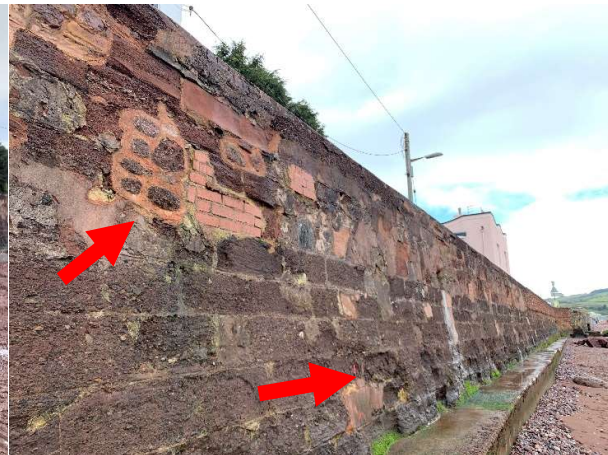
84538 Heavy abrasion to masonry blocks along some sections of wall, especially at toe, many brickwork repairs but in reasonable condition.

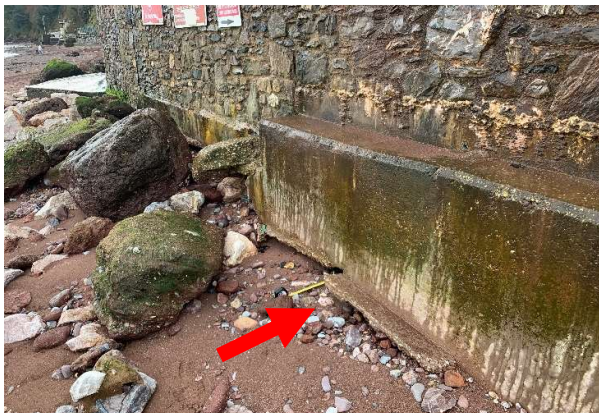
84537 Low beach levels at southern end of wall near outfall resulting in localised undermining up to 0.9m deep.

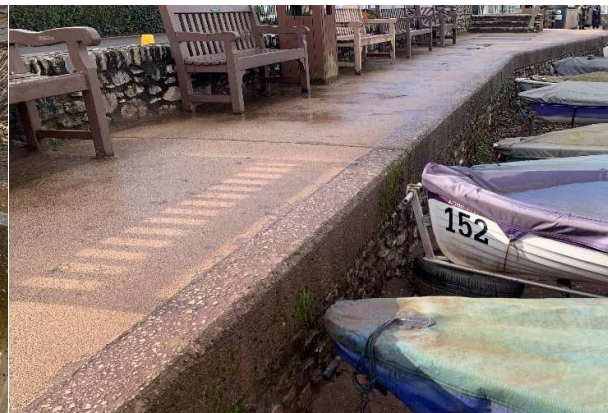
84537 High beach levels along promenade, concrete surfacing and masonry setback wall in good condition.

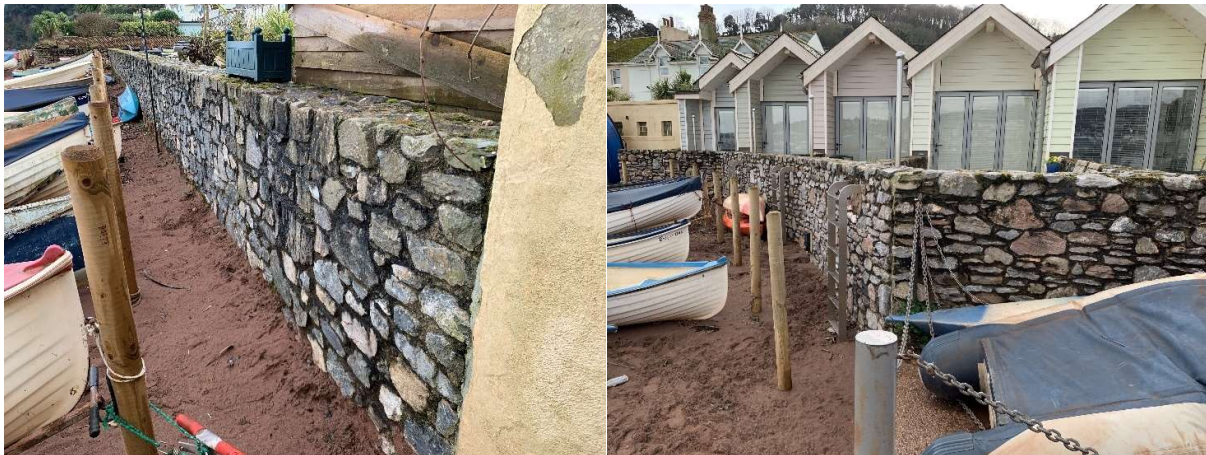
82711 Masonry blocks in good condition, no cracking or gaps in mortar joints, all flap valves present and working.
 82719 Masonry blocks in good condition, no cracking or gaps in mortar joints, all flap valves present.
