Teignbridge District Council

Teignmouth Beach Management Plan

Teignmouth and Shaldon Beach Management Plan

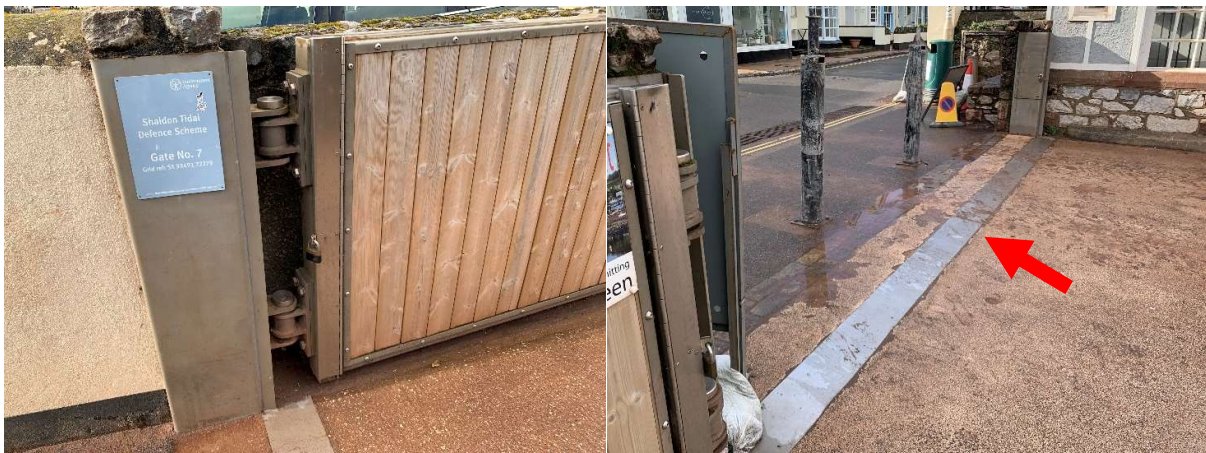
332933 No corrosion to hinges, all appear to be in good working order.

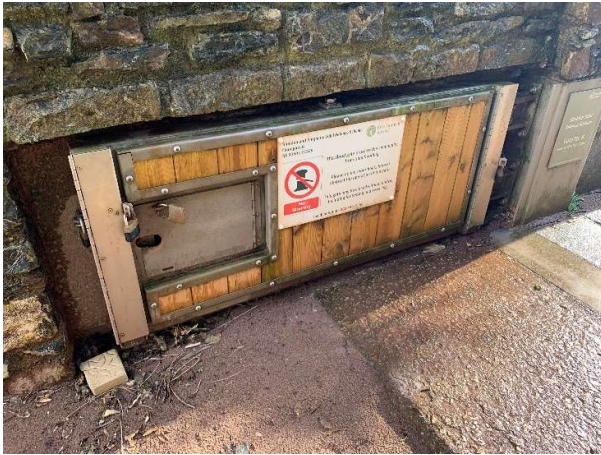
332934 Timber facings to all gates in good condition, no evidence of rot.

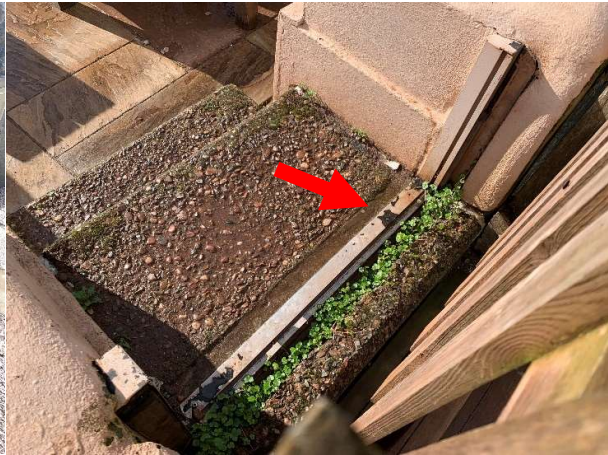
332936 Some loss of paint to aluminium channels for flood boards.

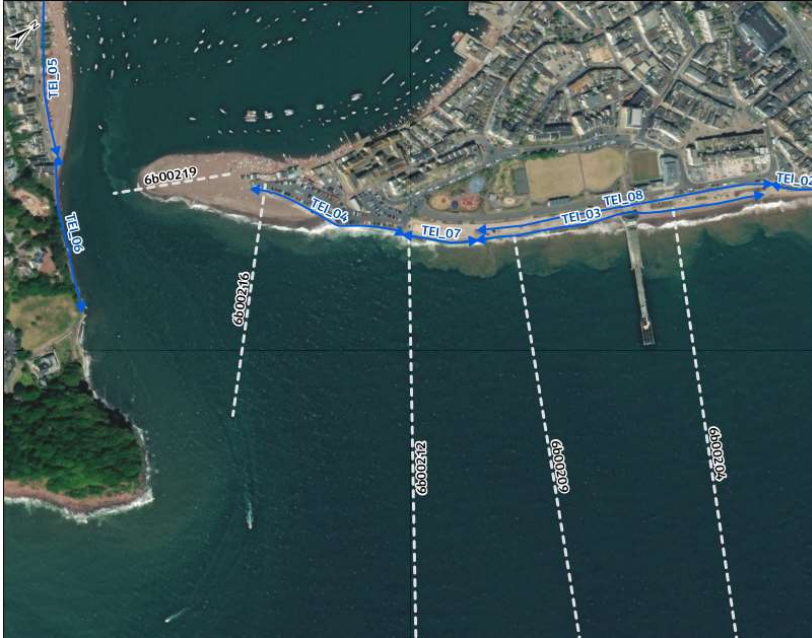
Figure 4.1 Profiles from JBA (2021) and BMP (2014)- Shaldon to the pier at Teignmouth.

An assessment of wave overtopping has been undertaken for Teignmouth Open Coast and Shaldon frontages. Profile locations investigated are provided in Figure 4.1 and Figure 4.2. Overtopping analysis from JBA (2021) and CH2M Hill (2014) has been considered as a way to indicate the current, 50-year and 100-year standard of protection. Overtopping limits from EurOtop II (2018) and EurOtop (2007) have been used to determine public safety and structural limits, respectively.

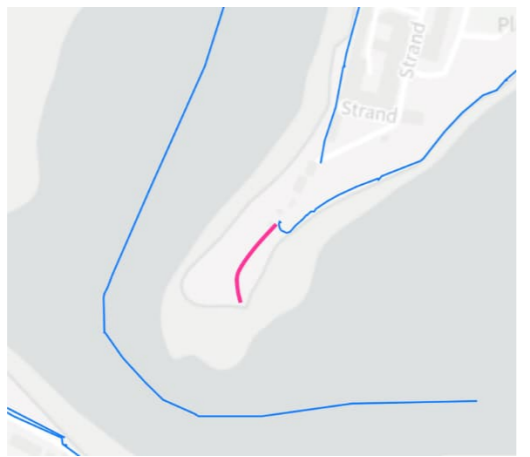
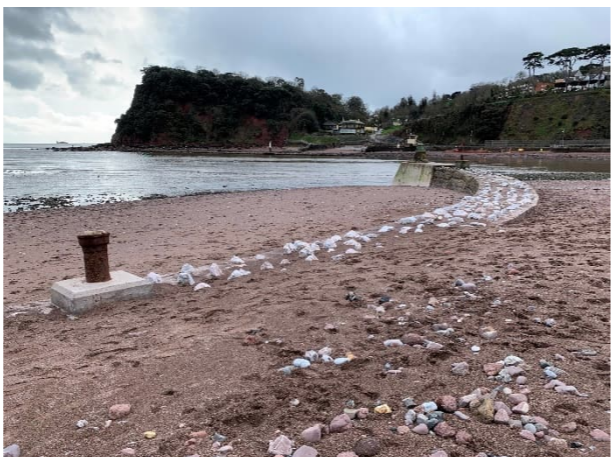
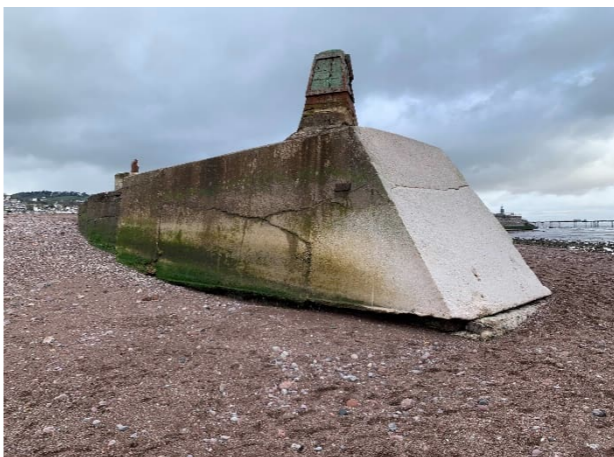
Cracks in concrete and abrasion. Undermining of facing concrete and exposure of stainless reinforcement at the seaward end.	3: Fair	Fastest	20 / 15
57776	Masonry Wall	245m

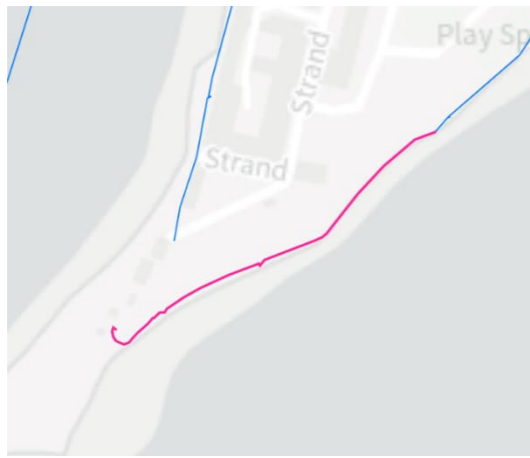
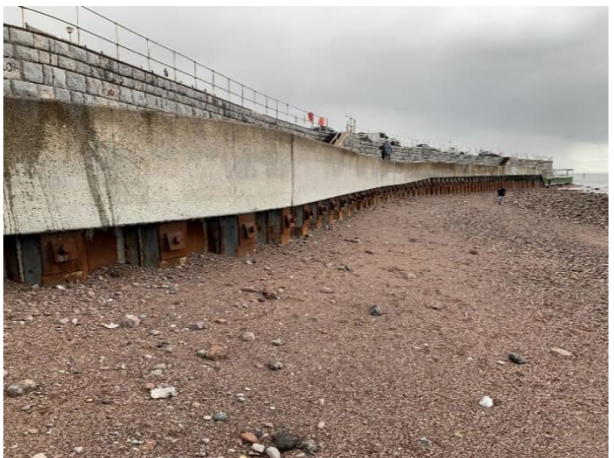
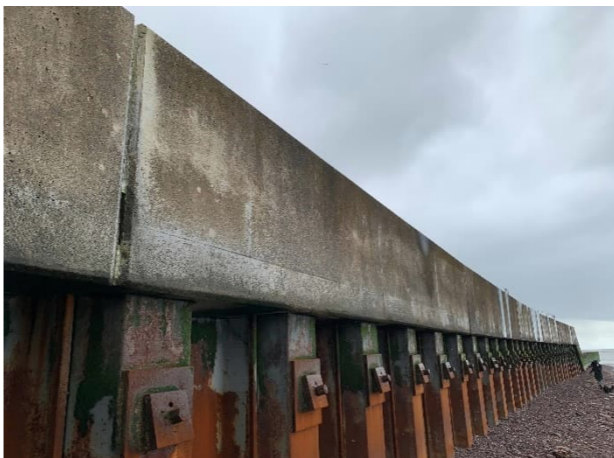
Masonry blocks and mortar joints good, minor differential movement in concrete slab at top of steps. Loss of majority of joint sealant to concrete slab and pile capping beam. Loss of majority of painted coating and some surface corrosion to piles.	2: Good	Fastest	30 (28) / 25
177697	Concrete Wall	526m

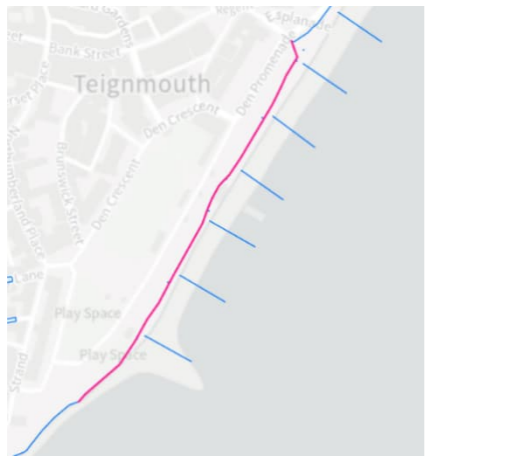
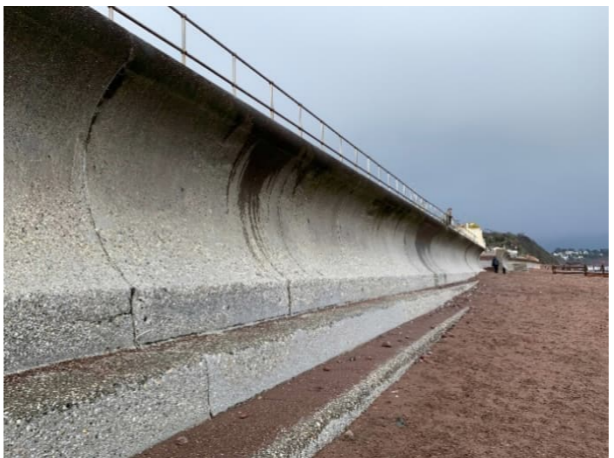
Sheet piled toe exposed at western end. Loss of majority of joint sealant along length. Small gap opening at top of precast step unit at west end. Abrasion of lower part of concrete wall, stepped toe and groyne access steps. Some cracks in concrete wall and some spalling of concrete at movement joints.	2: Good	Fastest	30 / 25 (5 - 11)

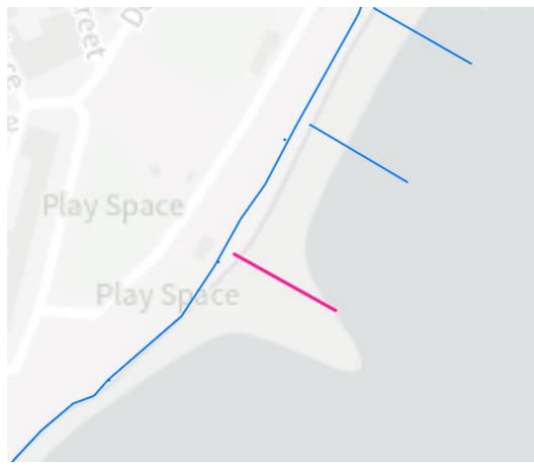
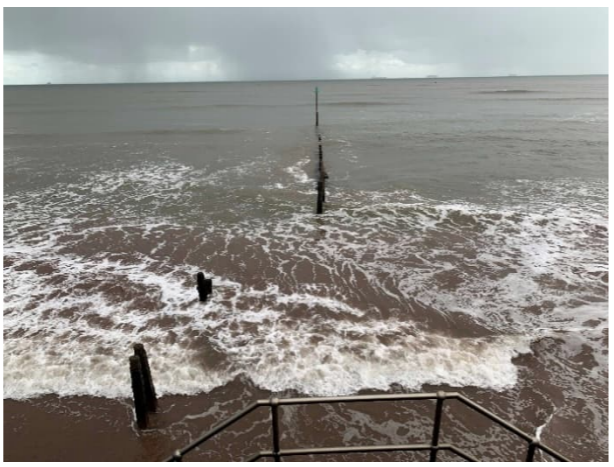
Groyne largely submerged at low tide so not possible to fully inspect. Piles still vertical, all planks missing across upper beach, significant number of planks missing across lower beach. Large gaps between planks, no longer retaining beach material. Navigation marker good.	4: Poor	Fastest	2 / 2
327118	Groyne 13	-

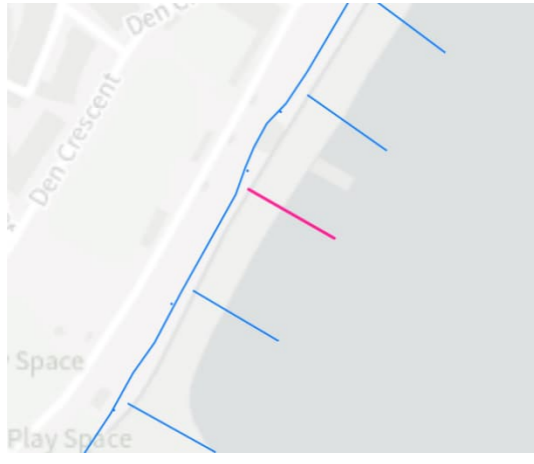
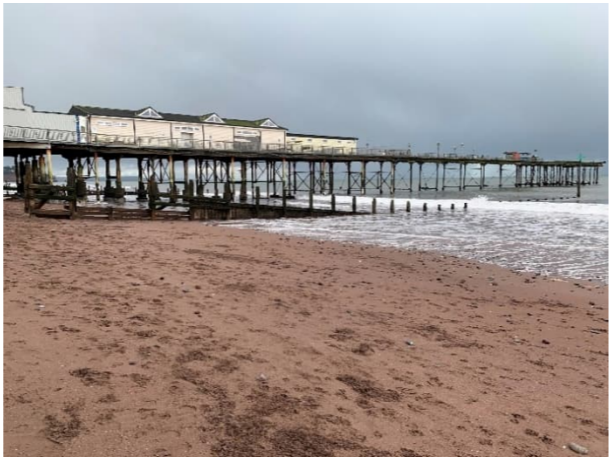
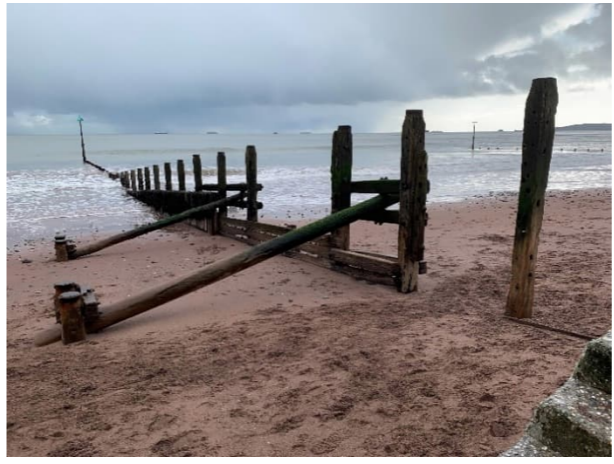
Piles vertical, no rotational movement. Many planks missing across upper beach. Abrasion to piles and planks abraded, large gaps between planks. Groyne not retaining beach material.	4: Poor	Fastest	2 / 2

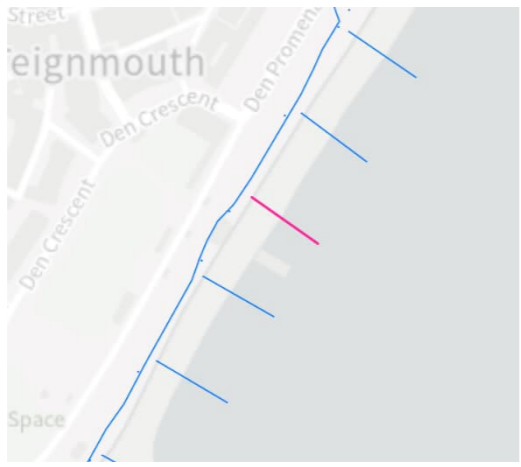
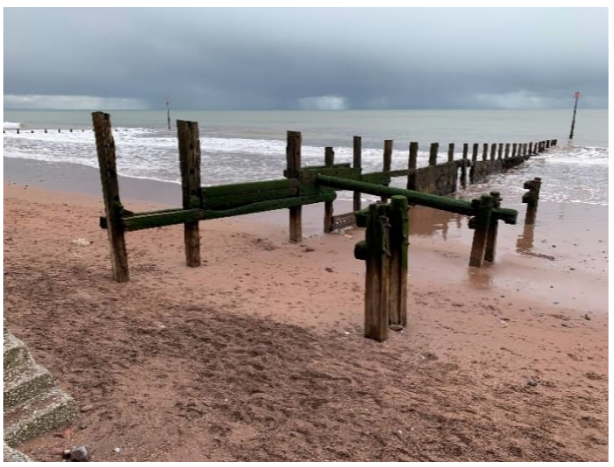
Piles vertical with no rotational movement. Some bracing support timbers missing. Majority of planks missing across upper beach. Abrasion to piles and plank. Fixings damaged or missing. Groyne not retaining beach material. Navigation marker ok.	4: Poor	Fastest	2 / 2
327115	Groyne 10	-

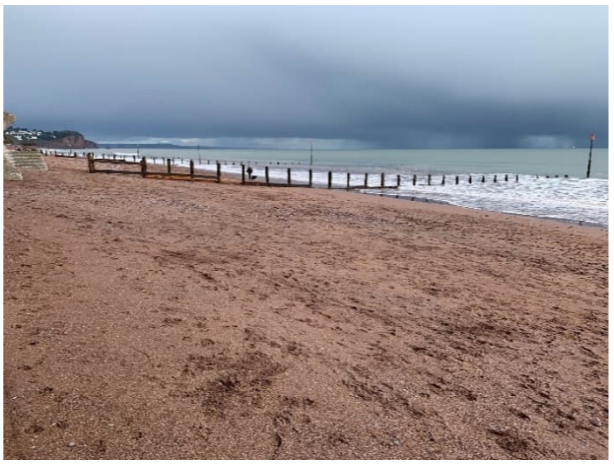
Piles vertical with no rotational movement. Missing planks across upper beach. Some splitting of piles, significant abrasion to piles and planks. Large gaps between planks where present. Fixings damaged or missing. Groyne not retaining beach material. Navigation marker ok.	4: Poor	Fastest	2 / 2

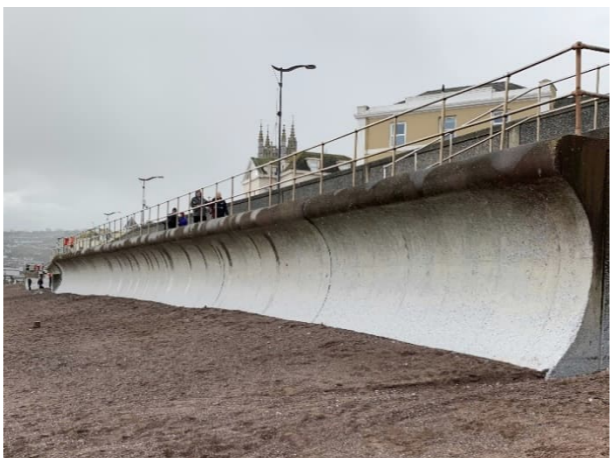
Masonry facing mostly good, some abrasion of mortar from joints. loss of mortar from joints. Loss of masonry along small section at east end by ramp. Sealant lost from many movement joints. High beach levels, toe steps not visible. Some cracks in upper concrete wall section. Navigation marker ok.	2: Good	Fastest	30 / 25
327084	Groyne 8	-

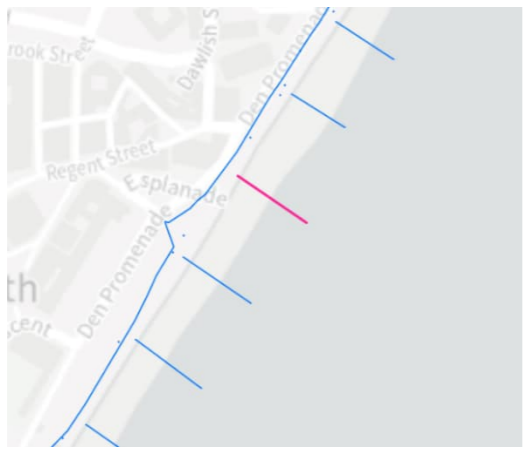
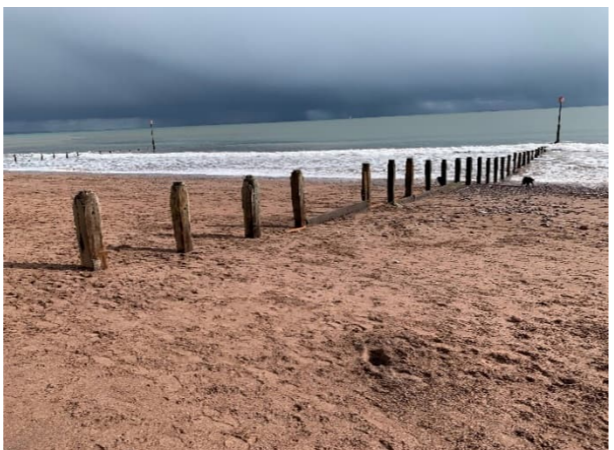
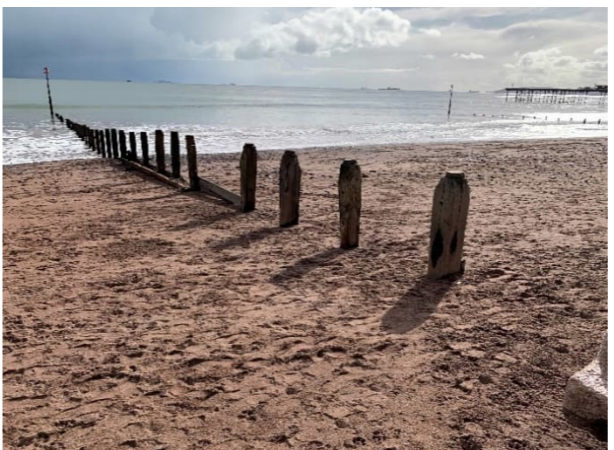
Piles vertical with no rotational movement. Significant abrasion and some splitting to piles. Planks missing or buried across upper and mid beach. Large gaps between planks where present. Groyne not retaining beach material. Navigation marker ok.	4: Poor	Fastest	2 / 2
327083	Groyne 7	-

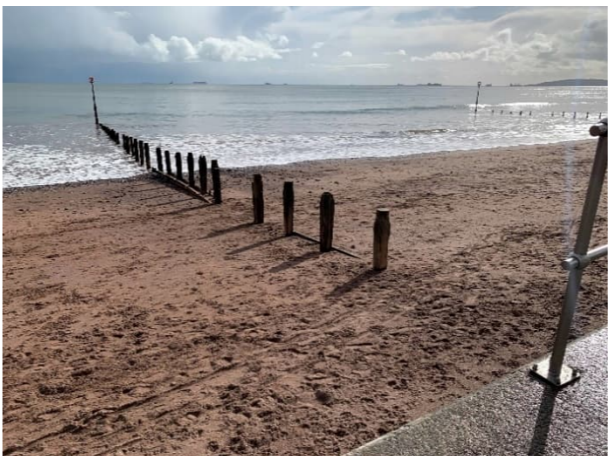
Groyne largely buried. Significant abrasion and splitting to piles, some piles broken/missing. Planks buried or missing along majority of groyne. Fixings damaged or missing. Groyne not retaining beach material. Navigation marker ok.	4: Poor	Fastest	2 / 2

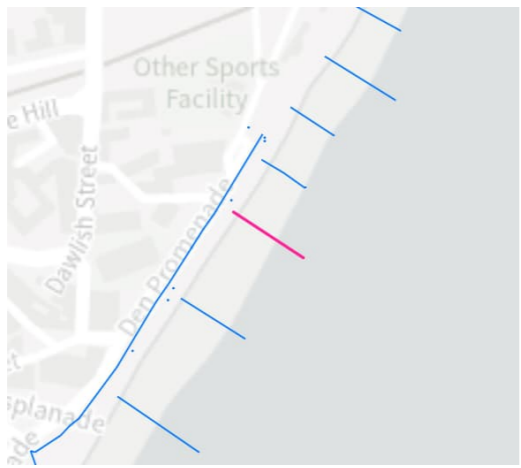
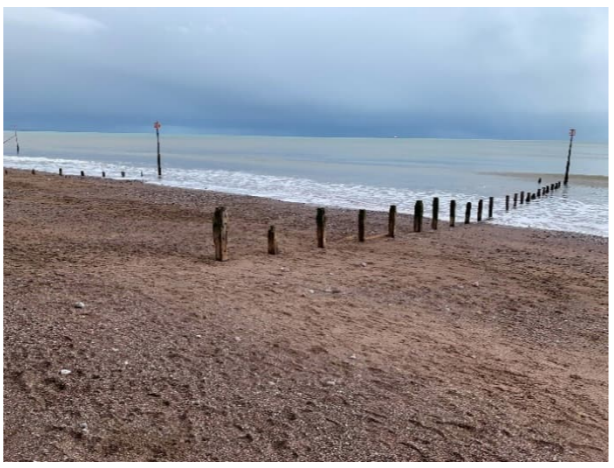
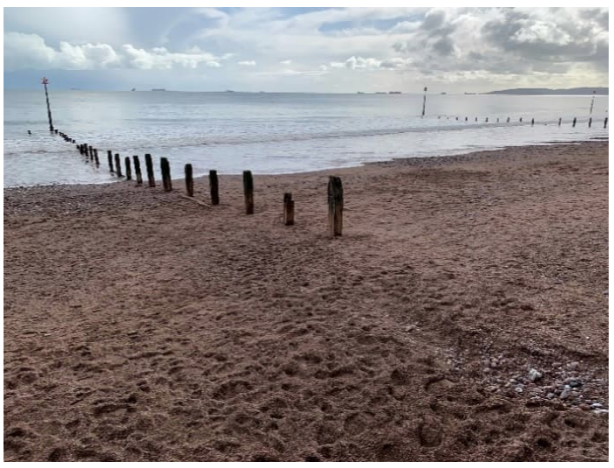
Piles vertical with no rotational movement. Significant abrasion and splitting of the piles, some piles missing. Planks missing or buried along majority of groyne. Groyne not retaining beach material. Navigation marker ok.	4: Poor	Fastest	2 / 2
497233	Groyne 5	-

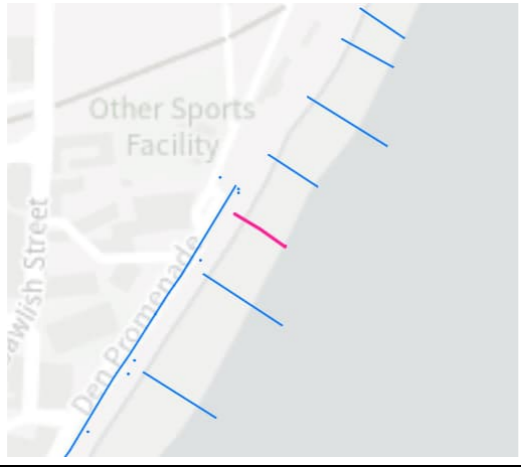
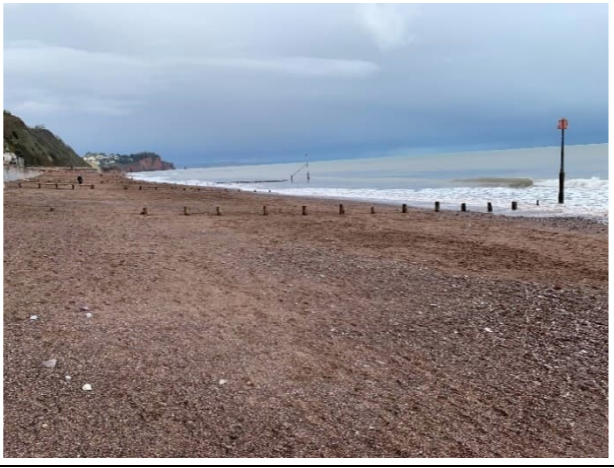
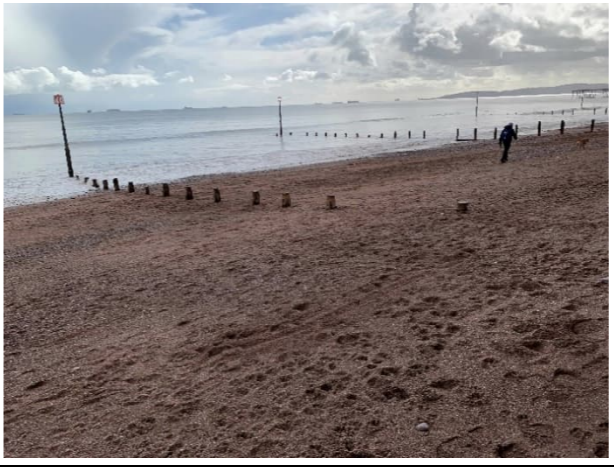
Groyne largely buried. Planks missing. Groyne not retaining beach material. Navigation marker ok.	4: Poor	Fastest	2 / 2
n/a	Masonry Wall	160m

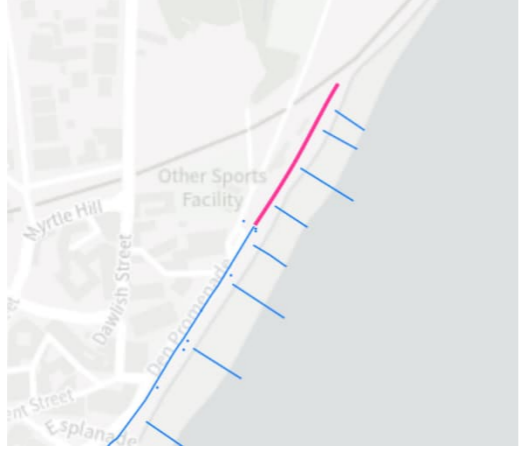
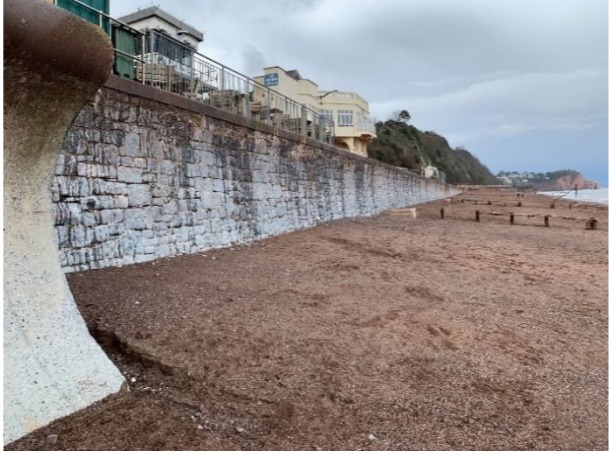
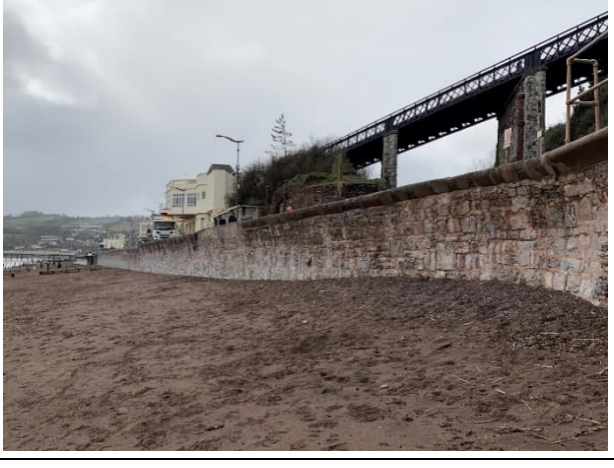
Masonry and mortar in ok condition, some abrasion of mortar but no gaps. Section of wall replaced by concrete, some horizontal gaps in construction joints. High beach levels over toe.	3: Fair	Fastest	20 / 15

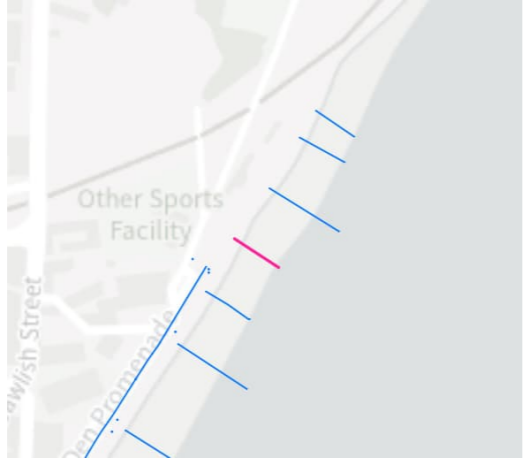
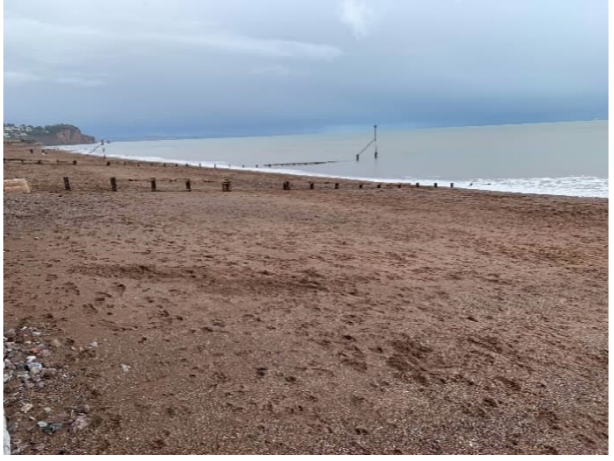
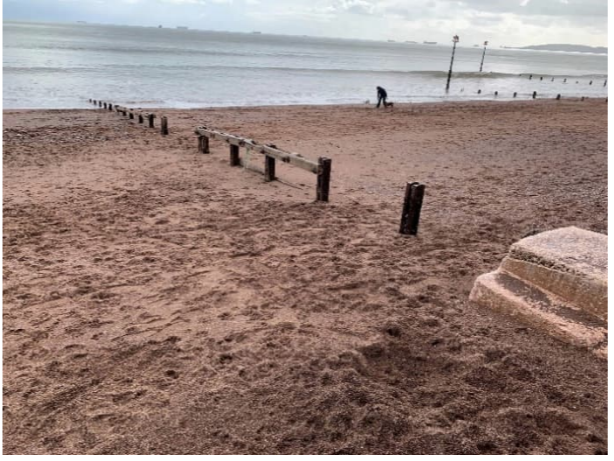
Groyne largely buried. Metal piles visible. Many planks missing, significant abrasion to planks that remain. Majority of fixings corroded. Groyne not retaining beach material. No navigation marker.	4: Poor	Fastest	2 / 2
327080	Groyne 3	-

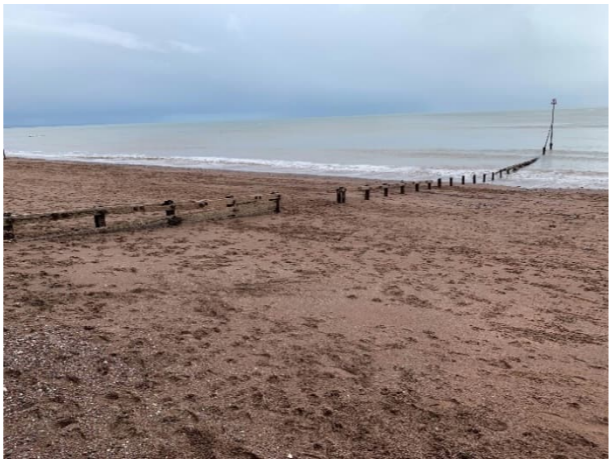
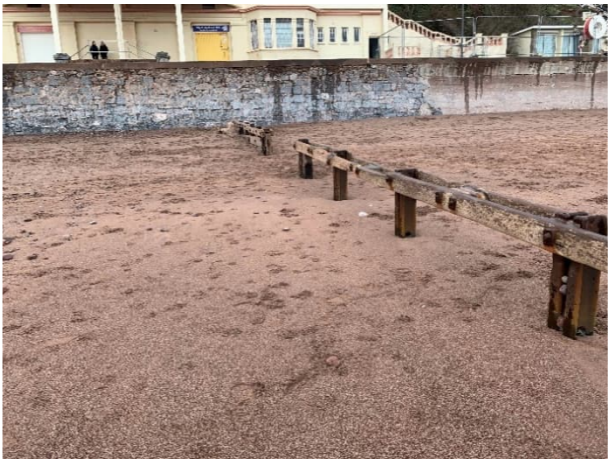
Groyne largely buried. Majority of planks missing, abrasion and large gaps between planks that remain. Groyne not retaining beach material. Navigation marker ok.	4: Poor	Fastest	2 / 2
327079	Groyne 2	-

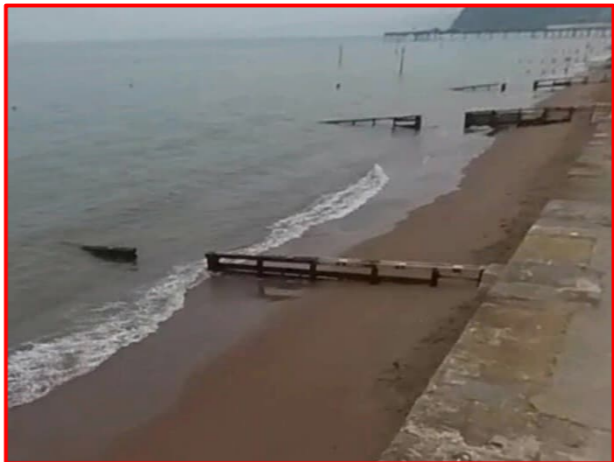
Completely buried at time of inspection. Historic photos from May 2018 included for reference (reference Google Street View).	Groyne completely buried. No navigation marker. Historic photos May-18 show missing planks missing, abrasion and large gaps between planks.	4: Poor	Fastest	2 / 2

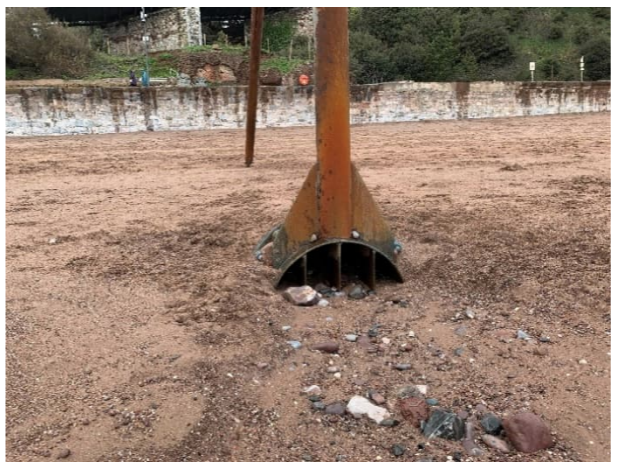
Groyne completed buried except for gridded outlet to pipe. Navigation marker ok.	-	Fastest	-

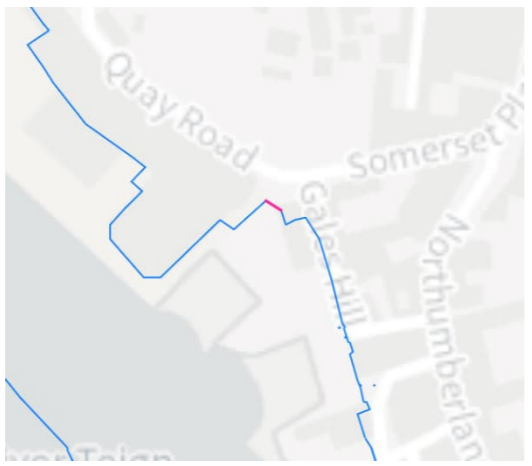
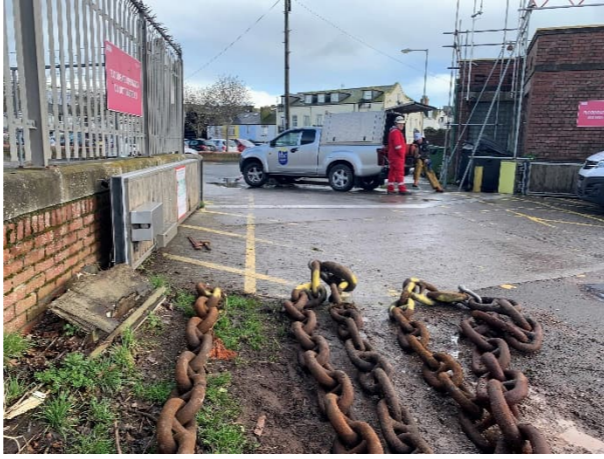
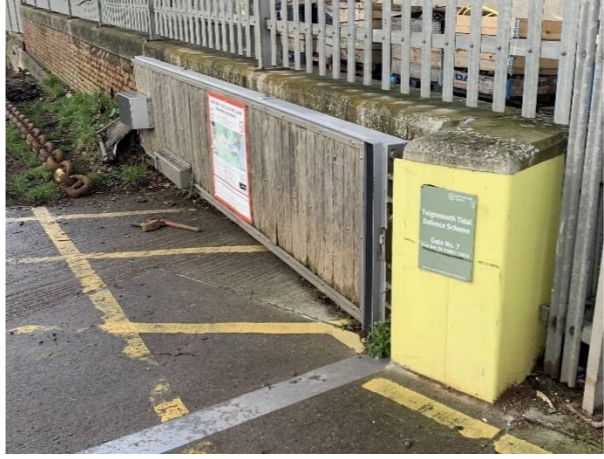
Gate, hinges and sealing faces in good condition. Timber facing ok. Gate and frame alignment appears ok. Gates not operated during inspection.	2: Good	Slowest	22 / 17
392717	Pumping Station Wall	7.1m

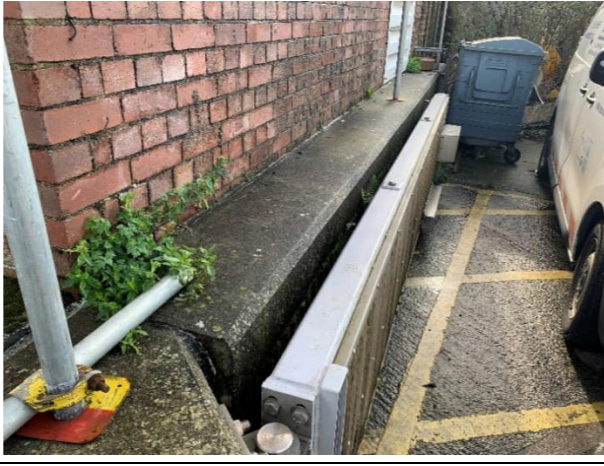
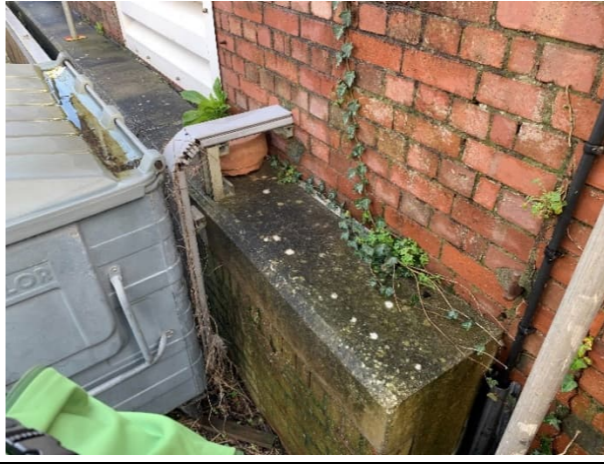
Some spalling of bricks and loss of mortar. Some vegetation growth.	2: Good	Slowest	80 / 65
392716	Masonry Wall	10.3m

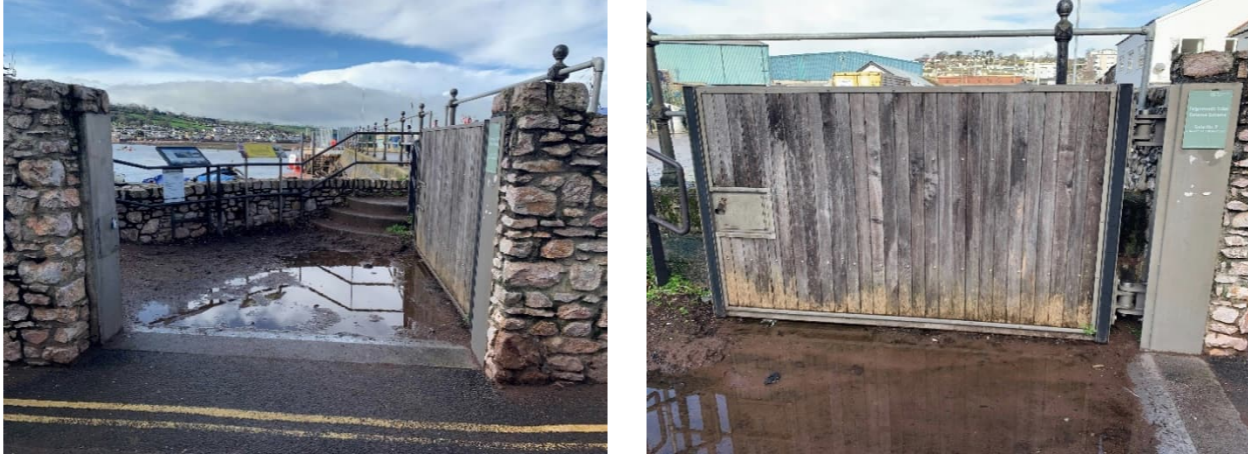
Gate, hinges and sealing faces in good condition. Gate and frame alignment appear ok. Gates not operated during inspection.	2: Good	Slowest	22 / 17

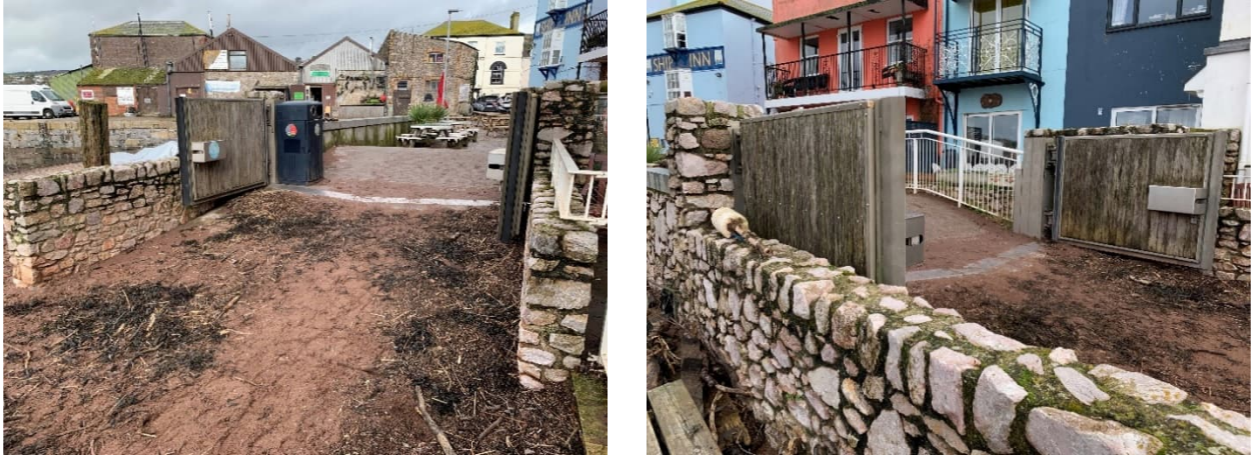
Gate and hinges in good condition. Some cracks and splitting of seals. Gate and frame alignment ok. Some rot to facing timbers. Debris on beach side of gate. No damage visible. Gate not operated during inspection.	2: Good	Slowest	22 / 17
180673	Masonry Wall with Glazing	3.8m

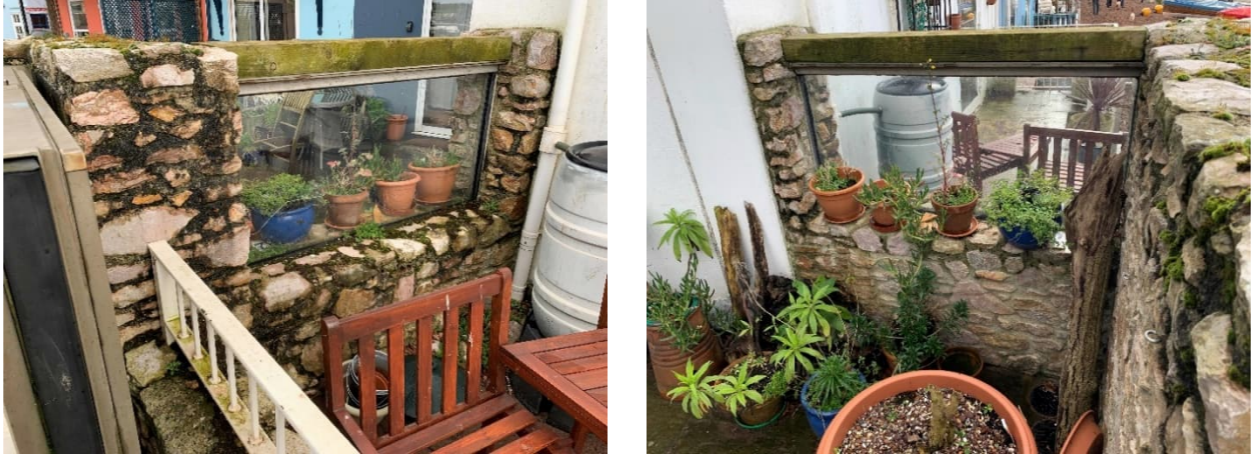
Masonry and mortar joints ok. No cracks or settlement. Large amounts of algae growth. Window and seal ok. Timber lintel in poor condition.	2: Good	Slowest	80 / 65

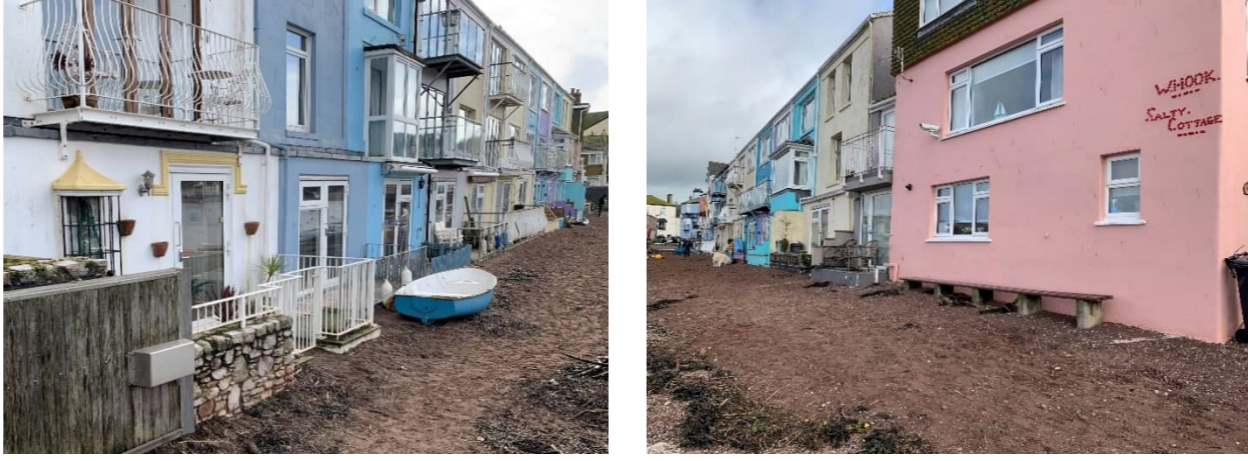
No cracks in render or signs of movement or settlement. Floodproof windows and doors appear ok. Evidence of one door having been replaced. High beach levels, wide crest.	3: Fair	Slowest	40 / 35
180630	Ivy Lane - north wall	24.6m

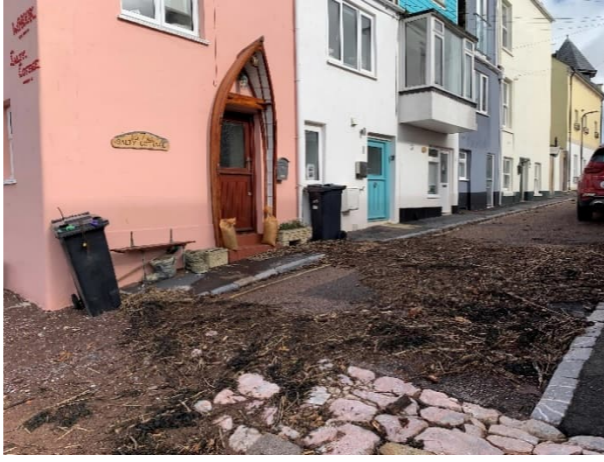
No cracks in render or signs of movement or settlement. Floodproof windows and doors appear ok.	3: Fair	Slowest	40 / 35
392783	Engineered High Ground	6.1m

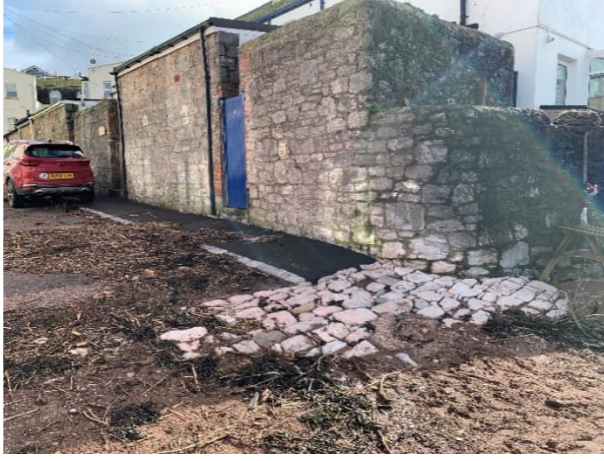
Masonry blocks and mortar joints ok. No cracks or signs of movement or settlement. No flood proof doors at openings.	3: Fair	Slowest	40 / 35
392776	Masonry Property Wall	24.0m

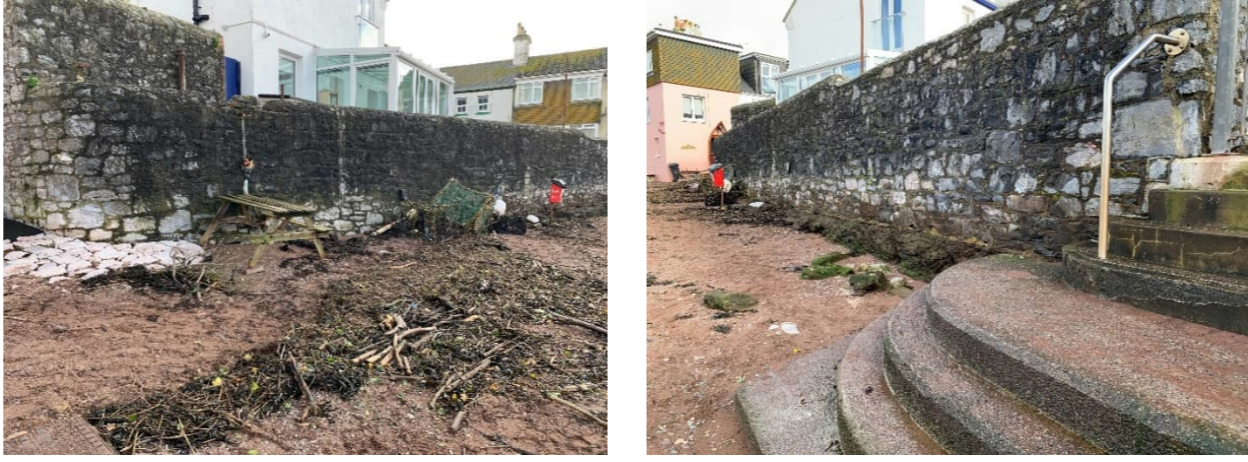
Stone blocks and mortar ok, no cracks. Two sections of missing coping. Flap valve in good condition. Minor erosion and undermining of concrete toe. No access to landward side.	2: Good	Slowest	80 / 65
392774	Floodgate Coastguard Station	2.8m

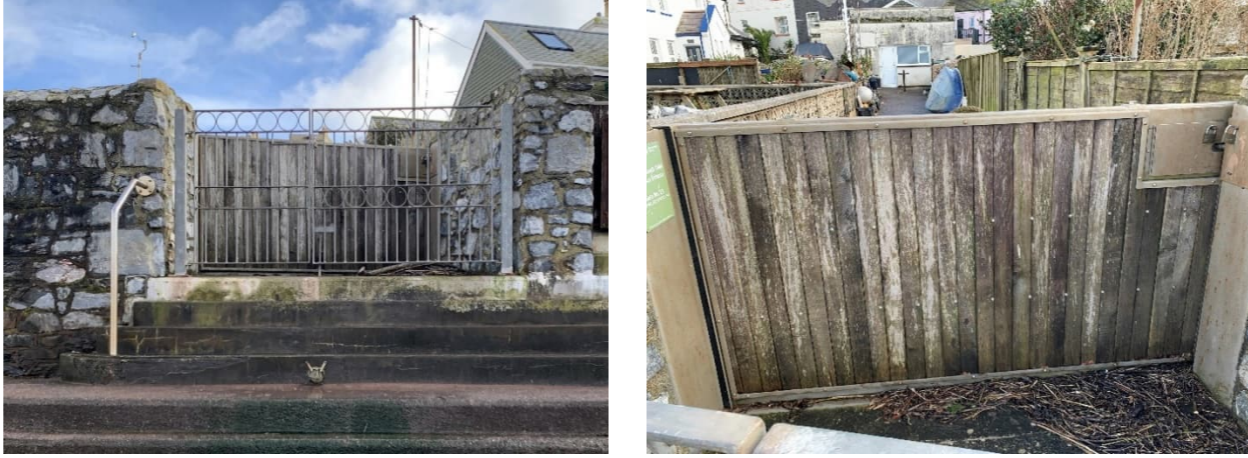
Gate and frame ok, timber facing boards in fair condition. Minor corrosion to frame. Seals not visible as gate closed. Hinges not accessible as no access to landward side. Gate not operated at time of inspection.	2: Good	Slowest	22 / 17

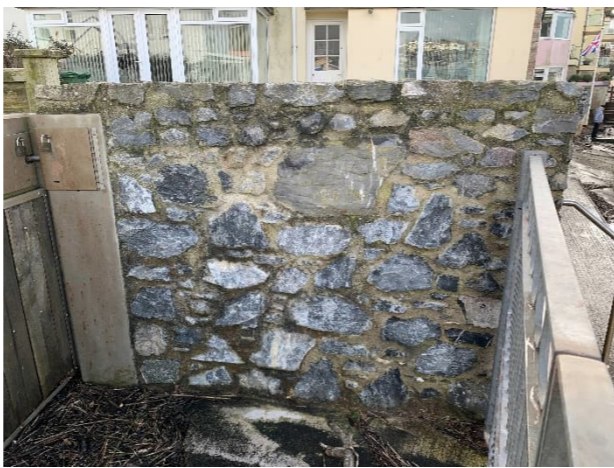
Masonry blocks and mortar joints ok, no cracks. No access to landward side.	2: Good	Slowest	80 / 65
392778	Floodgate 6 Marine Terrace	1.1m

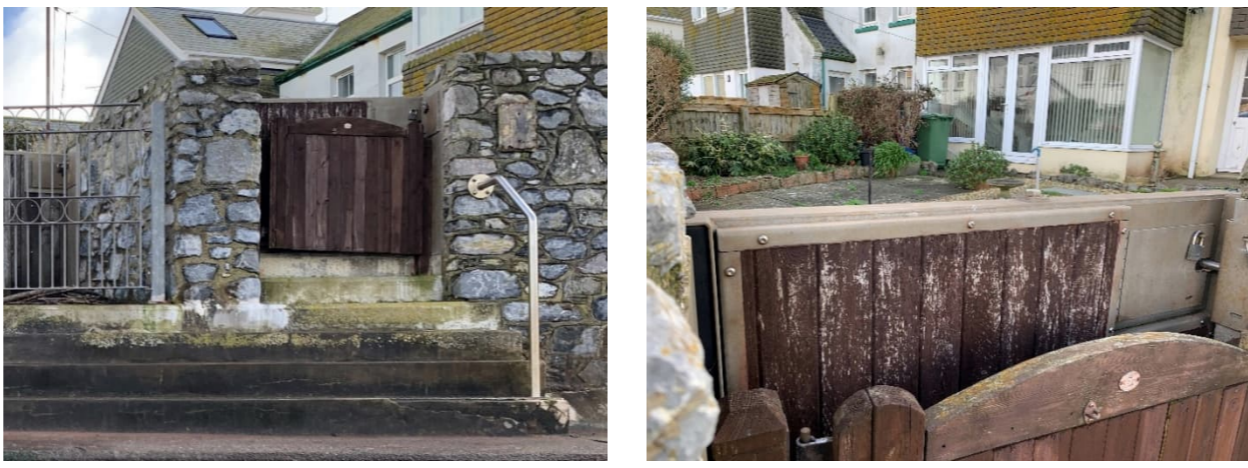
Gate and frame ok, timber facing boards in fair condition. Minor corrosion to frame. Seals and hinges not visible as gate closed. Gate not operated at time of inspection. No access to landward side.	2: Good	Slowest	22 / 17
392779	Masonry Property Wall	20.6m

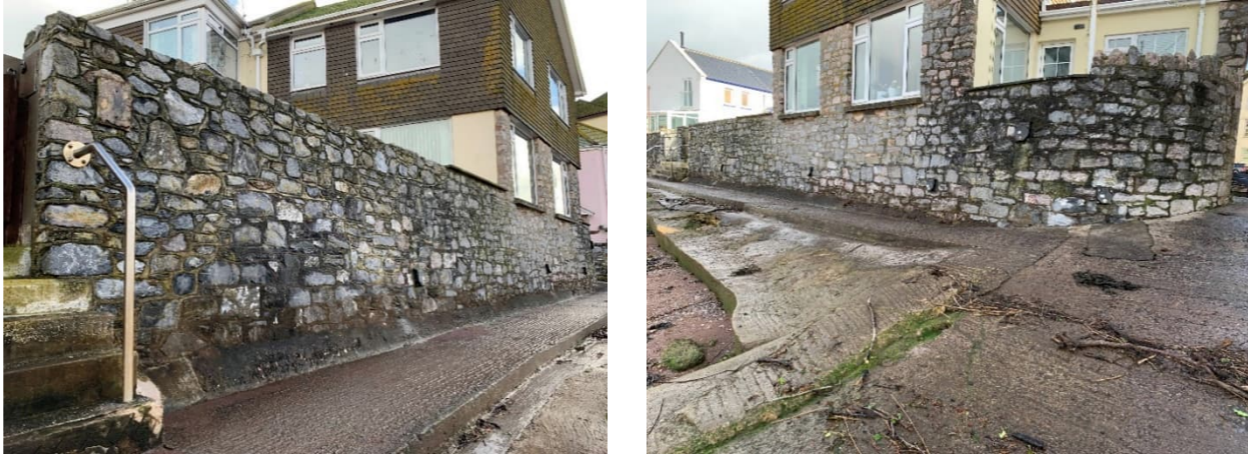
Masonry blocks and mortar joints in good condition, no cracks. Minor undermining to concrete apron at toe. Flap valves in good condition.	2: Good	Slowest	80 / 65

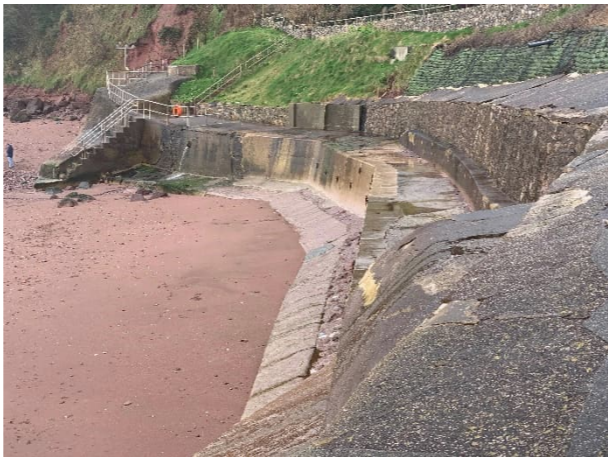
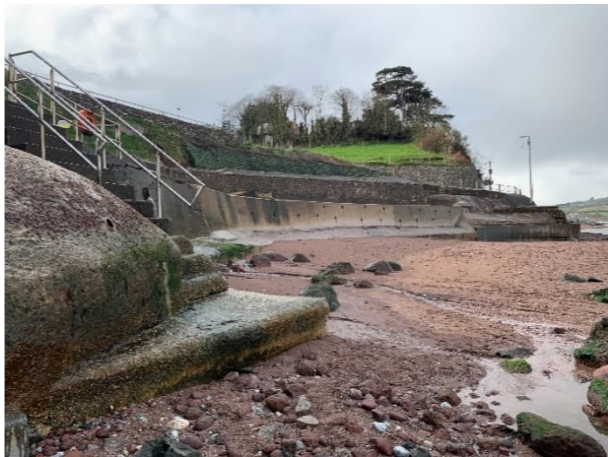
General cracks and spalling to concrete, missing flap valves, abrasion to concrete toe and steps, corrosion of reinforcement in sprayed concrete facing, erosion to earth bank at crest, some undermining of toe at northern end. Escape ladder in good condition.	3:Fair	Medium	30 / 20
84539	Masonry Wall	151.8m

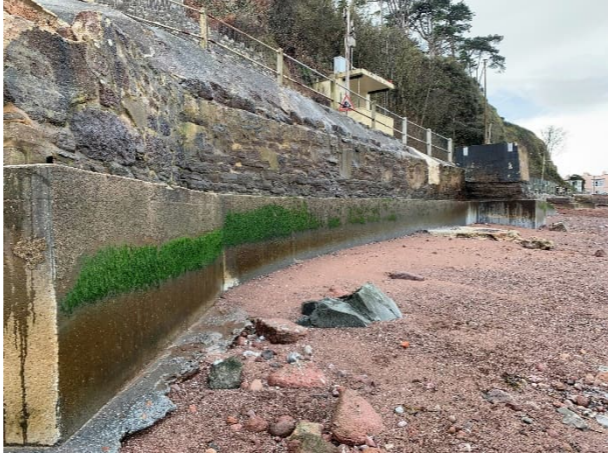
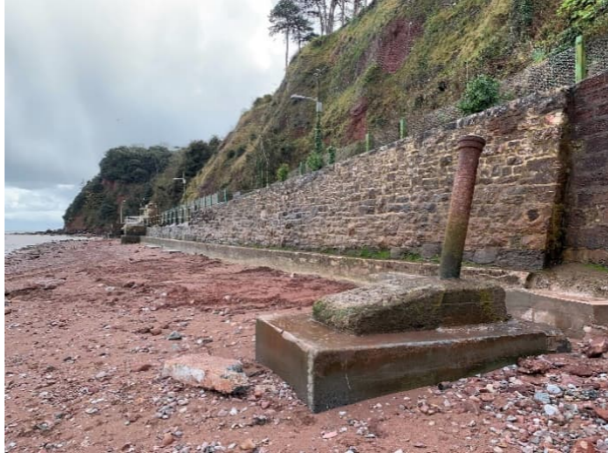
No gaps in masonry joints. Mortar good. Concrete repairs to masonry sound. Some abrasion to concrete toe, occasional cracks. Initial undermining of concrete toe in places, contractor on site filling voids with concrete.	2: Good	Medium	55 / 40

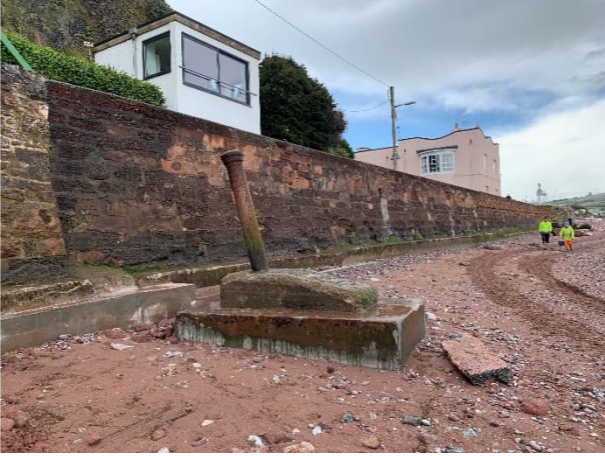
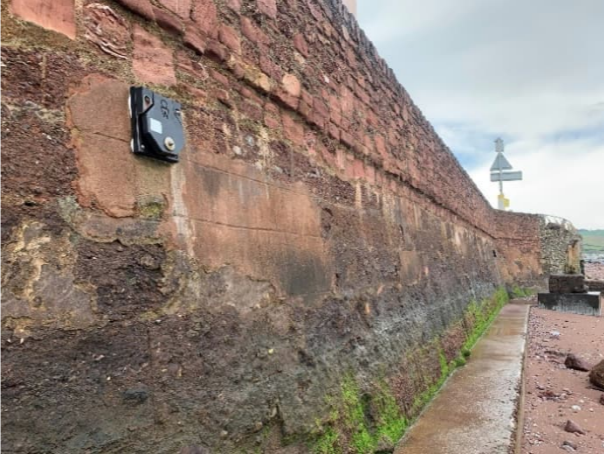
No gaps in masonry. Expansion joints good. Some masonry, in good condition. Minor erosion of lower wall and toes.	3: Fair	Medium	30 / 20
84537	Masonry Wall	106.5m

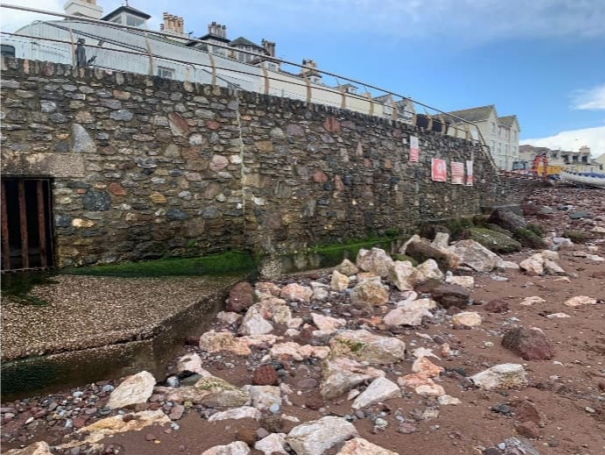
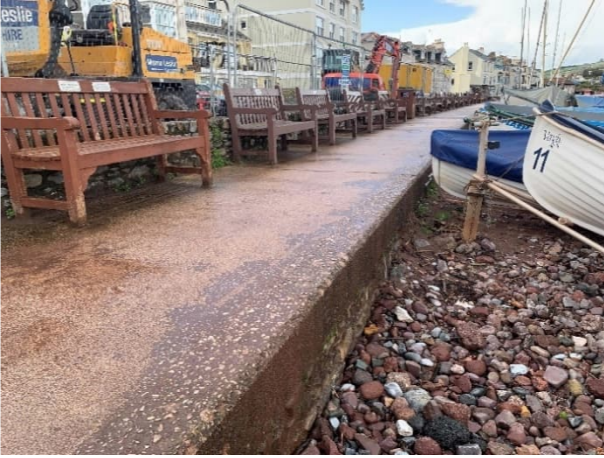
No gaps in masonry. Expansion joints good. No cracks in promenade surfacing. Generally high beach levels. Localised undermining of toe at southern end.	2: Good	Medium	55 / 40
332938	Ferry Boat Shelter flood gate 10	5.6m
