Teignbridge District Council

Teignmouth Beach Management Plan

Teignmouth and Shaldon Beach Management Plan

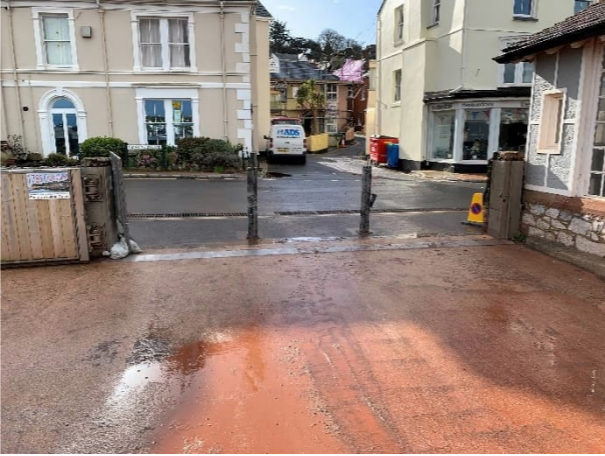
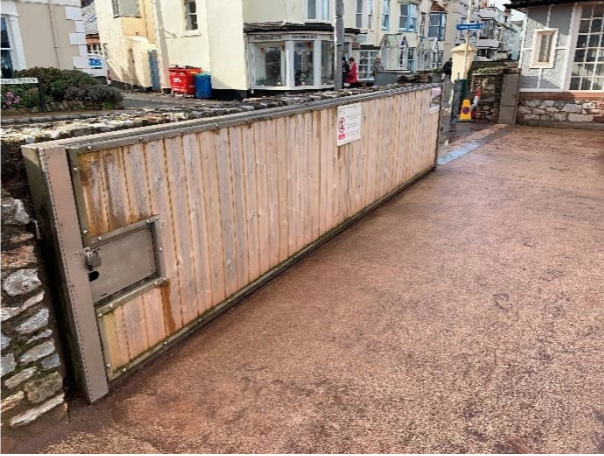
Gate, hinges and sealing faces in good condition. Gate and frame alignment appear ok. Seals protected by metal covers. Gates not operated during inspection.	2: Good	Slowest	22 / 17

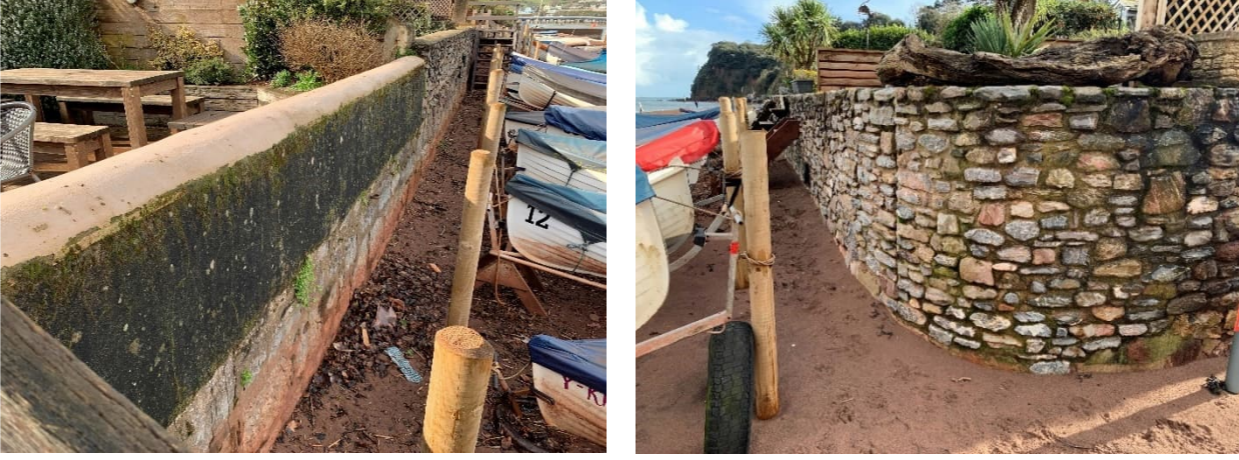
No gaps in masonry. Minor abrasion at the base of the historic wall. Mortar in good condition, some separation between mortar and masonry. Joints in good condition.	2: Good	Slowest	80 / 65
332936	Beach Comber flood boards	3.4m

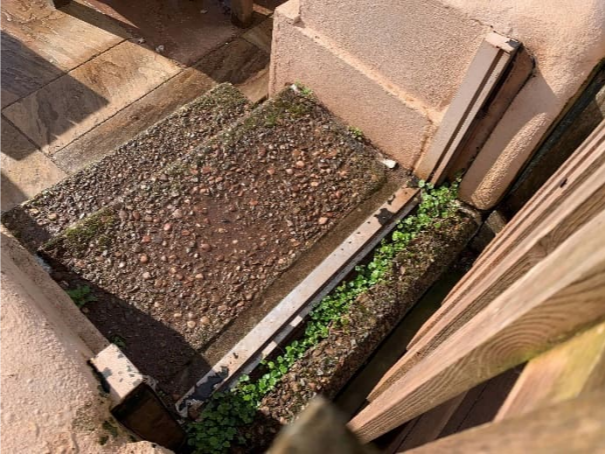
Channels appear straight. No signs of damage. Minor corrosion and degradation of protective coating, no boards present at time of inspection. Boards assumed to be metal due to narrow channels.	3: Fair	Slowest	50 / 15
332937	Ferry Boat Pub flood boards	3.3m

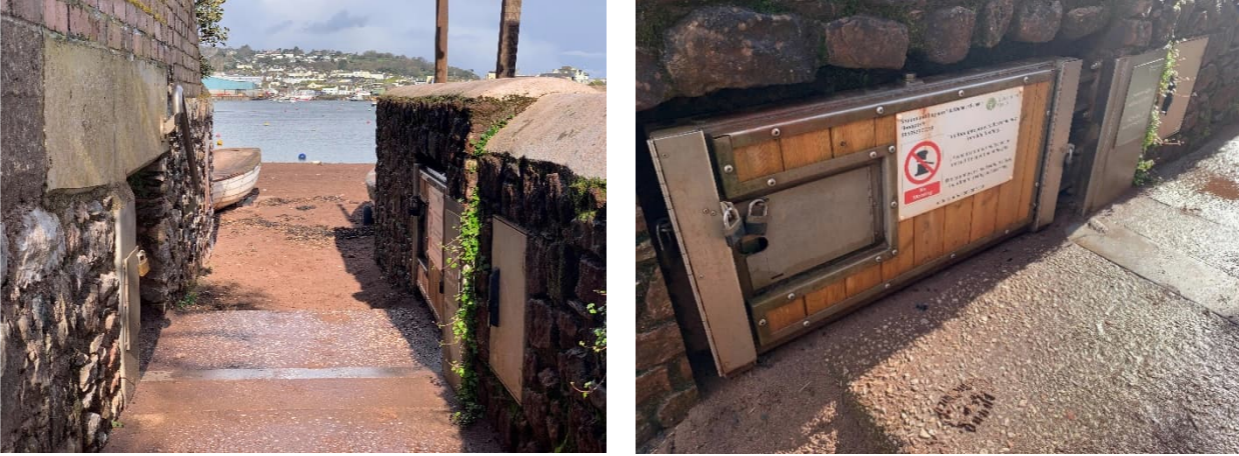
Gate, hinges and sealing faces in good condition. Gate and frame alignment appear ok. Seals protected by metal covers. Gate not operated during inspection.	2: Good	Slowest	22 / 17
332934	Tom Thumb Alleyway flood gate 8	1.5m

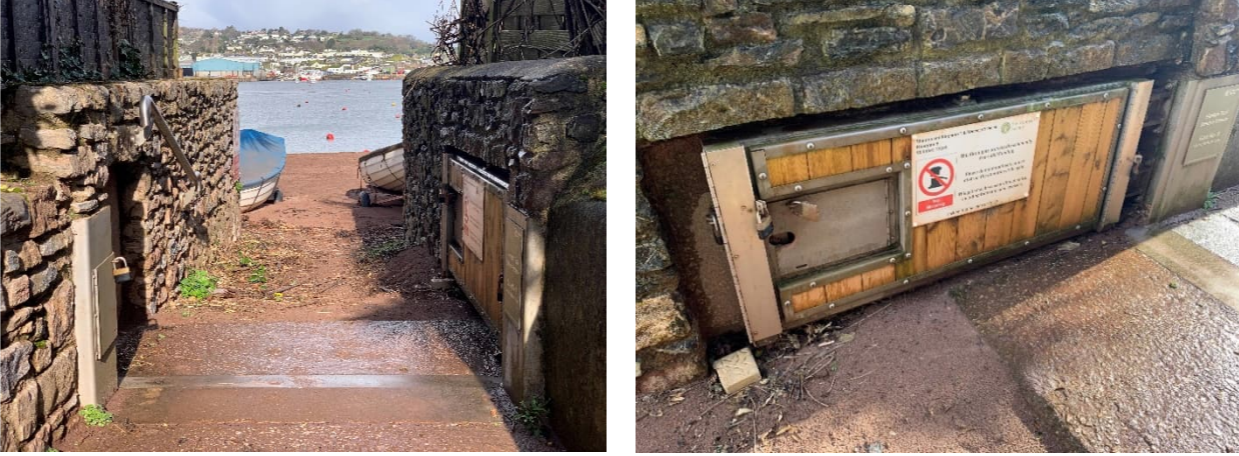
Gate, hinges and sealing faces in good condition. Gate and frame alignment appear ok. Seals protected by metal covers. Gate not operated during inspection.	2: Good	Slowest	22 / 17
332933	Manor Alleyway Slipway flood gate 7	4.4m

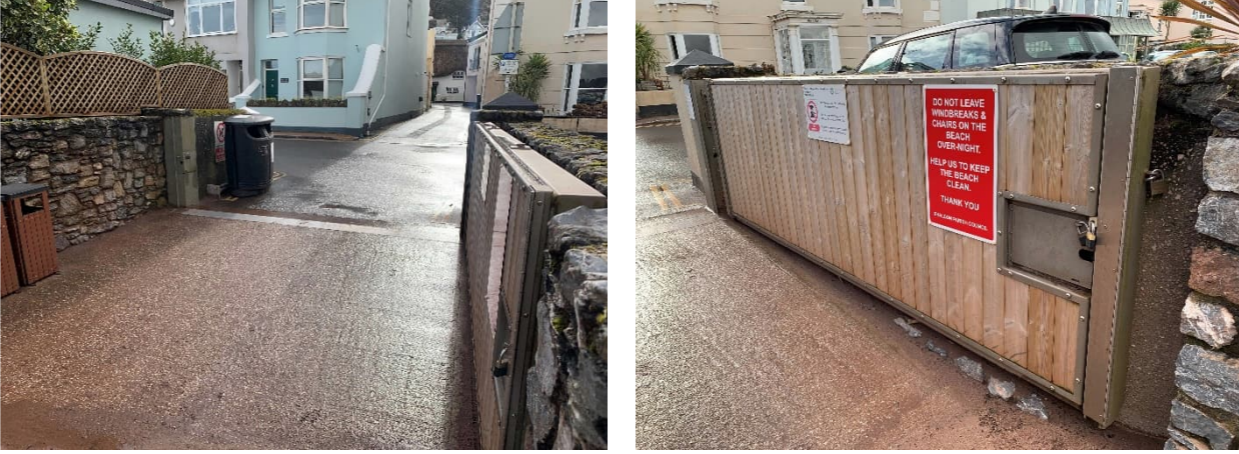
Gate, hinges and sealing faces in good condition. Gate and frame alignment appear ok. Seals protected by metal covers. Gate not operated during inspection.	2: Good	Slowest	22 / 17

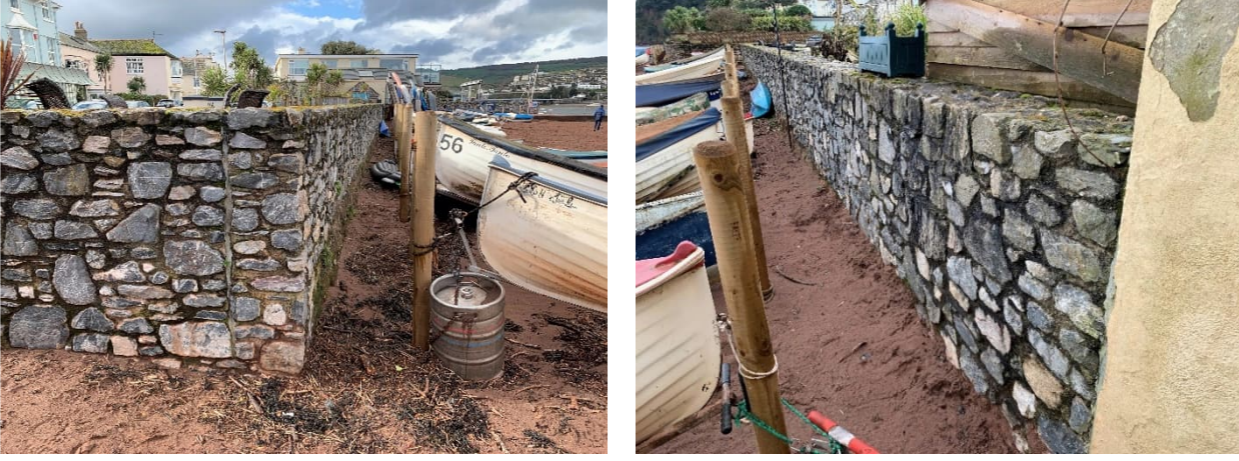
Minor abrasion to lower stone and mortar. Joints in good condition.	2: Good	Slowest	80 / 65
82710	Masonry Wall	35m

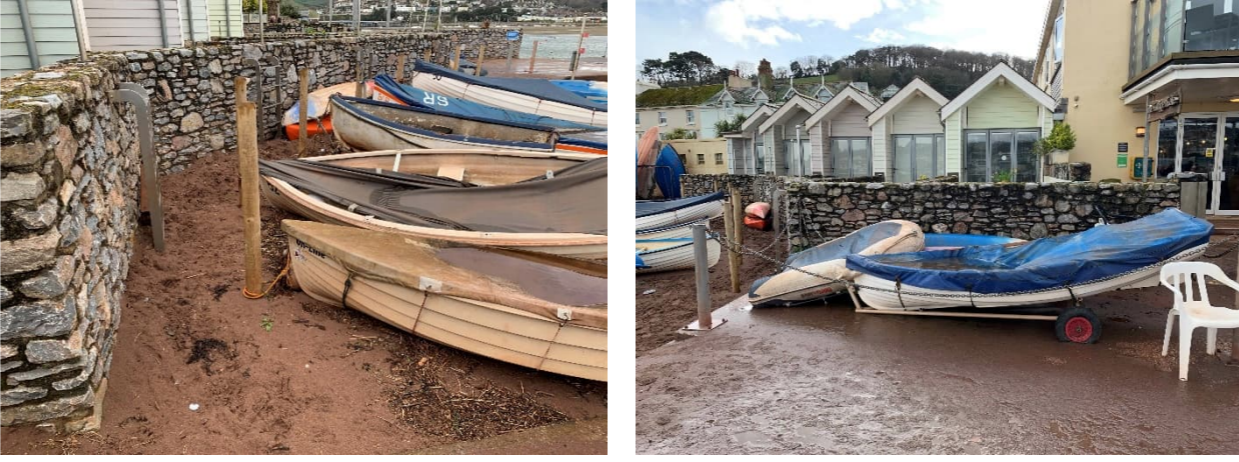
Minor undermining at building. Masonry and mortar in good condition. Some abrasion over lower half of the wall. Access ladders in good condition. Flap valves in good condition.	2: Good	Slowest	80 / 65
332932	Shaldon Quay flood gate 6	4.8m

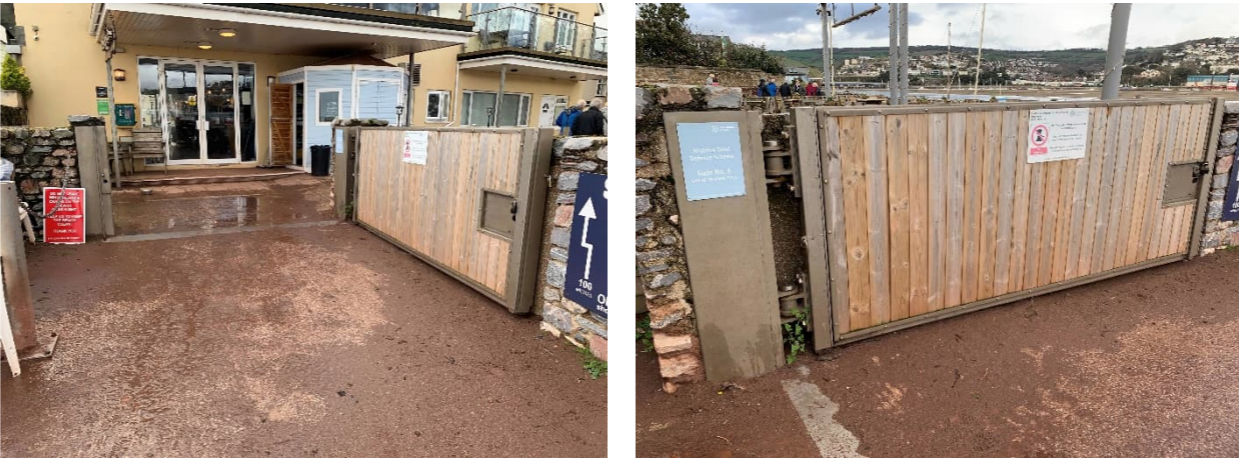
Gate, hinges and sealing faces in good condition. Gate and frame alignment appears ok. Seals protected by metal covers. Gates not operated during inspection.	2: Good	Slowest	22 / 17

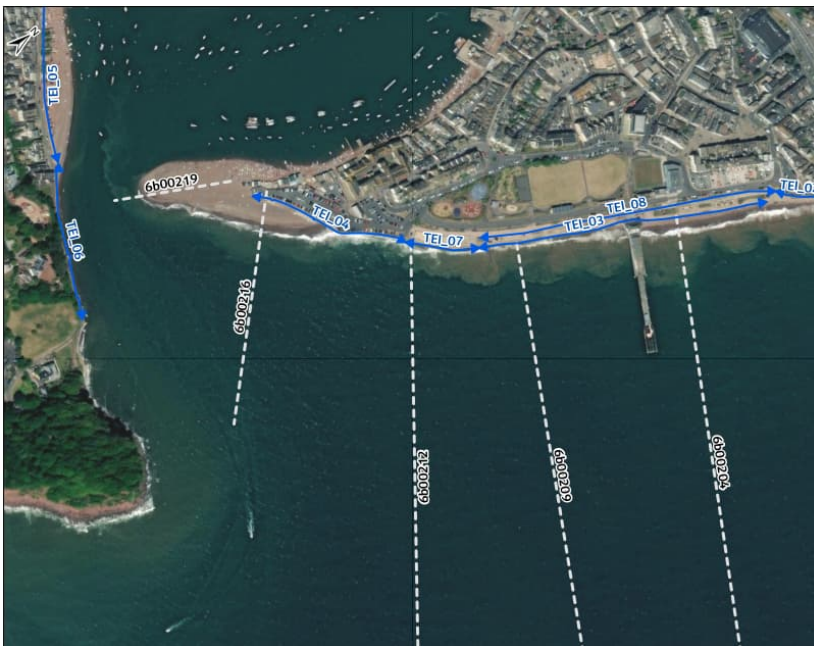
Figure 2-1: Profiles from JBA (2021) and BMP (2014)- Shaldon to the pier at Teignmouth.

The two reports consider different sets of profiles along the coast. The BMP uses beach profiles from the Southwest Regional Coastal Monitoring Programme (SWRCMP) while JBA have adopted other profiles these are combined in the plan as seen in Figure 2-1 and Figure 2-2.
