Visualisation of New Entrance

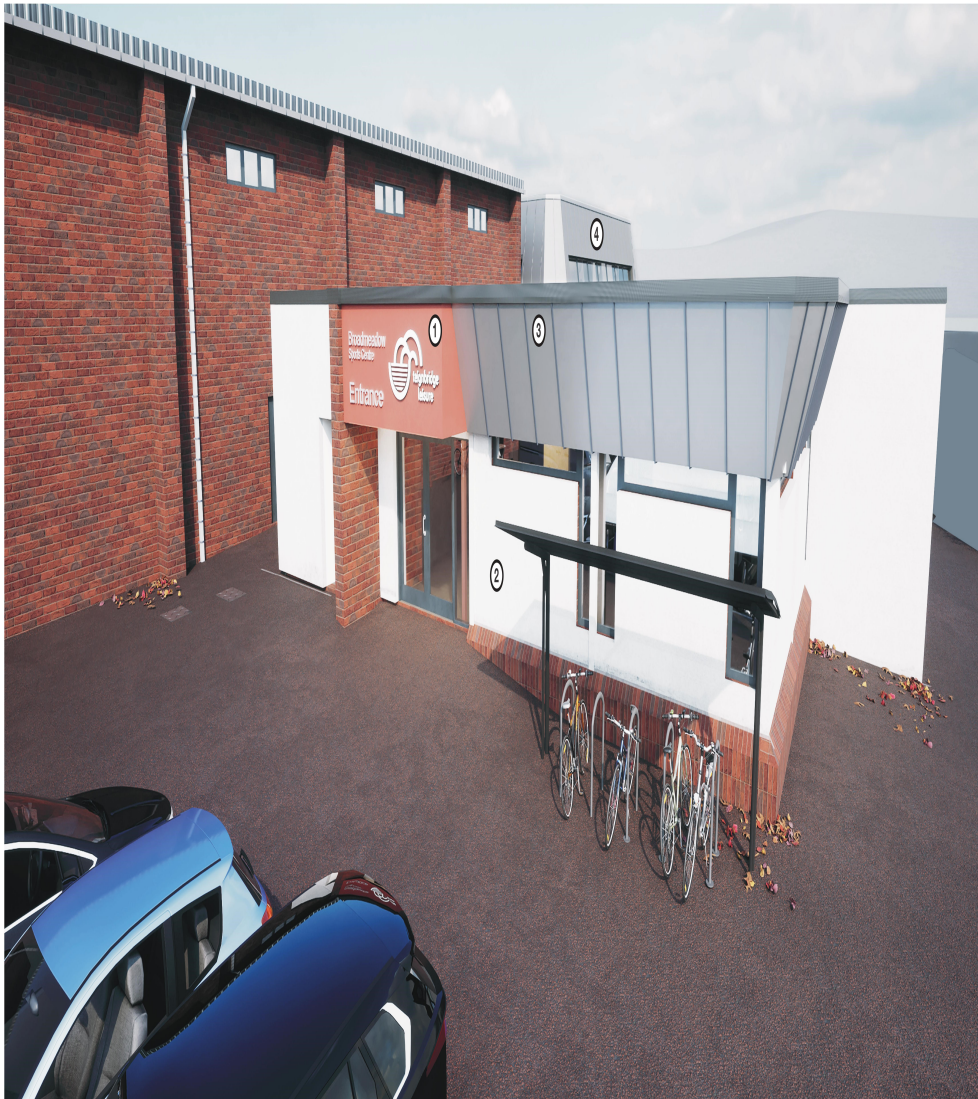
- ① Main entrance relocated to face car park. New external canopy created with signage over new entrance. External lighting to underside of canopy.
- ② Existing wall externally insulated and rendered for improvement of thermal performance. Windows upgraded throughout.
- ③ High-level metal cladding replaced throughout and insulation added.
- ④ Cladding and windows to spin studio upgraded.
